2015 Annual Groundwater Review*

Dundon Consulting Pty Limited

Re: Abel Coal Project – Annual Groundwater Review – 2015 Year

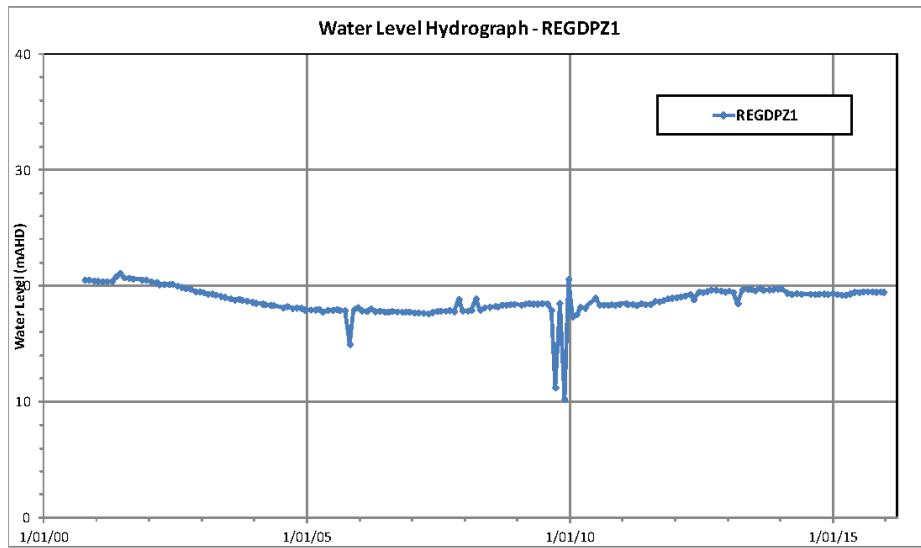
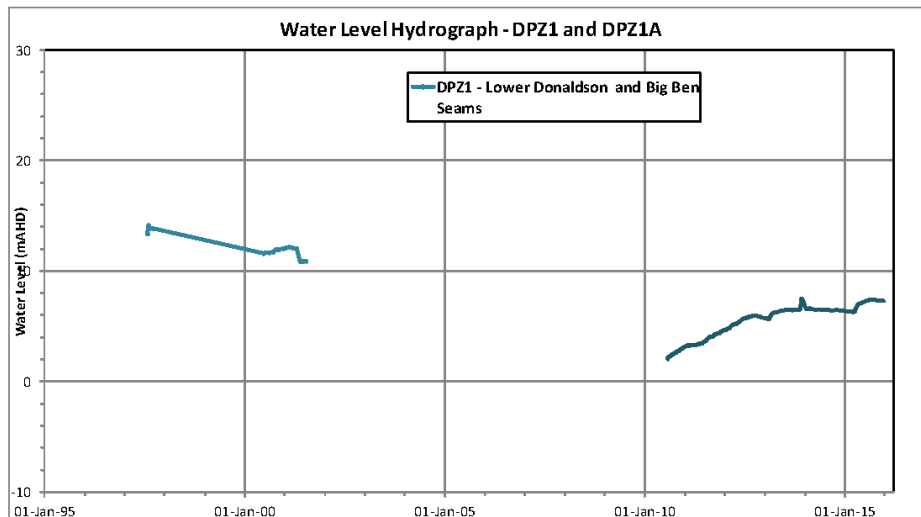
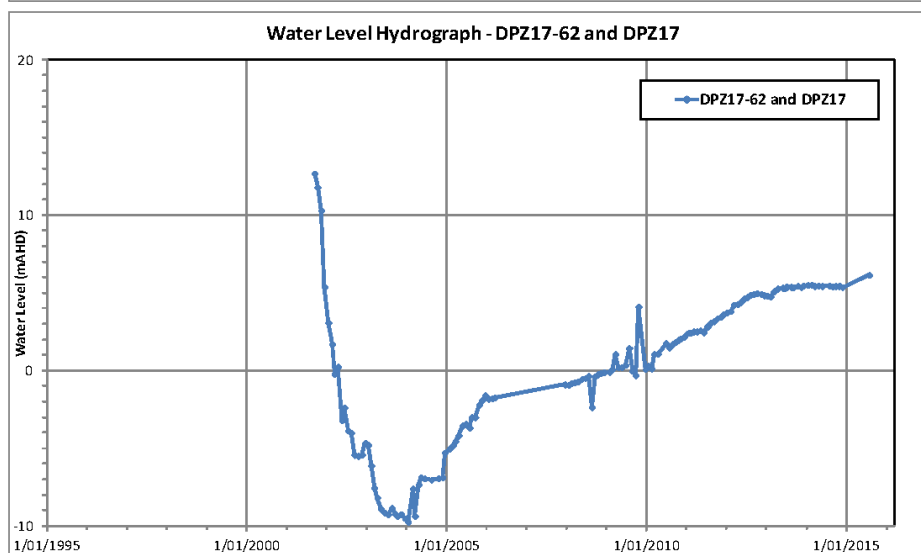
DATE: 15 February 2016	SCALE: N/A	Donaldson Coal Pty Ltd ABEL UNDERGROUND MINE WATER LEVEL HYDROGRAPHS - REGDPZ1, DPZ1A and DPZ17
AUTHOR: PD CHECKED: PD	PROJECT NO: 16-0313	
DRAWING NO: 0313-002	REVISION:	
Dundon Consulting Pty Ltd		Figure 2

- REGDPZ1 (**Figure 2**) – a regional control bore located in strata well below the Donaldson Seams. Shows gentle change in response to long-term rainfall pattern, declining gradually from 2000 to 2005 (a period of below average rainfall), and rising gradually from 2005 to 2015 (a period of slightly above average rainfall).

- DPZ1A (**Figure 2**) – replacement for DPZ1 which was screened in Donaldson Seam. Showed steady water level rise from 2010 to 2015, more slowly through 2014; relatively stable since cessation of mining in Donaldson OC, but at lower than pre-mining level.

- DPZ17 (**Figure 2**) – piezometer at 62m to base of Donaldson Seam. Showed rapid drawdown 2001 to 2004 during mining in Donaldson OC, then strong recovery from 2004 to 2013 after mining moved westwards in pit. Water level steady in 2014, and rising slightly again in 2015, but lower than pre-mining level.

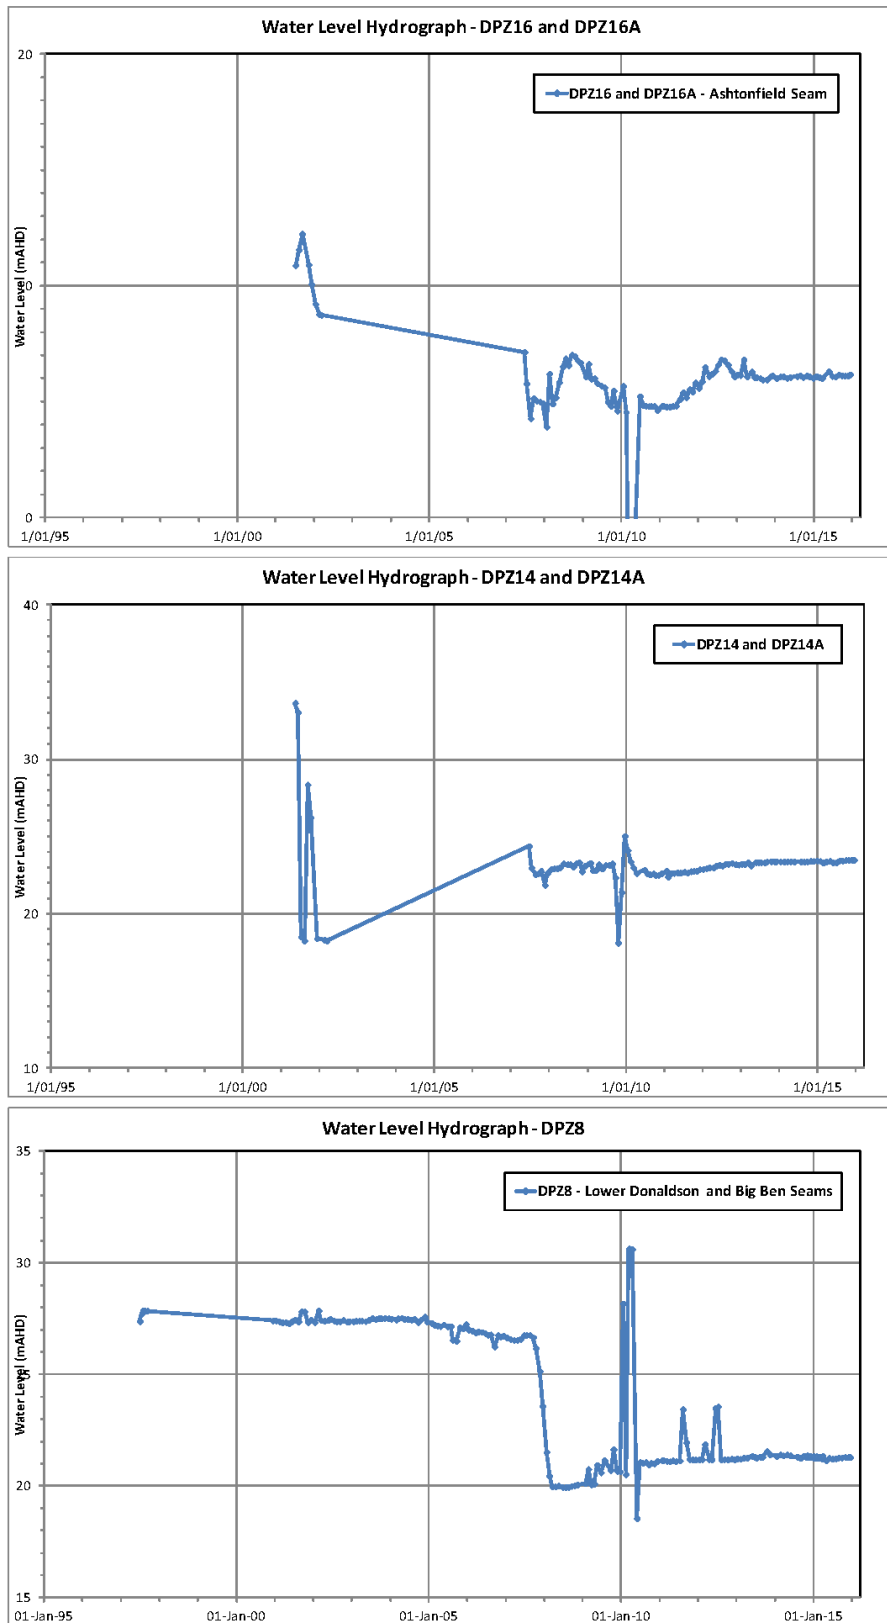
DATE: 15 February 2016	SCALE: N/A	Donaldson Coal Pty Ltd	
AUTHOR: PD CHECKED: PD	PROJECT NO: 16-0313		ABEL UNDERGROUND MINE WATER LEVEL HYDROGRAPHS - DPZ16A, DPZ14A and DPZ8
DRAWING NO: 0313-003	REVISION:		
Dundon Consulting Pty Ltd		Figure 3

- DPZ14 and 16 (**Figure 3**) – Both show some response to mining in Donaldson OC, and subsequent partial recovery, with stable water levels through 2014 and 2015.

- DPZ8 (**Figure 3**) – Screened in Donaldson and Big Ben Seams. Responded to mining in OC in 2007, then slight post-mining recovery thereafter. Water level steady in 2014-2015.

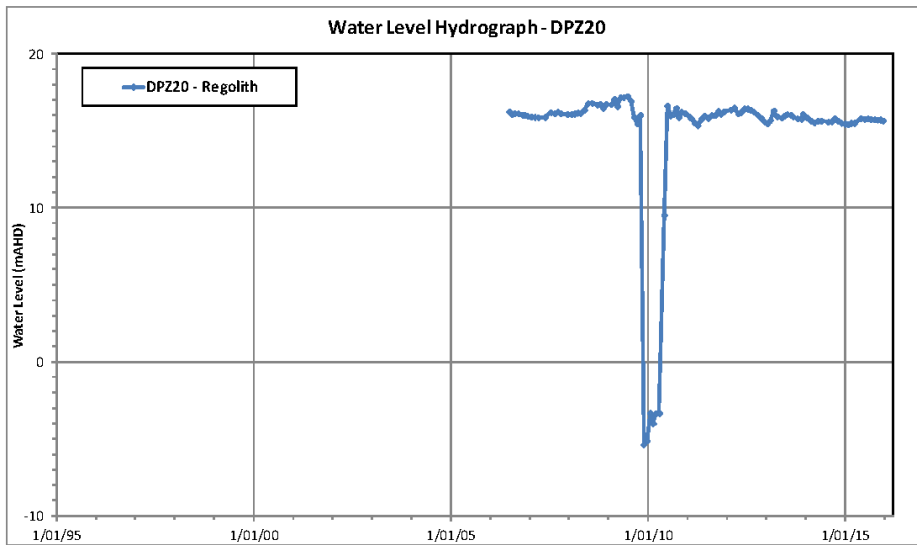
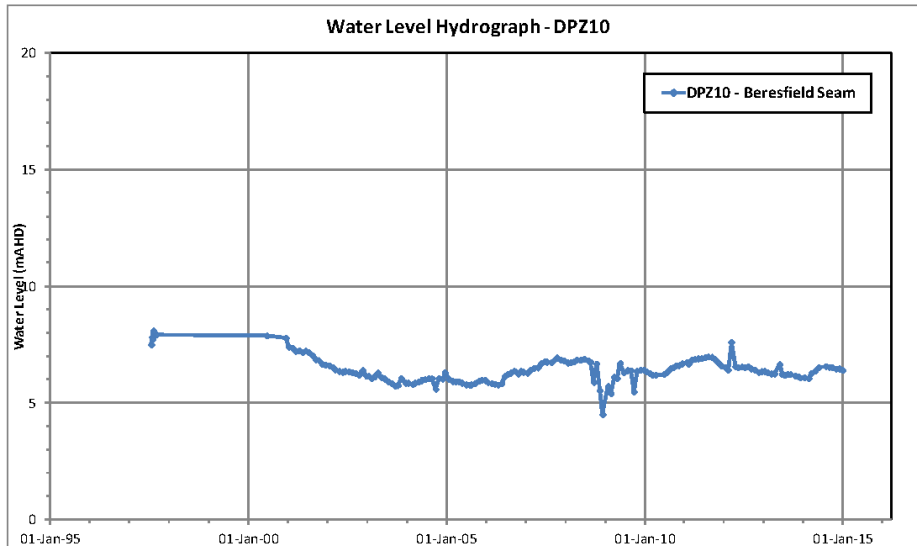
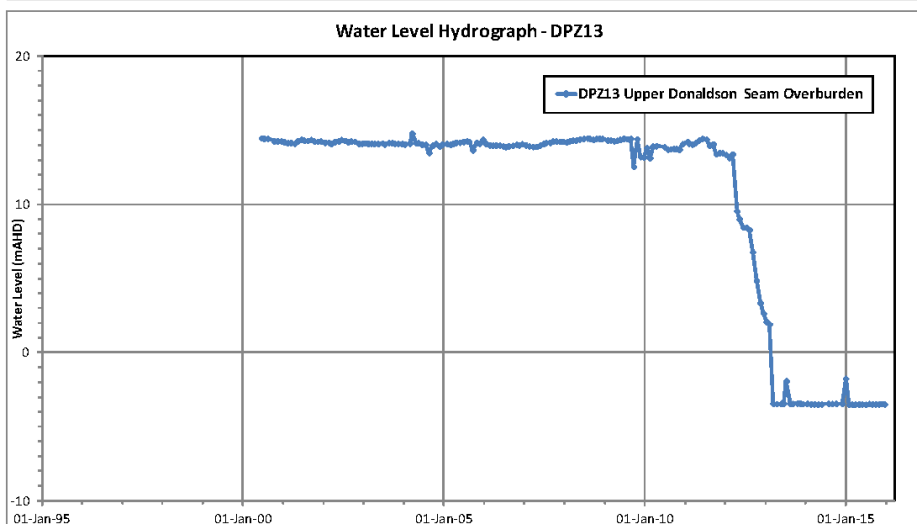
DATE: 15 February 2016	SCALE: N/A	Donaldson Coal Pty Ltd ABEL UNDERGROUND MINE WATER LEVEL HYDROGRAPHS - DPZ20, DPZ10 and DPZ13
AUTHOR: PD CHECKED: PD	PROJECT NO: 16-0313	
DRAWING NO: 0313-004	REVISION:	
Dundon Consulting Pty Ltd		Figure 4

- DPZ20 (**Figure 4**) – Regolith bore, shows modest drawdown over period of monitoring. The low water levels in 2009 and 2010 were inadvertently measured in the deep piezometer at the same site (DPZ20B).

- DPZ10 (**Figure 4**) – Screened in the Beresfield Seam, and shows modest OC mining effect from 2001 to 2006, then modest recovery, and more recent response to Abel UG mining from 2011.

- DPZ13 (**Figure 4**) – Screened in Donaldson Seam overburden, and showed no response to OC mining, but clear response to Abel UG mining from early 2012. Groundwater level appears to have been below the bottom of the bore since 2013.

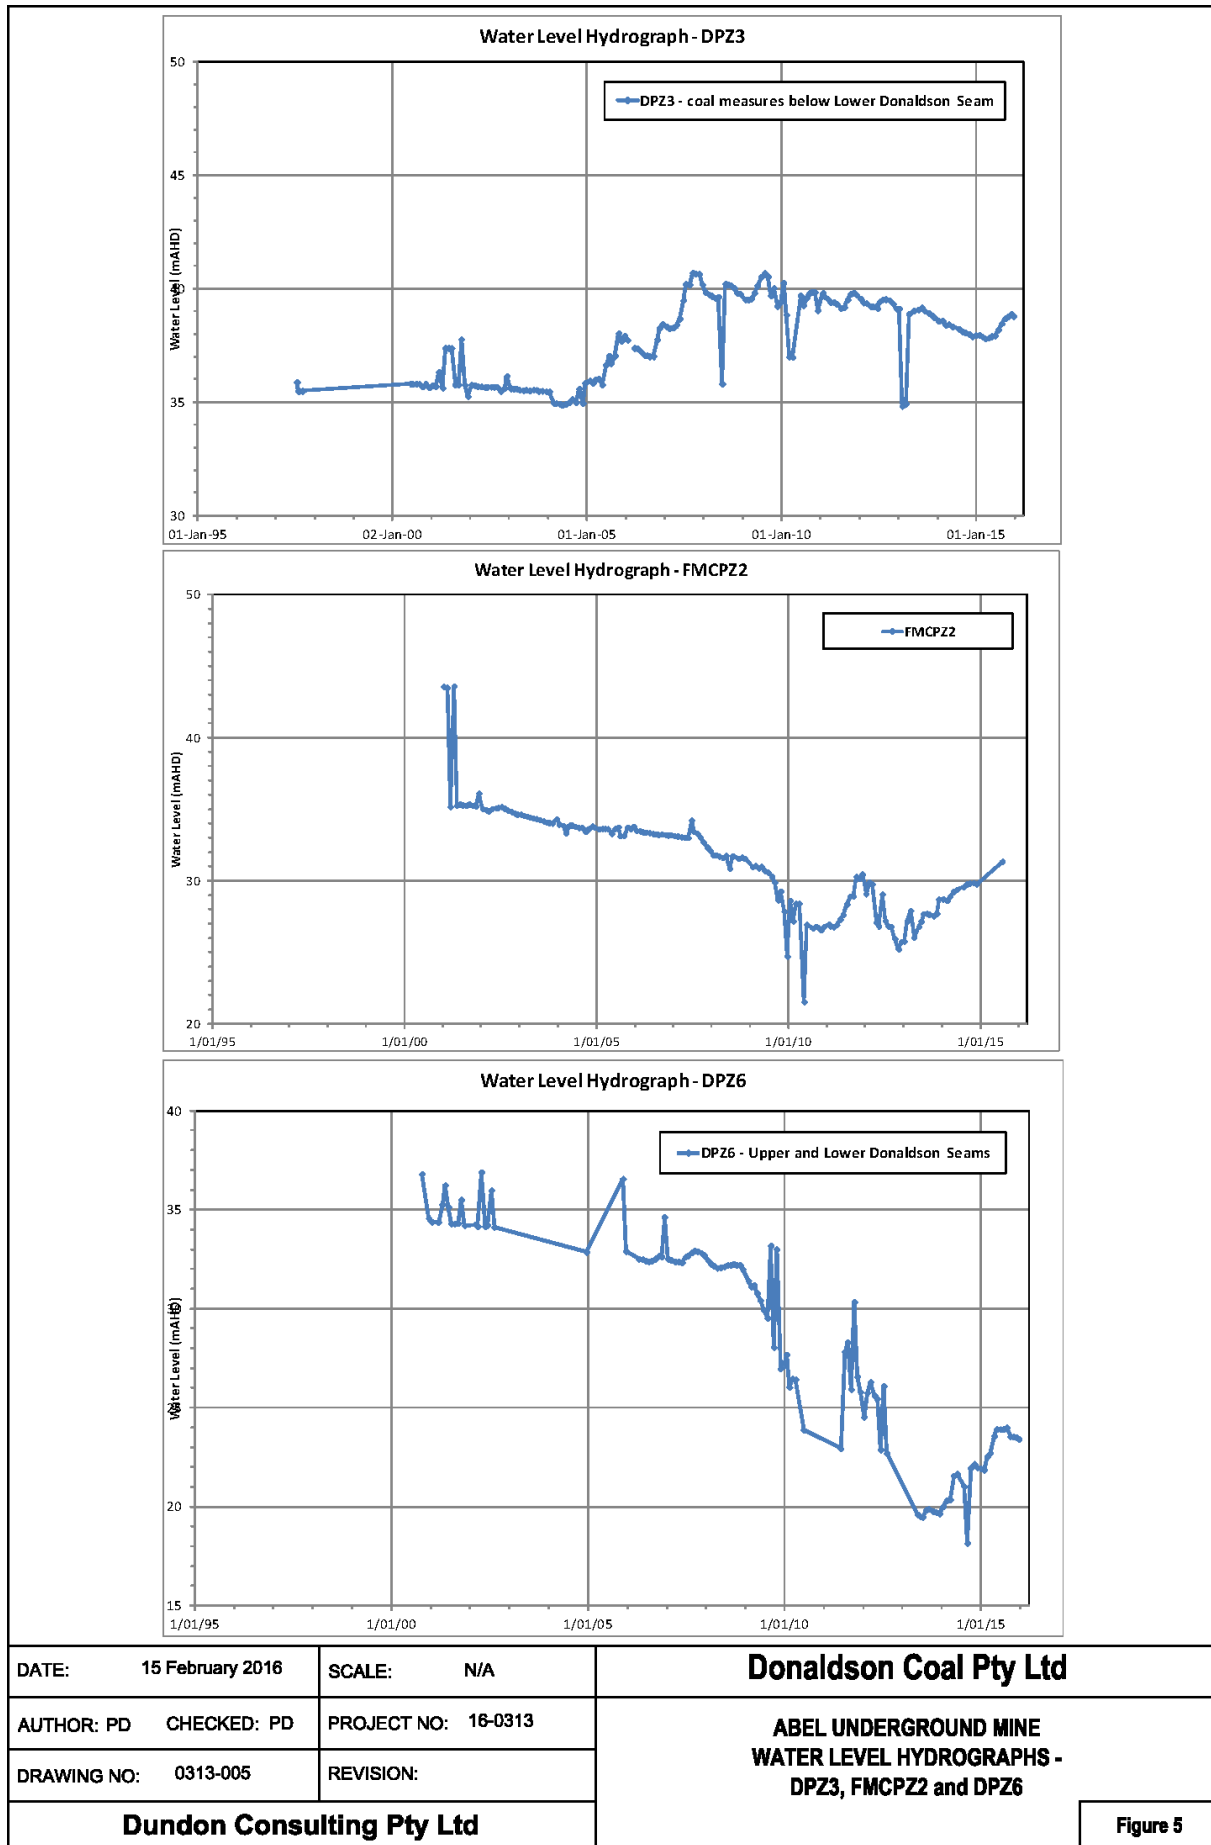
- DPZ3 (**Figure 5**) – Located in OC area, and screened in coal measures below Donaldson Seam. Showed unexplained rise in water level from 2004 to 2010, then decline apparently in response to mining from Donaldson OC. The rise in water level from 2004 to 2010 may be due to leakage from the Big Kahuna Dam or from Four Mile Creek both of which are close to the bore location. Current behaviour appears to be response to rainfall and natural recession.

- FMCPZ2 and DPZ6 (**Figure 5**) – Both showed drawdowns during latter stages of Donaldson OC, then more pronounced drawdown once development of the Abel UG South Mains started in April 2008. Both have showed partial recovery during 2013 to 2015, probably due to recovery in the former OC.

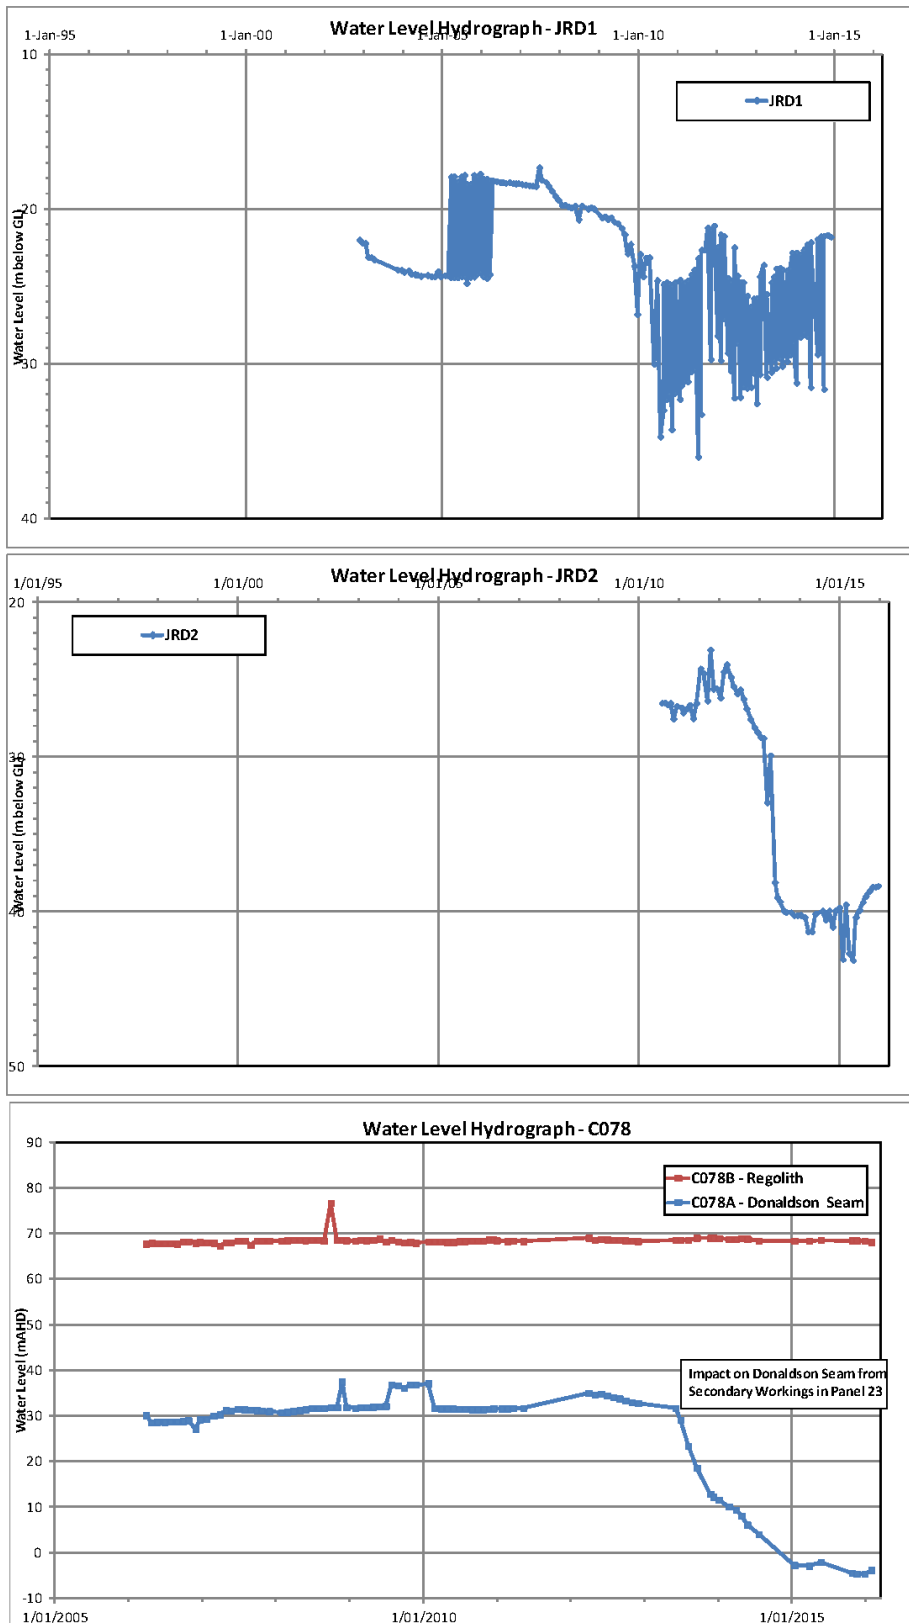
DATE: 15 February 2016	SCALE: N/A	Donaldson Coal Pty Ltd ABEL UNDERGROUND MINE WATER LEVEL HYDROGRAPHS - JRD1, JRD2 and C078
AUTHOR: PD CHECKED: PD	PROJECT NO: 16-0313	
DRAWING NO: 0313-006	REVISION:	
Dundon Consulting Pty Ltd		Figure 6

- JRD1 and JRD2 (**Figure 6**) – Bore construction is not known. Both bores show mining impacts.
- C078B (regolith) and C078A (Donaldson Seam) (**Figure 6**) – The shallow regolith bore shows no mining impact. The deeper Donaldson Seam bore showed no mining impact until the start of secondary extraction in Panel 23 in June 2013. Still declining, but at a slower rate in 2015.

At the C078 and C081 sites, where two piezometers are present, a shallow piezometer in the regolith and a deep piezometer in the Donaldson Seam, the lack of drawdown response in the regolith is clearly apparent.

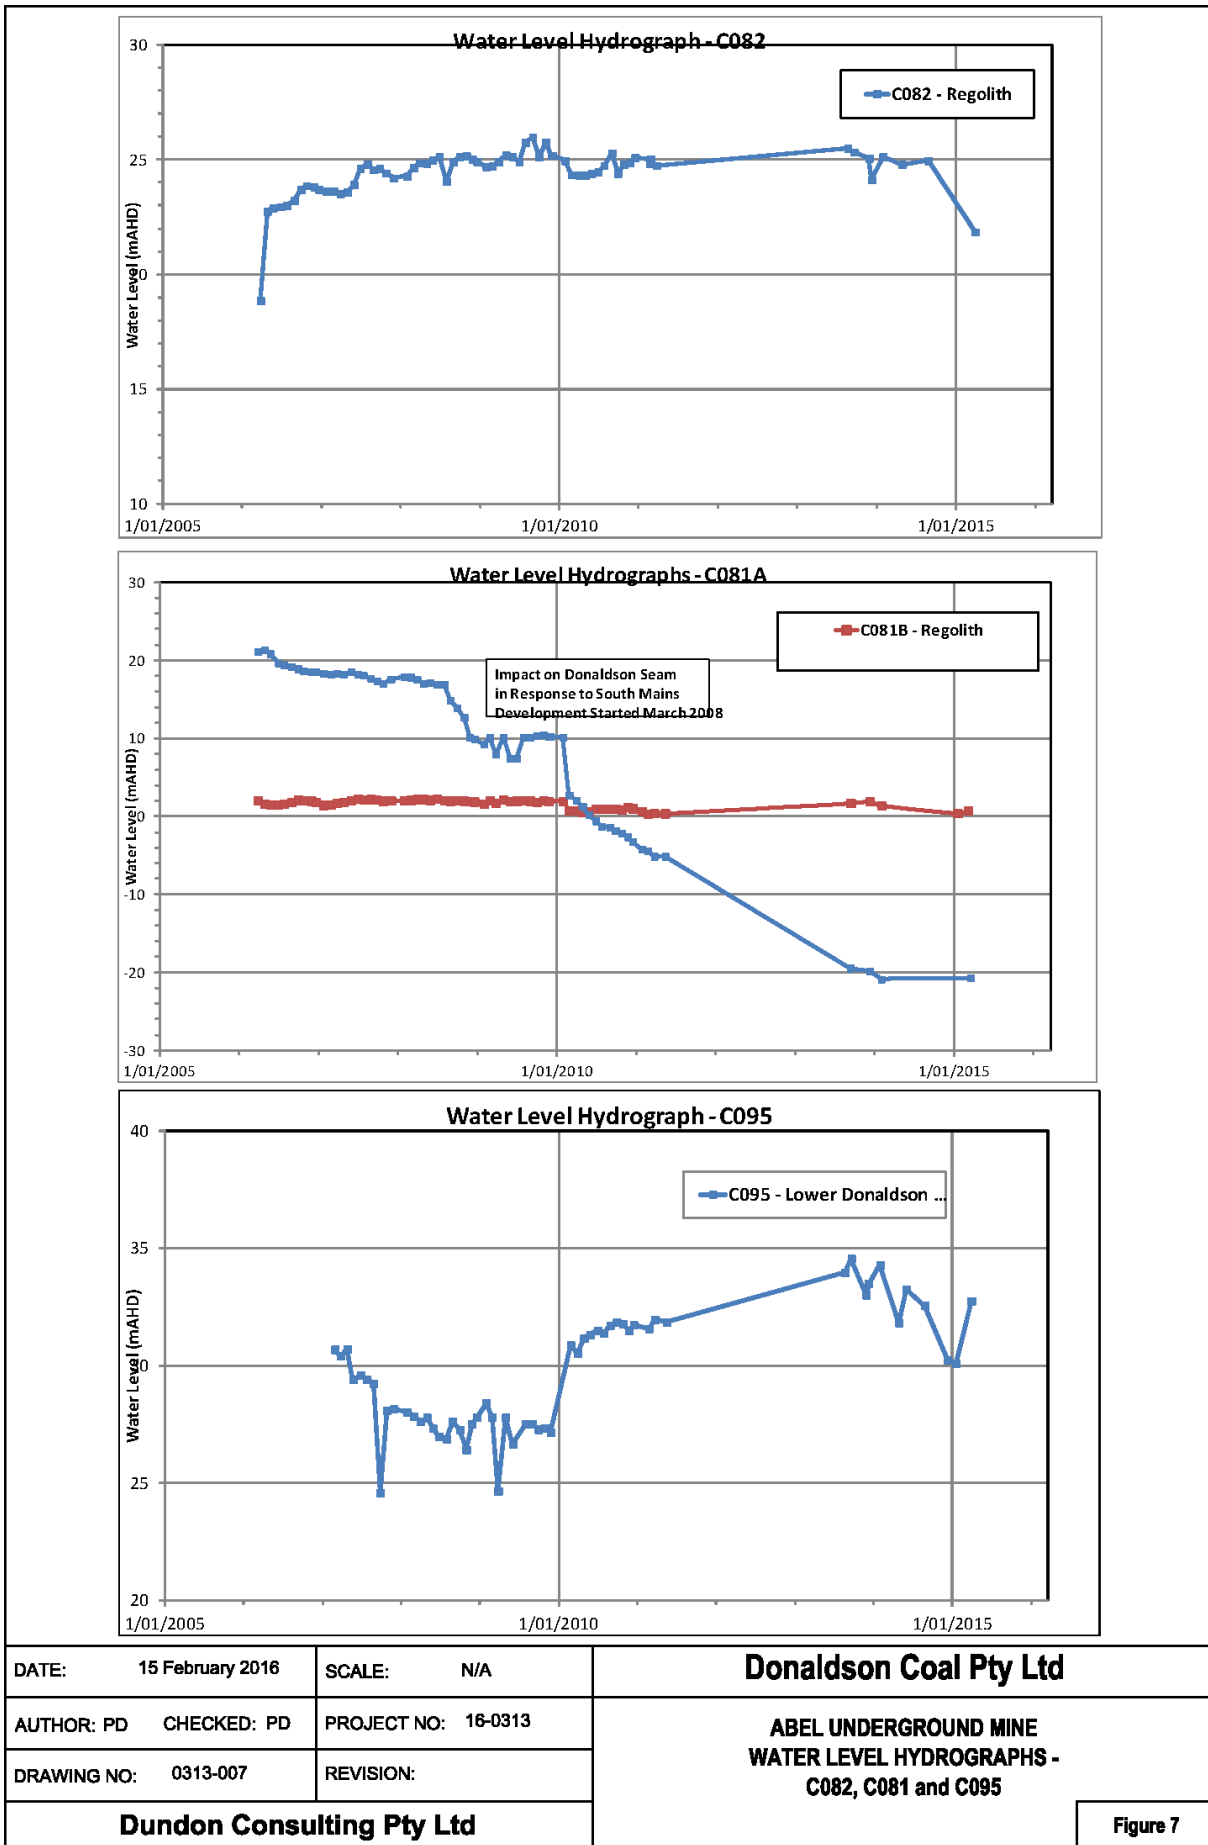
- C082 (**Figure 7**) – Regolith bore which has showed steadily rising water level since 2006. No mining impact at least until 2014. The single water level measured in 2015 may indicate drawdown, and should be verified by follow-up monitoring.

- C081B (regolith) and C081A (Upper Donaldson Seam) (**Figure 7**) – The shallow regolith bore

shows no mining impact. Deeper Donaldson Seam bore shows continual steady drawdown since installation in 2006. Both bores steady during 2014 and early 2015.

- C095 (**Figure 7**) – Lower Donaldson Seam bore, showing drawdown during 2006-2009, then rising till 2013, and then drawdown again. The reason for this behaviour is not clear.

Bores C081A and B (**Figure 7**) are located adjacent to Pambalong Nature Reserve, and the shallow regolith monitoring bore shows no response to mining, while there is a clear response to mining in the deeper bore in the Donaldson Seam. The lack of response in the shallow regolith bore indicates that there has been no mining impact on the wetland located in Pambalong Nature Reserve. These two bores have had only limited monitoring in 2014 and 2015. It is recommended that monitoring resume on a more regular basis, as they are key bores for demonstrating that the Pambalong wetland is not being impacted.

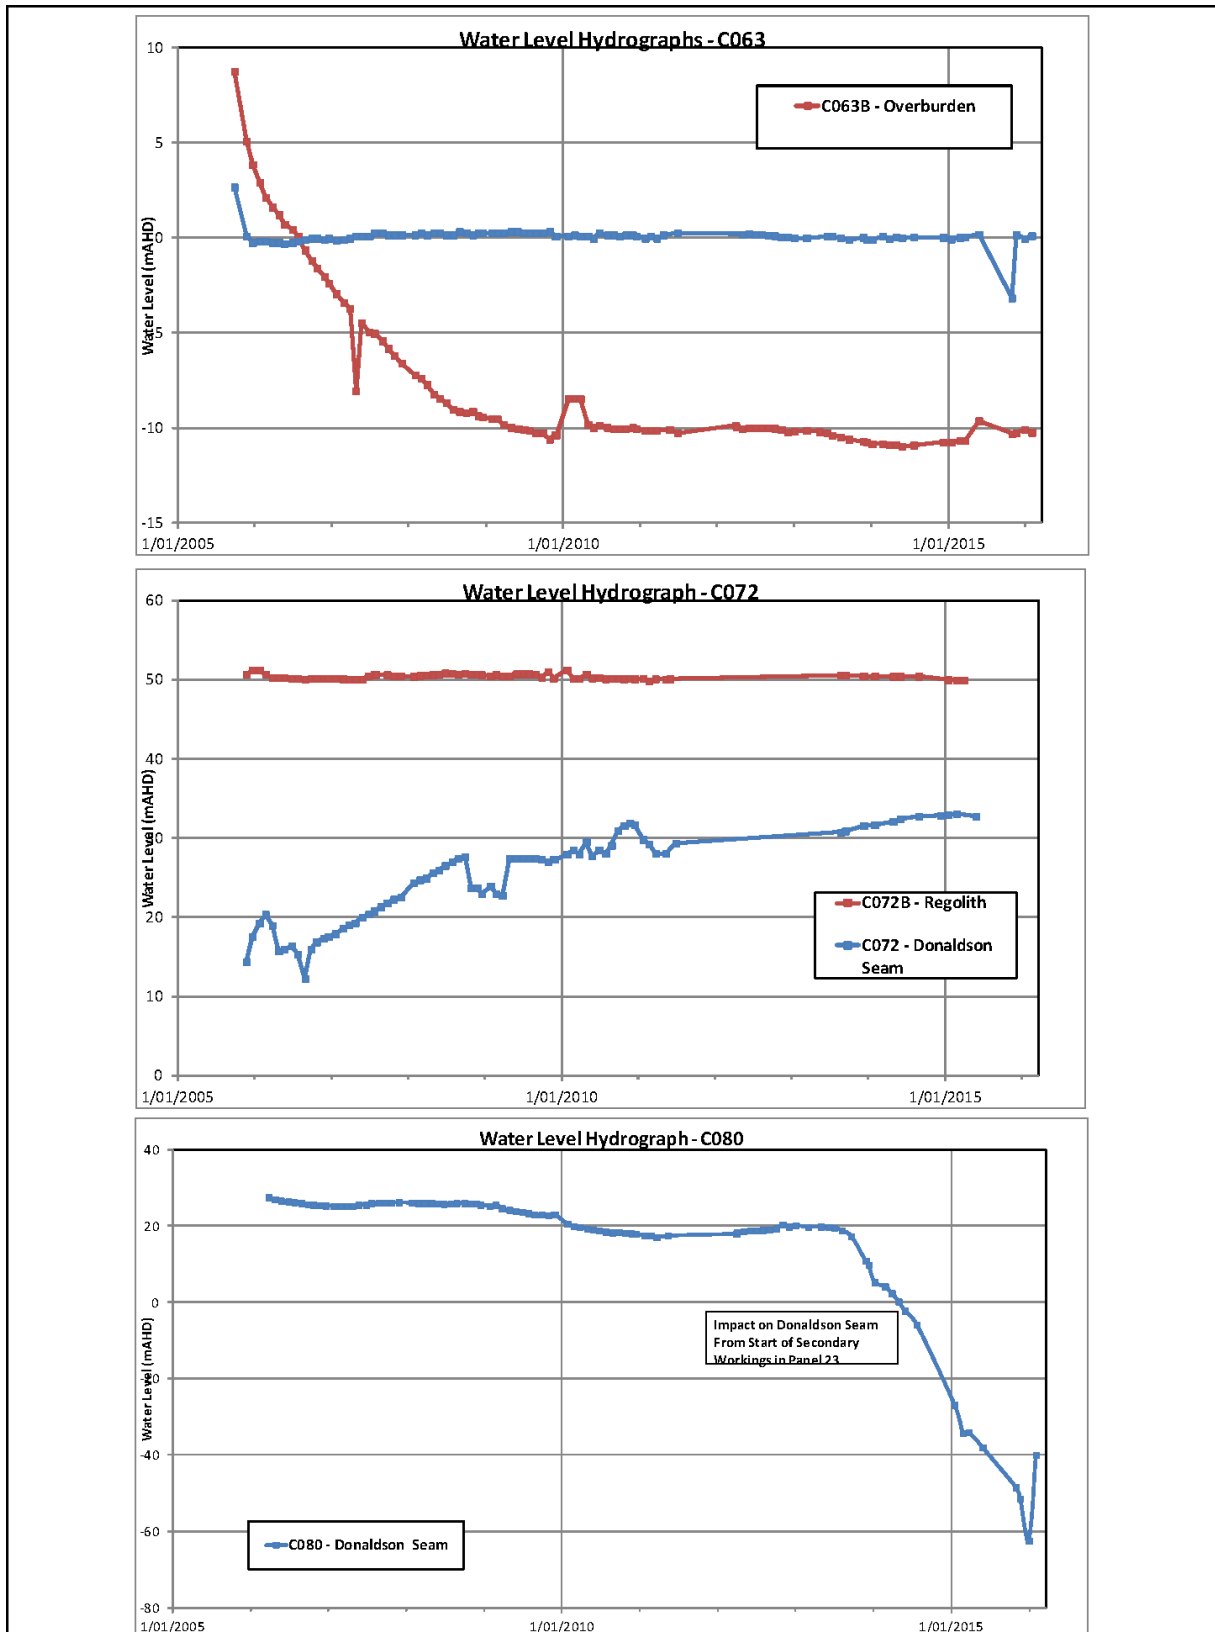
DATE: 15 February 2016	SCALE: N/A	Donaldson Coal Pty Ltd ABEL UNDERGROUND MINE WATER LEVEL HYDROGRAPHS - C063, C072 and C080
AUTHOR: PD CHECKED: PD	PROJECT NO: 16-0313	
DRAWING NO: 0313-008a	REVISION:	
Dundon Consulting Pty Ltd		Figure 8

- C063B and C072B (regolith bores located east of Abel mine area) (**Figure 8**) – Both show no mining impacts over the period 2005 to early 2016.
- C063A (**Figure 8**) – This Donaldson Seam piezometer is believed to have failed. The hydrograph shows very slow decline in water level from installation until 2015 to well below sea level. The pattern of decline is the same through both mining and non-mining periods, and is suggestive of a piezometer not in hydraulic connection with the groundwater system. It is recommended that monitoring of C063A be discontinued.

- C072 (**Figure 8**) – Donaldson Seam piezometer, which has reported a steadily rising water level since installation in 2005. It is suspected that this bore is either not functioning or is not in good hydraulic connection with the groundwater system.

- C080 (**Figure 8**) – Donaldson Seam piezometer that showed modest mining impact during early development stages of Abel UG, then a pronounced drawdown impact from the start of secondary extraction from Panel 23 in August 2013. The final water level measurement in late 2015 is against the prior trend, and may indicate water level recovery. This should be verified from future monitoring.

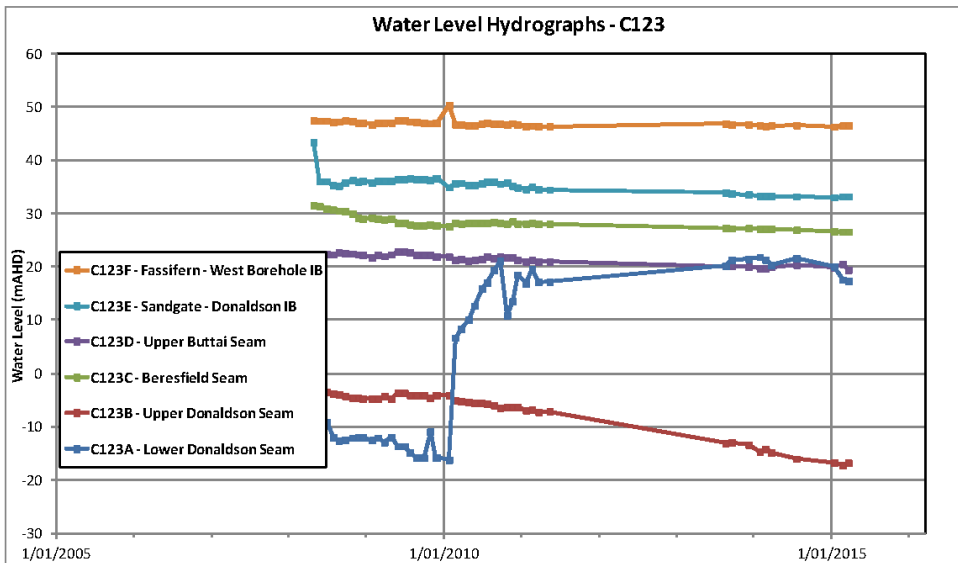
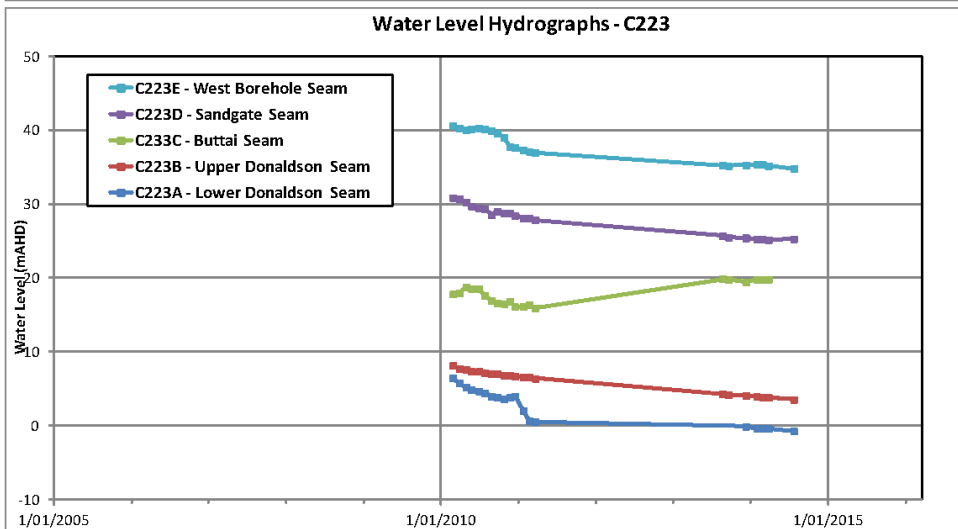
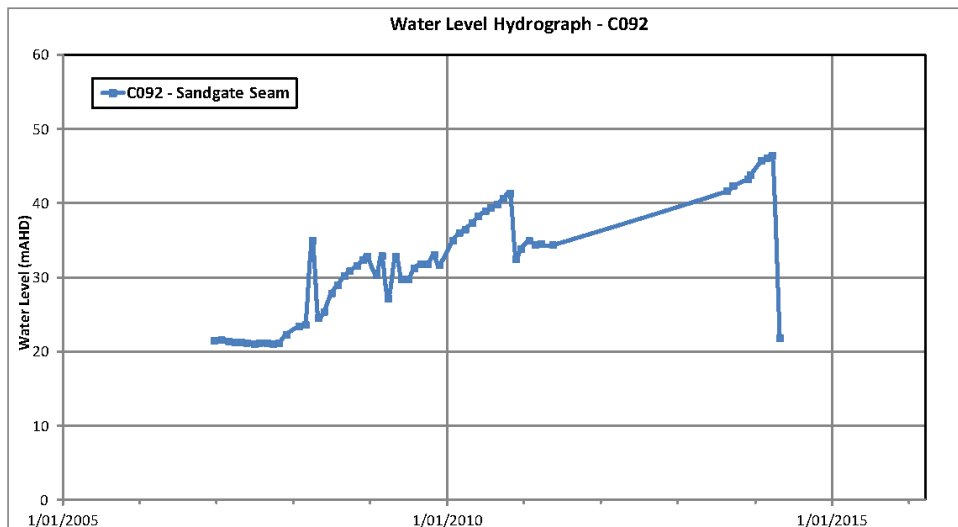
DATE: 15 February 2016	SCALE: N/A	Donaldson Coal Pty Ltd ABEL UNDERGROUND MINE WATER LEVEL HYDROGRAPHS - C123, C223 and C092
AUTHOR: PD CHECKED: PD	PROJECT NO: 16-0313	
DRAWING NO: 0313-009	REVISION:	
Dundon Consulting Pty Ltd		Figure 9

- C123 and C223 (**Figure 9**) – Located near western side of the Abel ML, both are multi-level VW piezometers, screened at several levels from the Lower Donaldson up to the West Borehole Seams. C123 was only monitored in early 2015, and C223 has not been monitored since mid-2014. The Upper Donaldson in both bores shows steady drawdown, with lesser drawdown in the overburden piezometers as well. C123 Upper Donaldson and C223 Buttai responses suggest those piezometers may not be functioning correctly.

- C092 (**Figure 9**) – Apparent recovery in Sandgate Seam is unexplained.
- C133, C138 and C093 (**Figure 10**) – These three piezometer bores are located west of the Abel mine. C133 shows drawdown until late 2014 or early 2015, but recovery since that time. The partial recovery of groundwater levels in the Rathluba Seam, stratigraphically deeper than any mining at Abel or Donaldson, is clearly a response to changes in mining at Bloomfield where the Rathluba Seam was mined historically.

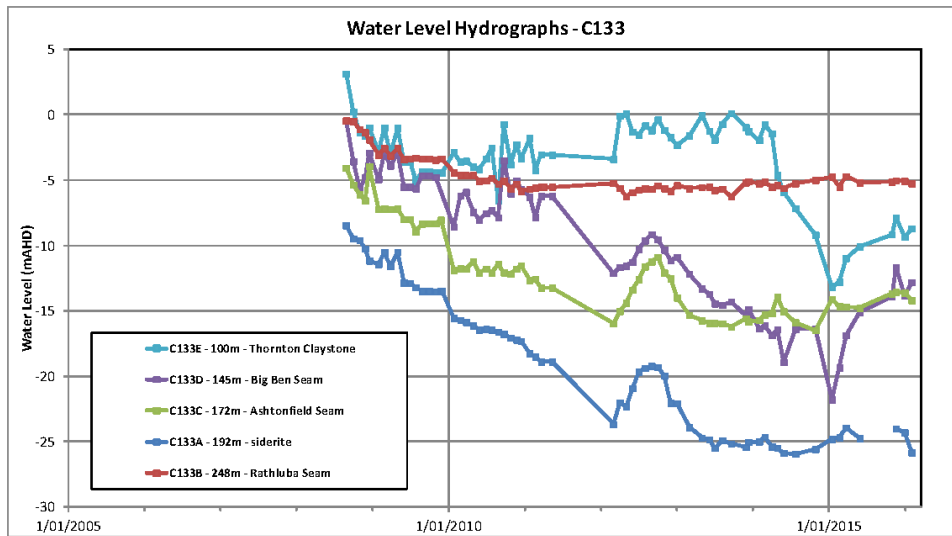
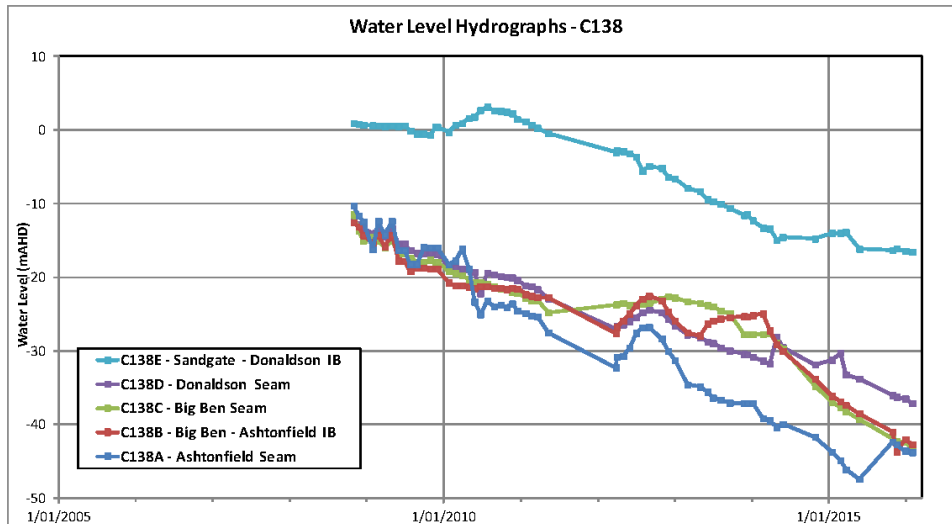
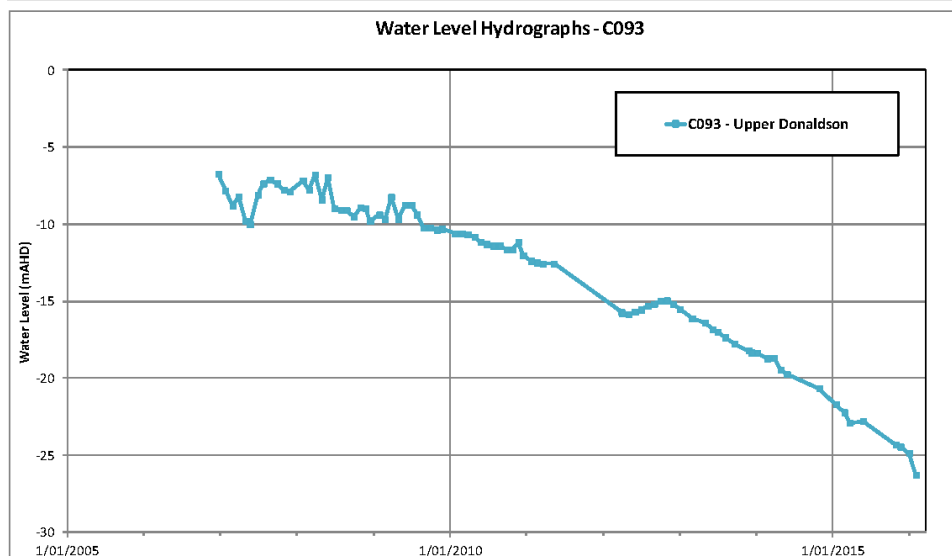
DATE: 15 February 2016	SCALE: N/A	Donaldson Coal Pty Ltd ABEL UNDERGROUND MINE WATER LEVEL HYDROGRAPHS - C133, C138 and C093
AUTHOR: PD CHECKED: PD	PROJECT NO: 16-0313	
DRAWING NO: 0313-010	REVISION:	
Dundon Consulting Pty Ltd		Figure 10

The C138 and C093 piezometers show drawdown almost continually since installation in 2007 or 2008, at all stratigraphic levels, apart from the Ashtonfield Seam which showed partial recovery in 2015. Drawdown started before mining commenced at Abel, and even before development of the South Mains headings, indicating that the responses at least initially were probably due to mining at Bloomfield.

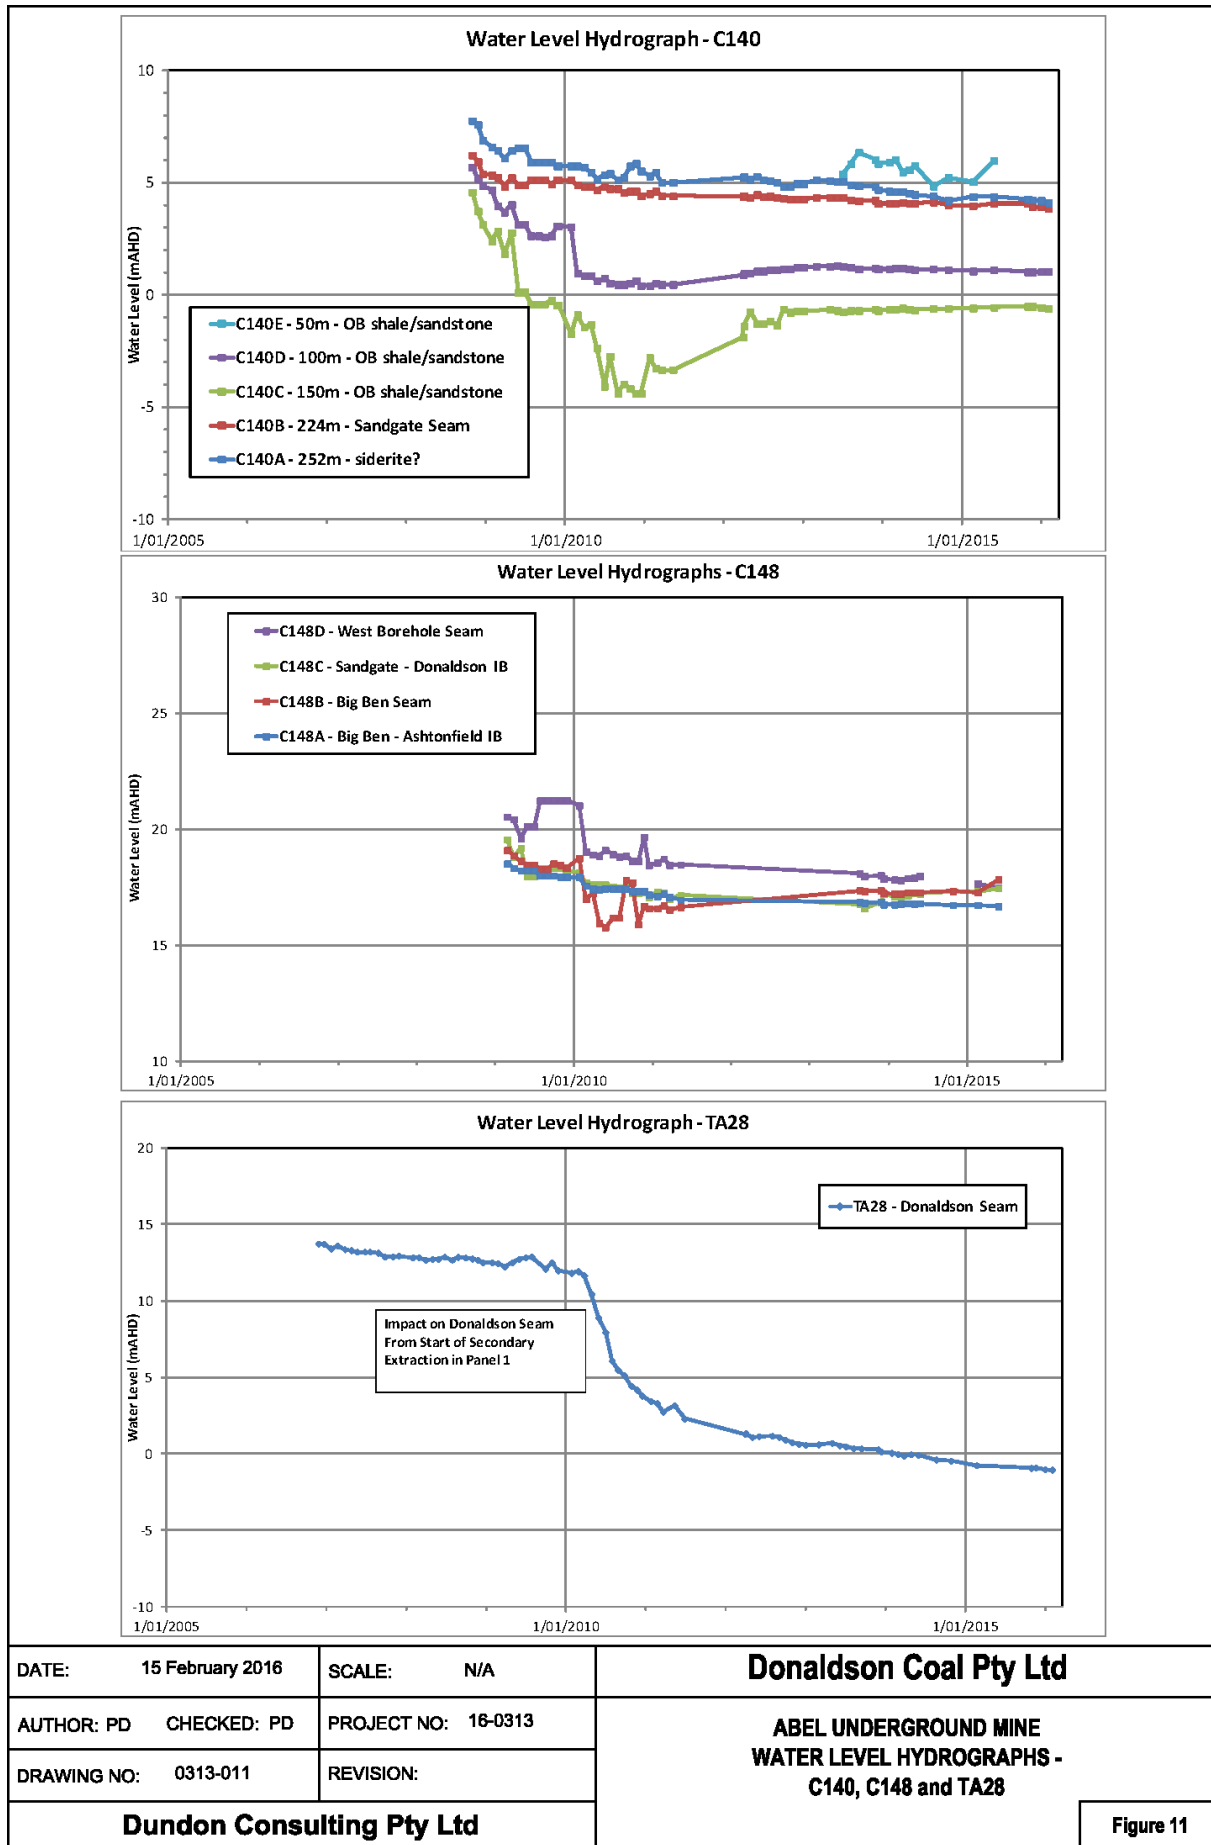
- C140 and C148 (**Figure 11**) – Responses occur before mining started at Abel, and are probably related to mining at Bloomfield. Water levels are relatively stable through 2015.
- TA28 (**Figure 11**) – Bore shows gradual drawdown in Donaldson Seam from 2006, believed to be in response to Donaldson OC, the pronounced drawdown from April 2010, coinciding with the start of secondary extraction from Panel 1.
- B029, B030 and B031 (**Figure 12**) – All three bores show drawdowns in the Donaldson Seam and some of the overburden strata. Early responses from 2008 to 2010 at B029 are probably slow adjustment to ambient heads in very low permeability strata.

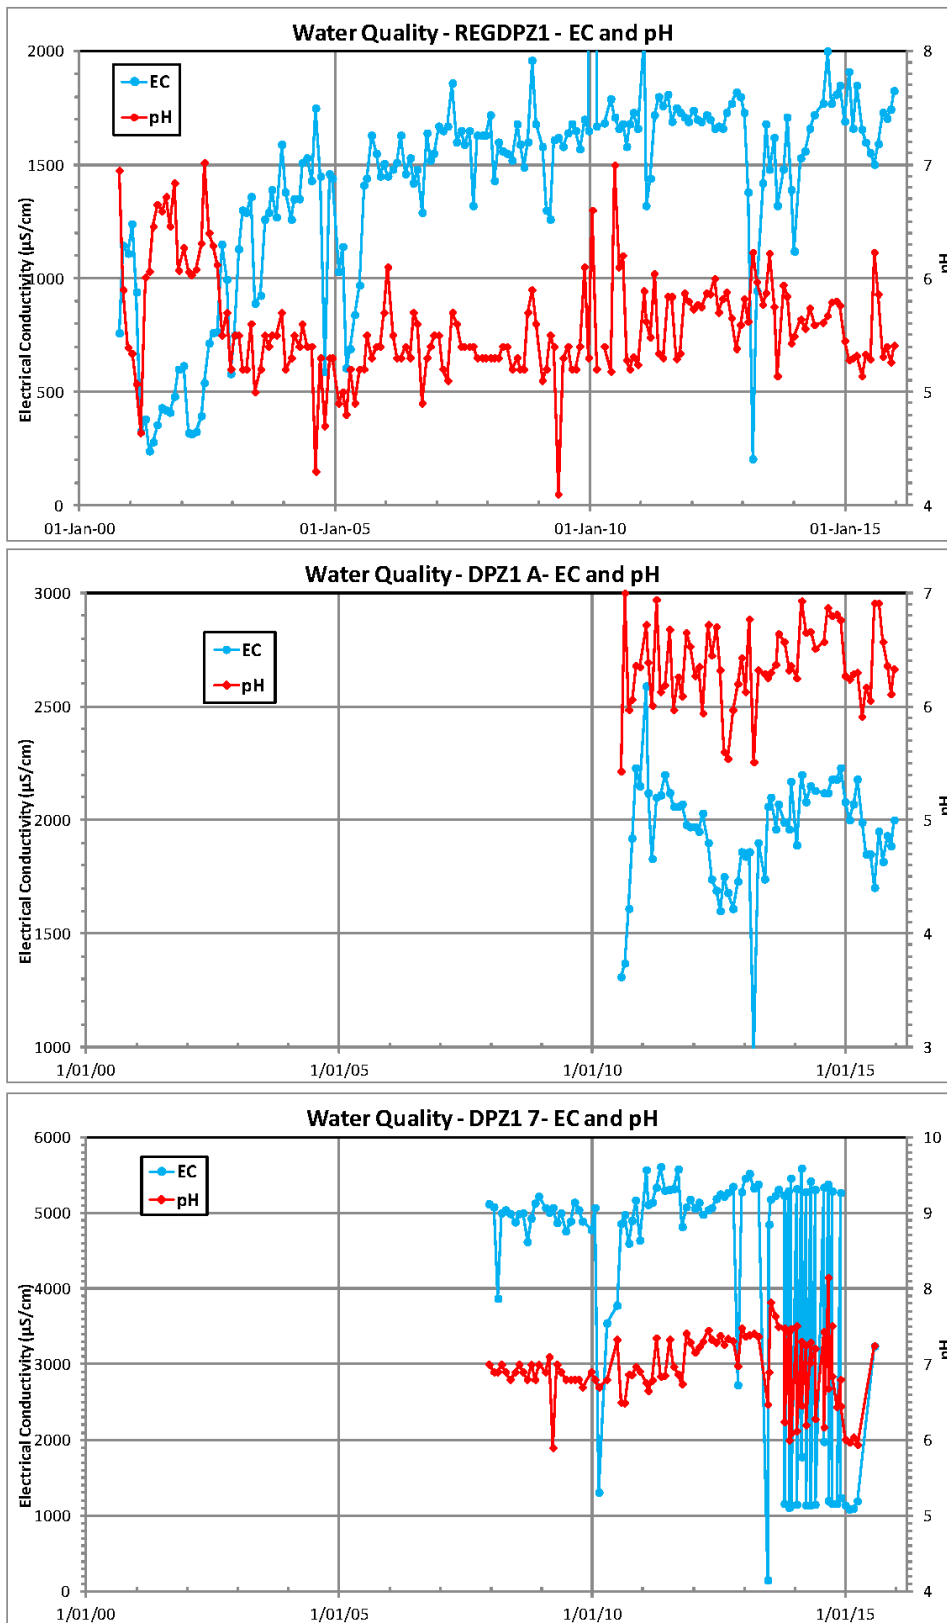
DATE: 15 February 2016	SCALE: N/A	Donaldson Coal Pty Ltd
AUTHOR: PD CHECKED: PD	PROJECT NO: 16-0313	
DRAWING NO: 0313-013	REVISION:	
Dundon Consulting Pty Ltd		ABEL UNDERGROUND MINE WATER QUALITY - EC and pH REGDPZ1, DPZ1A and DPZ17
		Figure 13

Salinity varies over a wide range from bore to bore, but within each bore, salinity generally is quite stable over time. Some of the monitored bores have reported occasional outliers of significantly lower salinity (EC and TDS) which are likely due to ingress of rainwater temporarily lowering the salinity in the bore. This is particularly apparent at bores DPZ17 (**Figure 13**), DPZ3 (**Figure 16**) and JRD2 (**Figure 17**).

A recent downward trend in EC has been noted at bores DPZ13 (**Figure 15**) and DPZ6 (**Figure 16**), which could be due to enhanced recharge following drawdowns in the coal measures as a result of mining. However, the monitoring has not indicated any rising trend in salinity in any bore, apart from the regional control bore REGDPZ1 (**Figure 13**), which is unrelated to any mining activity.
