2015 Annual Groundwater Review*

Dundon Consulting Pty Limited

Re: Abel Coal Project – Annual Groundwater Review – 2015 Year

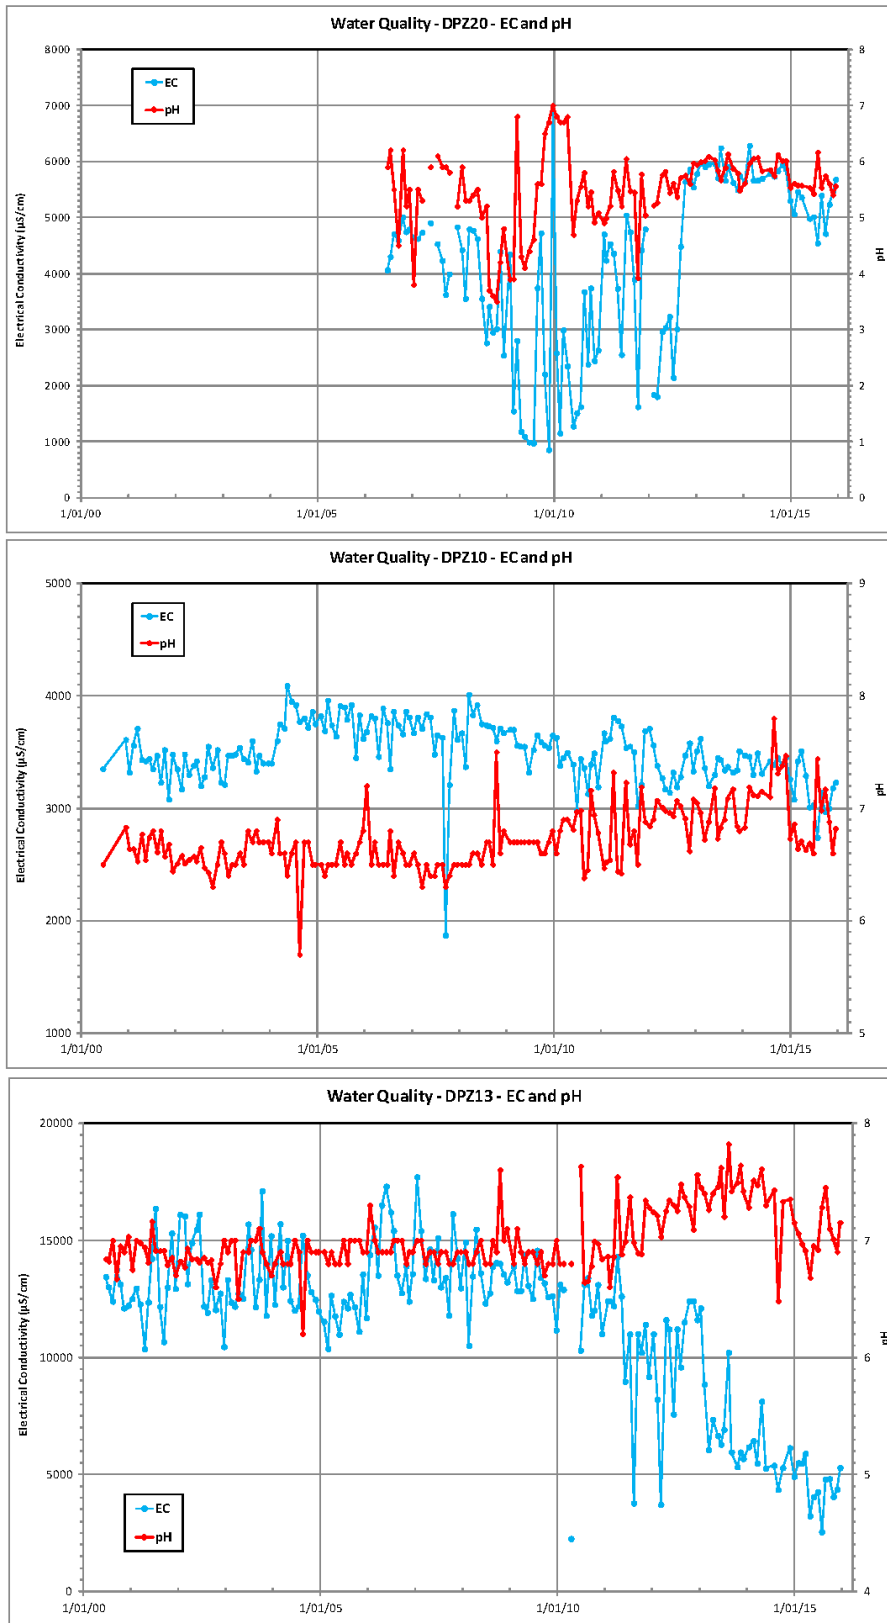
DATE: 15 February 2016	SCALE: N/A	Donaldson Coal Pty Ltd
AUTHOR: PD CHECKED: PD	PROJECT NO: 16-0313	
DRAWING NO: 0313-015	REVISION:	
Dundon Consulting Pty Ltd		ABEL UNDERGROUND MINE WATER QUALITY - EC and pH DPZ20, DPZ10 and DPZ13
		Figure 15

A recent downward trend in EC has been noted at bores DPZ13 (**Figure 15**) and DPZ6 (**Figure 16**), which could be due to enhanced recharge following drawdowns in the coal measures as a result of mining. However, the monitoring has not indicated any rising trend in salinity in any bore, apart from the regional control bore REGDPZ1 (**Figure 13**), which is unrelated to any mining activity.

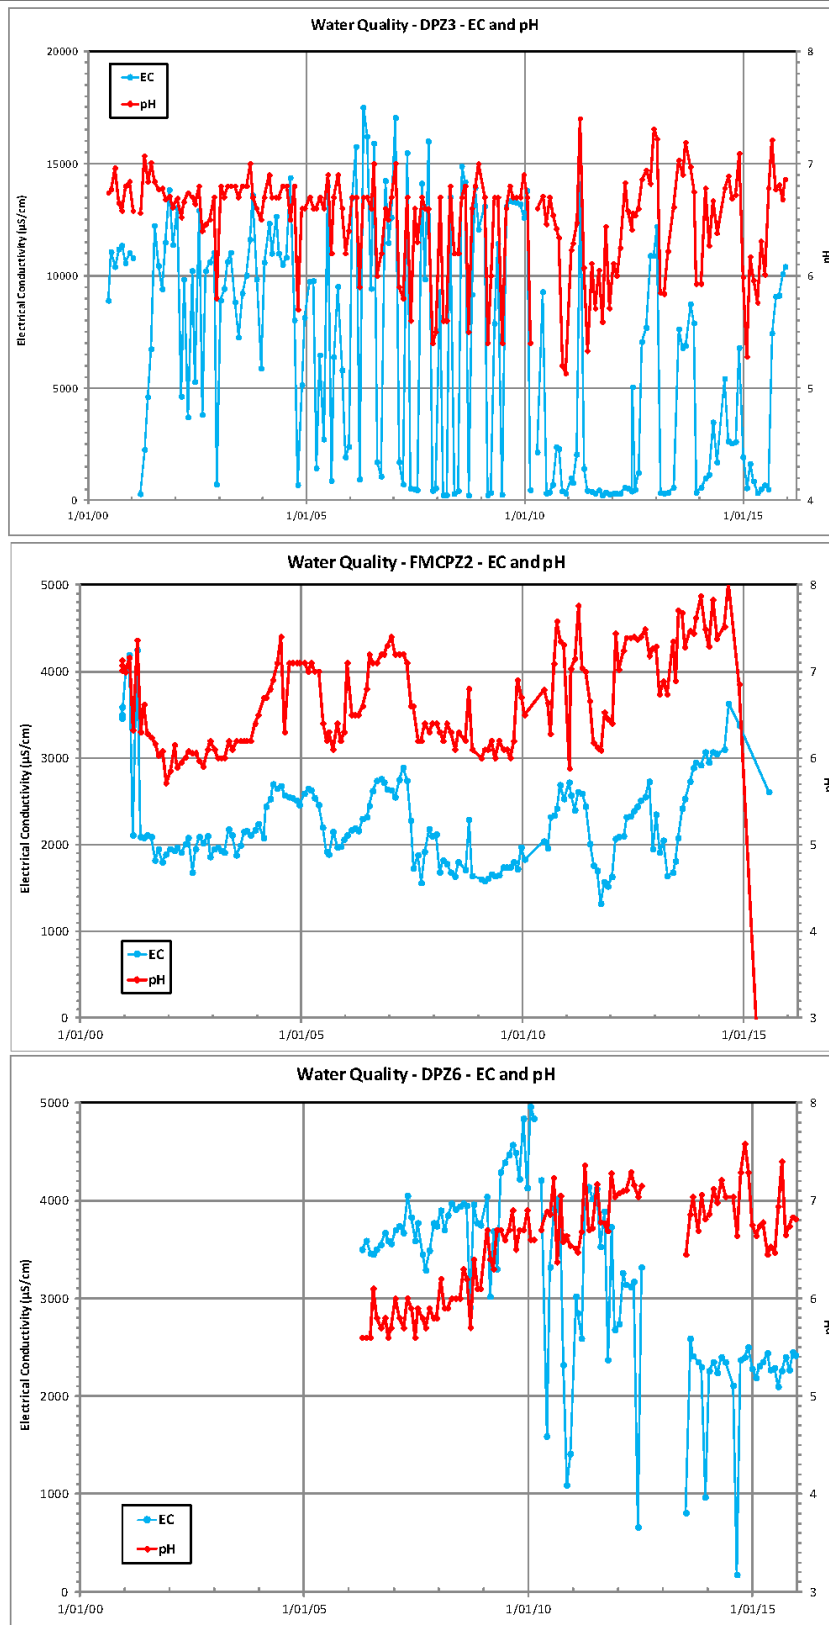
DATE: 15 February 2016	SCALE: N/A	Donaldson Coal Pty Ltd ABEL UNDERGROUND MINE WATER QUALITY - EC and pH DPZ3, FMCPZ2 and DPZ6
AUTHOR: PD CHECKED: PD	PROJECT NO: 16-0313	
DRAWING NO: 0313-016	REVISION:	
Dundon Consulting Pty Ltd		Figure 16

Salinity varies over a wide range from bore to bore, but within each bore, salinity generally is quite stable over time. Some of the monitored bores have reported occasional outliers of significantly lower salinity (EC and TDS) which are likely due to ingress of rainwater temporarily lowering the salinity in the bore. This is particularly apparent at bores DPZ17 (**Figure 13**), DPZ3 (**Figure 16**) and JRD2 (**Figure 17**).

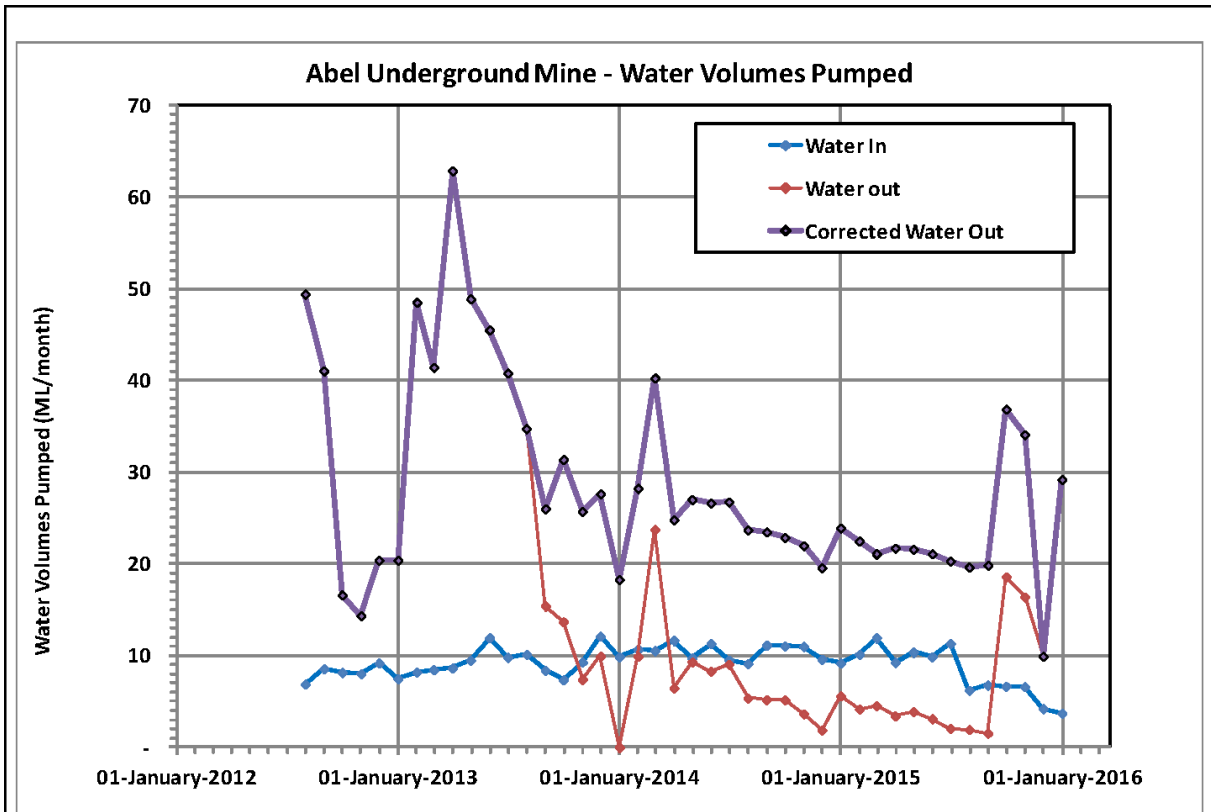
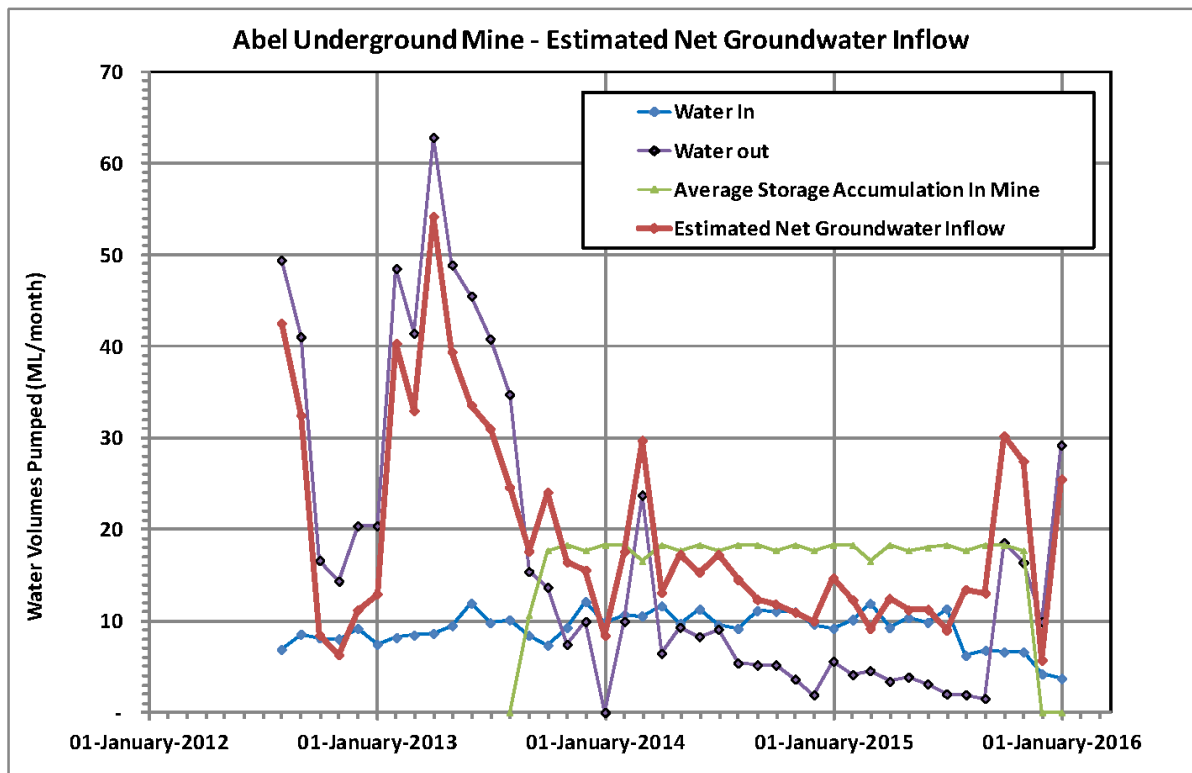
DATE: 29 February 2016	SCALE: N/A	Donaldson Coal Pty Ltd	
AUTHOR: PD CHECKED: PD	PROJECT NO: 16-0313		ABEL UNDERGROUND MINE ESTIMATED NET GROUNDWATER INFLOW
DRAWING NO: 0313-018	REVISION:		
Dundon Consulting Pty Ltd		Figure 18

This is illustrated on **Figure 18**, which in the upper pane shows 'Water In', 'Water Out', 'Average Storage Accumulation' and 'Maximum Corrected Water Out' (ie, the reported Water Out figure plus 18 ML/month during the period 13 August 2013 to 1 October 2015). In the lower pane on **Figure 18**, the estimated net groundwater inflow derived as described above is plotted. From Figure 18, it is interpreted that the average rate of groundwater inflow has mostly been in the approximate range 20 to 10 ML/month (240 to 120 ML/y), but after 1 October 2015, the estimated inflow rate has jumped to between 20 and 30 ML/month (240 to 360 ML/y).

The mining sequence has varied a little from that simulated in the groundwater modelling carried out for MOD3 (RPS Aquaterra, 2013). However, the model-predicted rate of groundwater inflow by the stage that mining has reached by the second half of 2015 was between 800 and 1000 ML/y, which is well above the maximum rates of inflow actually occurring.
