**Abel Mine
Subsidence Management Plan
End of Year Report 2010**

31 March 2011

Technical Services Manager- UG Operations
Donaldson Coal

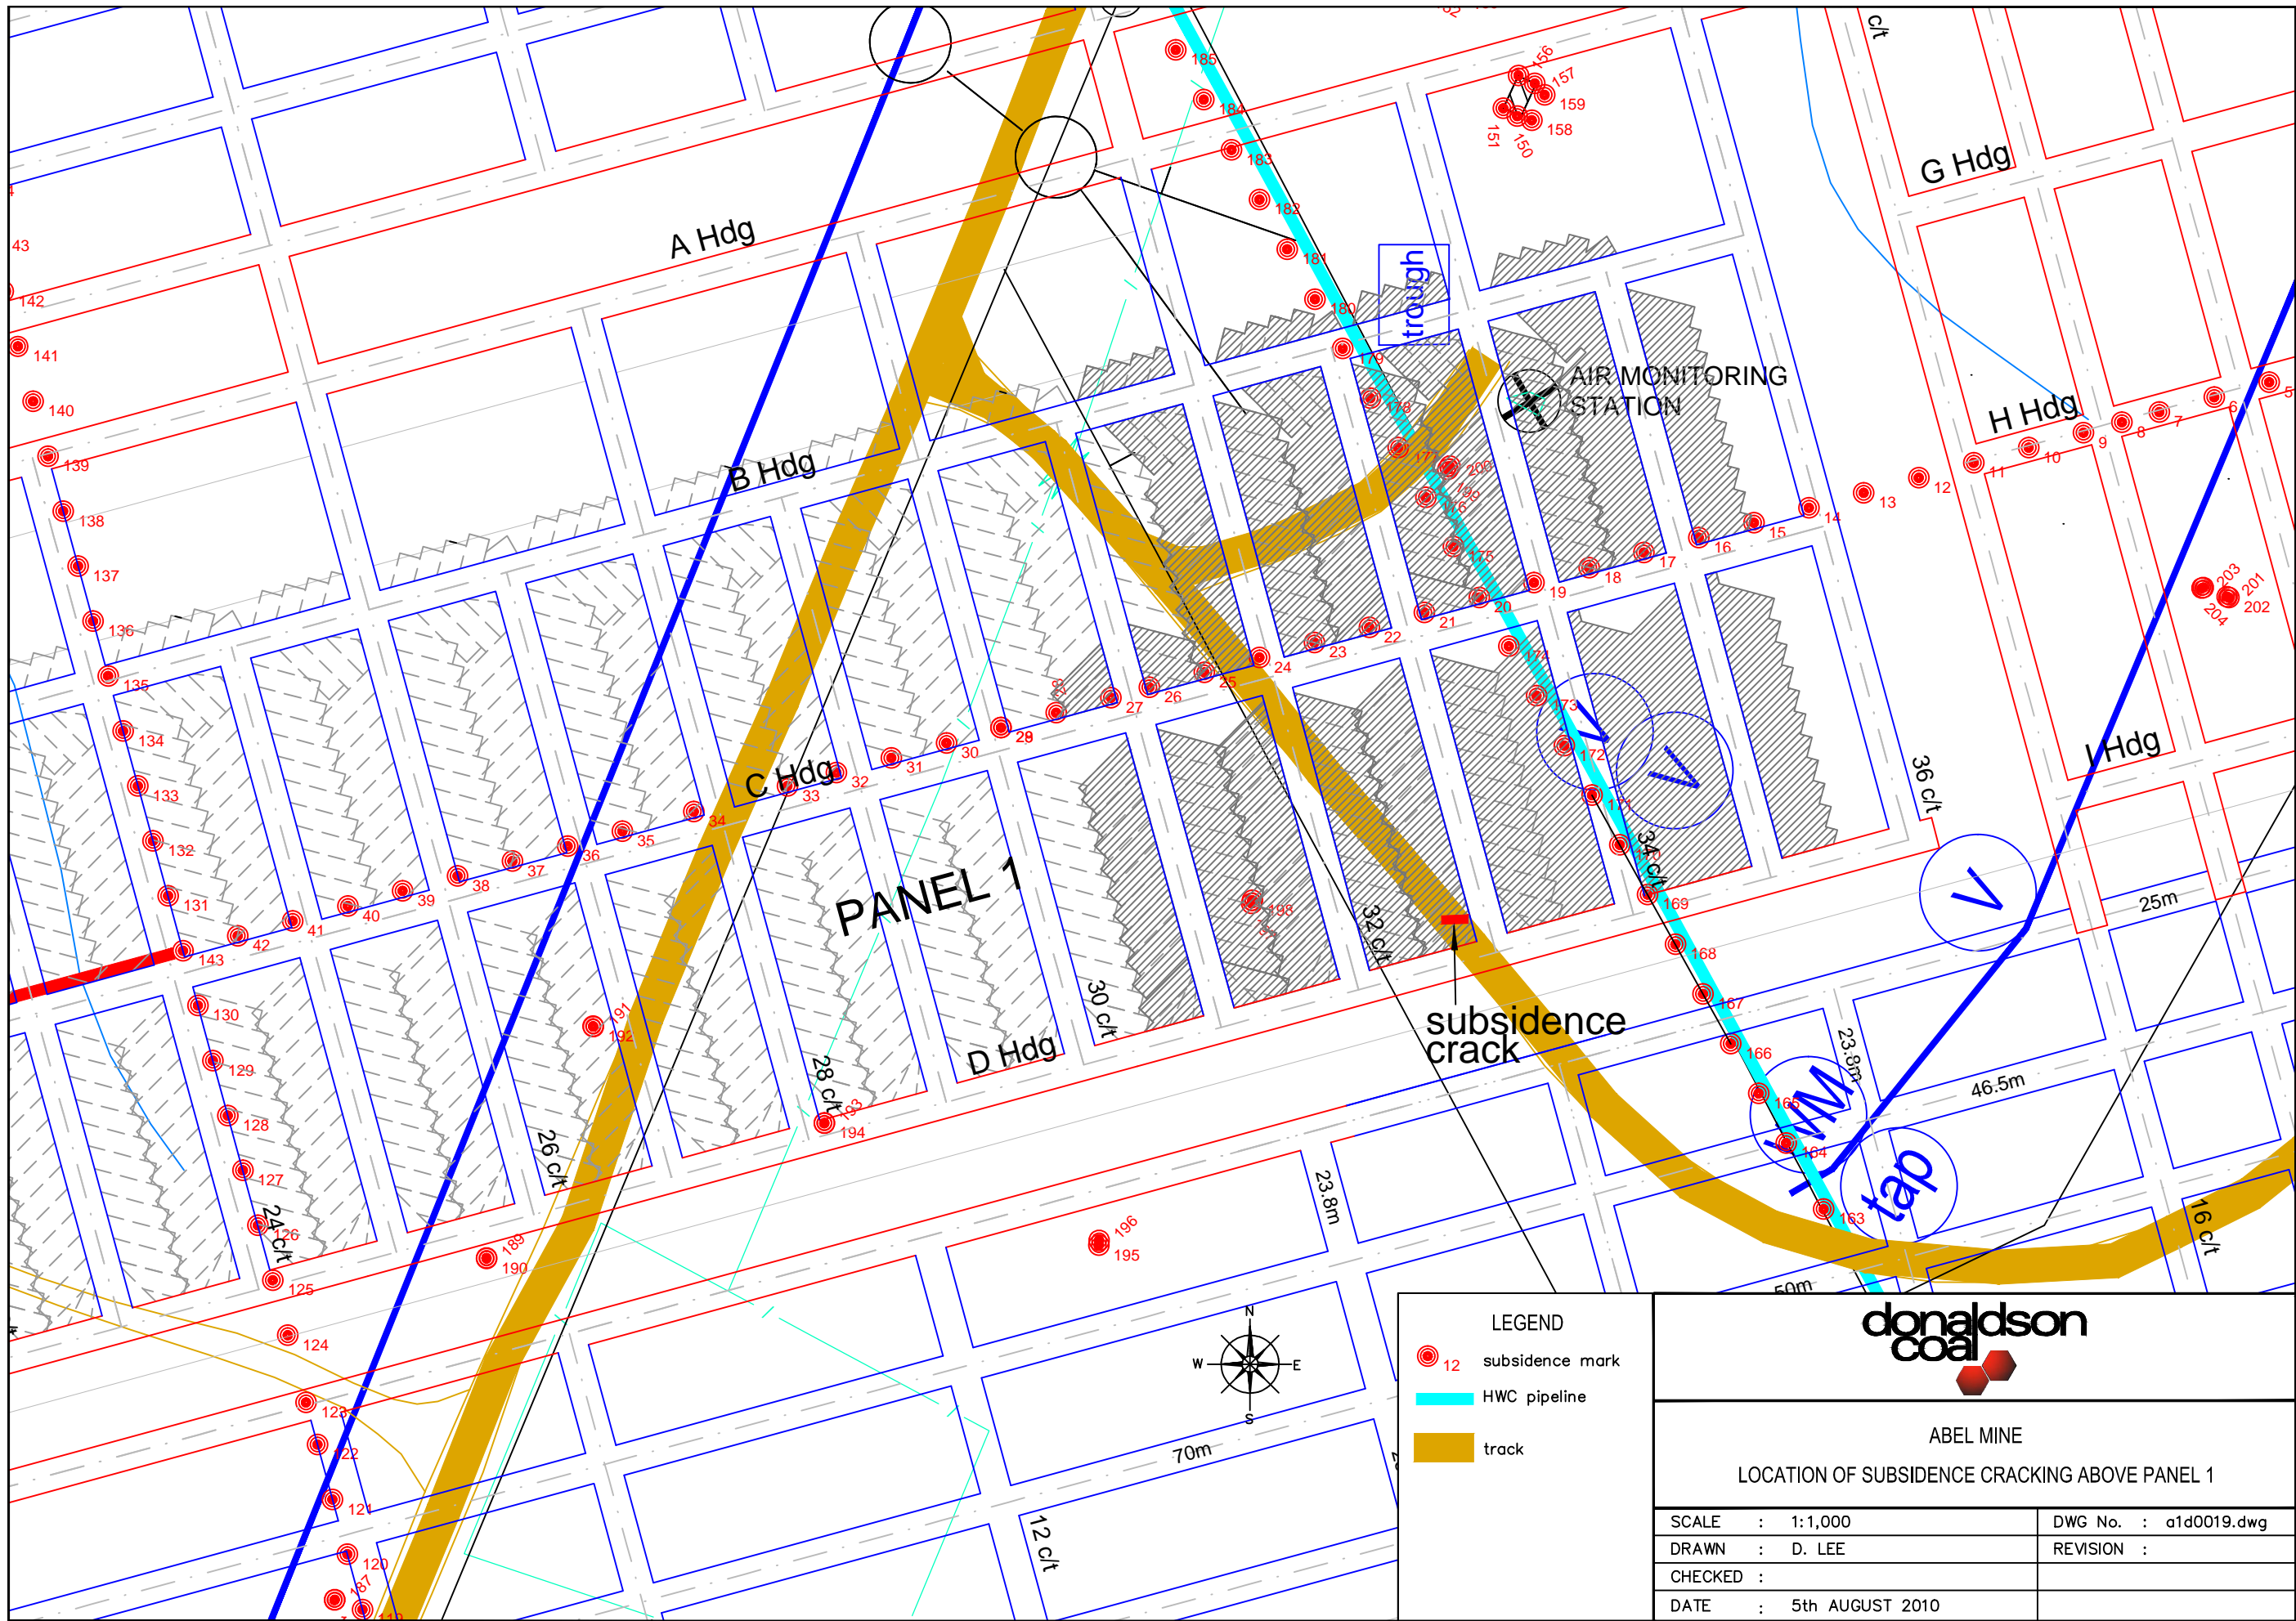
ABEL MINE
LOCATION OF SUBSIDENCE CRACKING ABOVE PANEL 1

Minor cracking was observed over Abel Panel 1 area (see attached plan Dwg No a1d0025.dwg) and this cracking increased to a current maximum of 200mm width across an access track where the depth of cover is 105 metres.

This exceeded the SMP Application predictions relating to cracking, where cover was in excess of 80 metres, which were "likely to be in the order of 30 to 150 mm."

This cracking exceeded the triggers in the following Management Plans and Approval Conditions:

| <u>Action / Response</u> | <u>Current Status</u> |
|--|--|
| <ul style="list-style-type: none"> • Note GPS location and orientation of crack or erosion and photograph. | Complete. |
| <ul style="list-style-type: none"> • Review public safety aspect. | Reviewed, temporary fences erected |
| <ul style="list-style-type: none"> • Maintain warning signs and erect additional signs and/or temporary fencing in immediate area. | Temporary fences erected. |
| <ul style="list-style-type: none"> • Discuss / confirm appropriate level of action / remediation with landholders, and any other relevant Government Department | Action confirmed, remediation completed |
