DONALDSON COAL

ABEL MINE

Mine Design SMP Compliance Audit

Panel 21

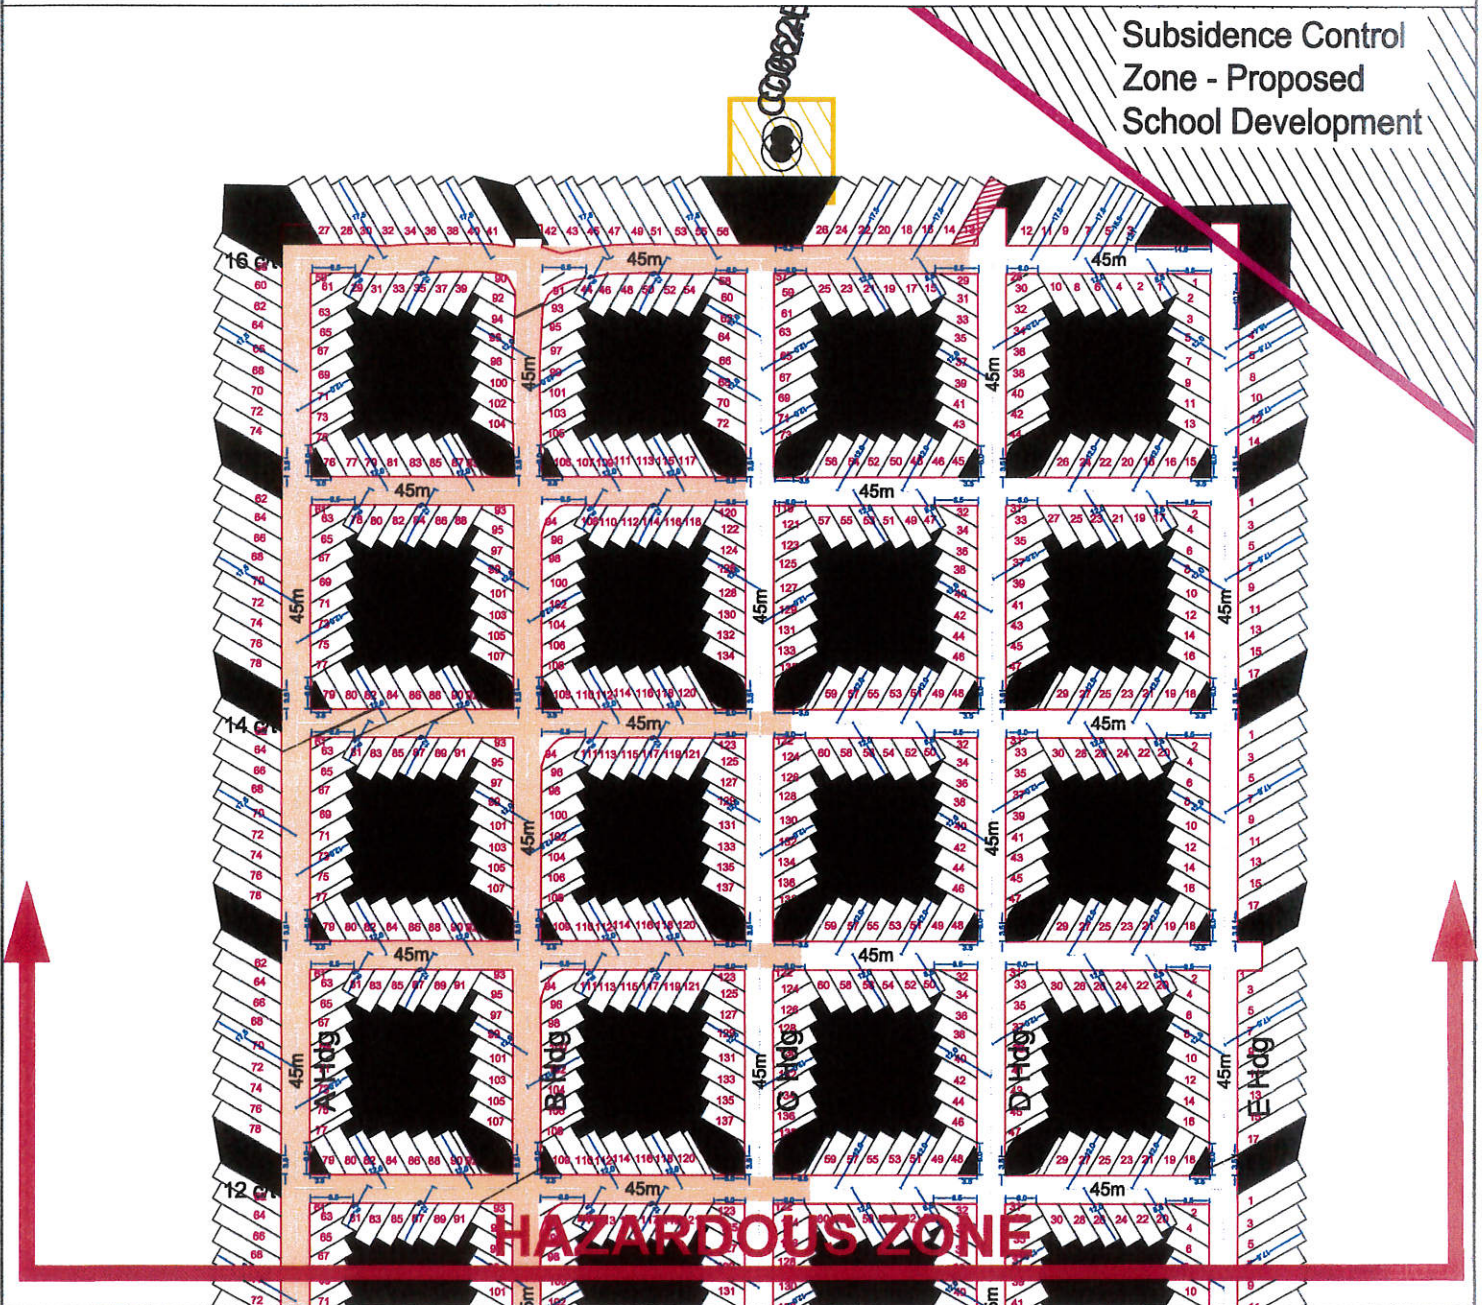
Authority to Mine Plan - Panel 21 (16c/t to 12c/t)

Panel 21 - 16c/t to 12c/t

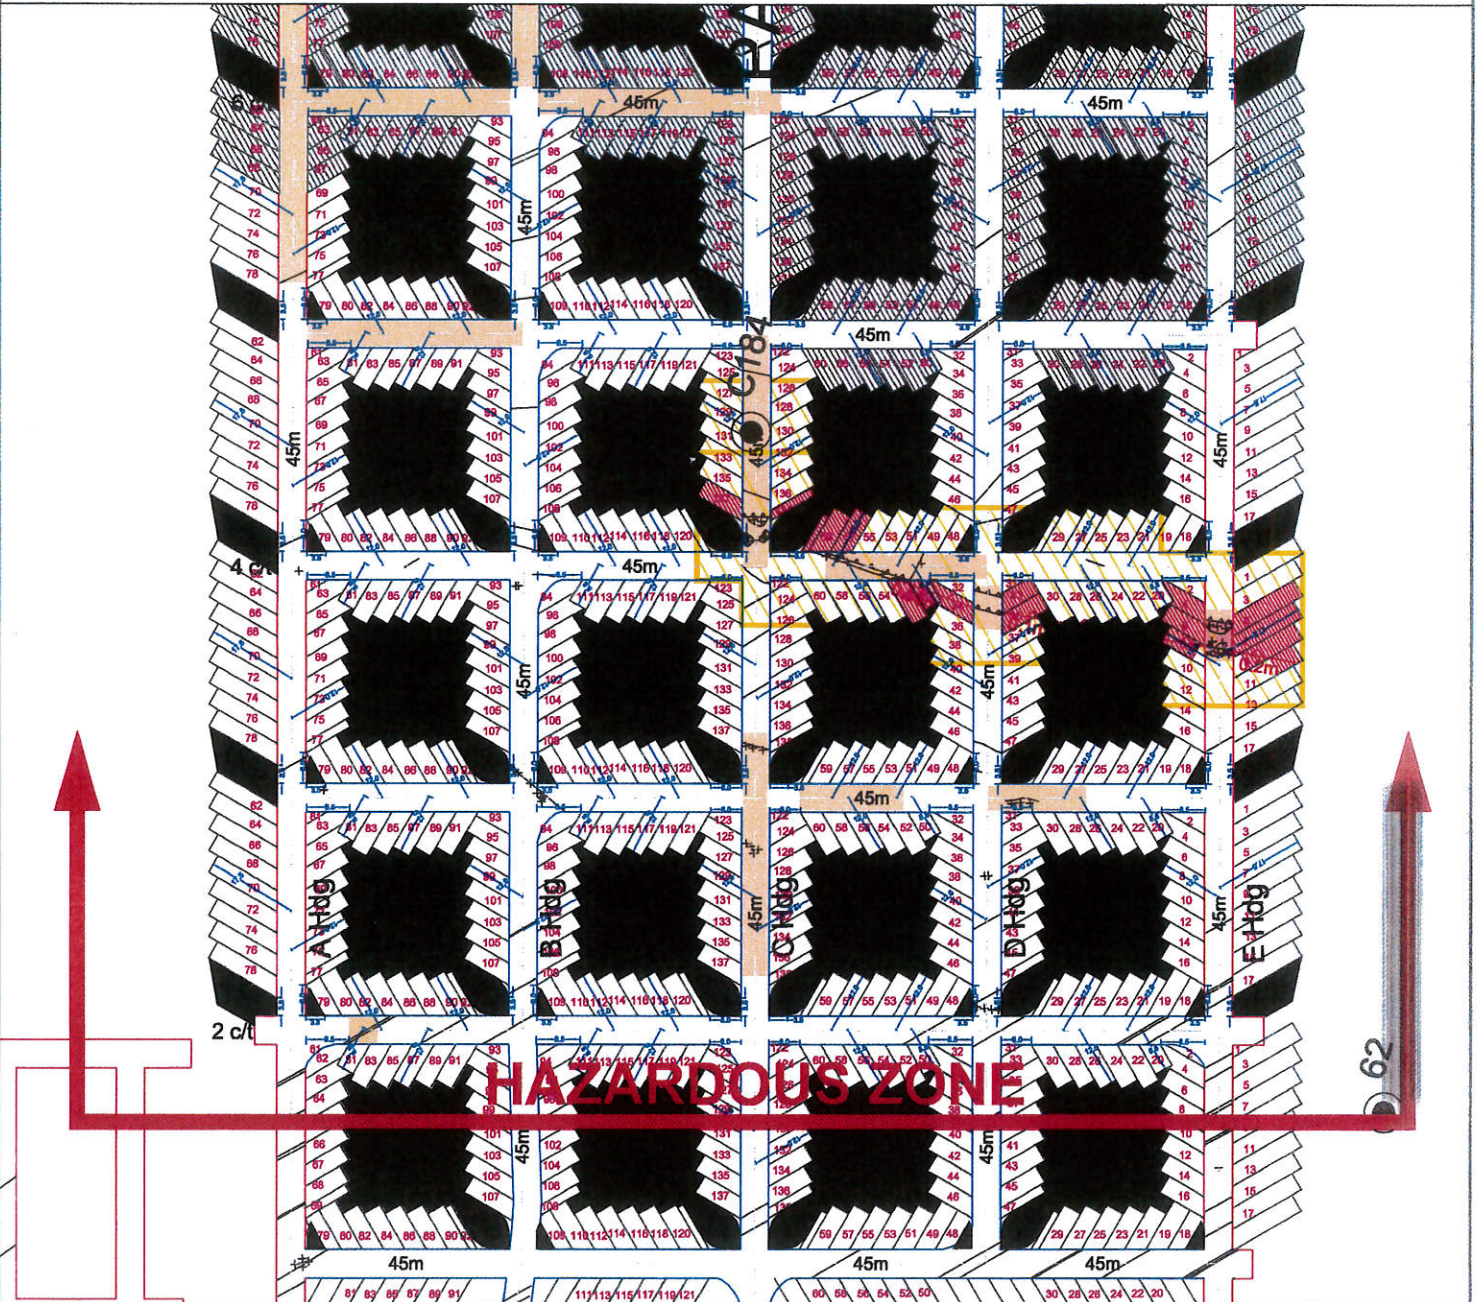
Authority to Mine Plan - Panel 21 (6c/t to 2c/t)

KEY:		Panel 21 - 6c/t to 2c/t
