DONALDSON COAL

ABEL MINE

Mine Design SMP Compliance Audit

Panel 22

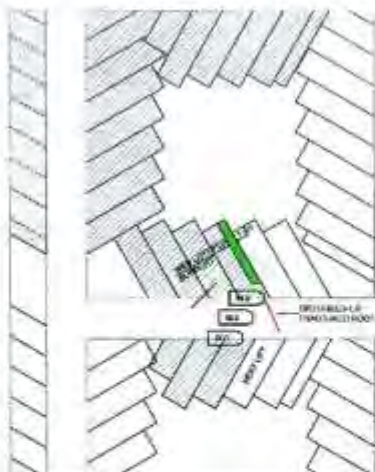
EXAMPLE (A) - FRACTURED ROOF IN EXISTING HEADING OR CUT-THROUGH

IT IS IMPORTANT TO SUPPORT DISTURBED OR FRACTURED ROOF ZONES.

- FOR DOUBLE SIDED LIFTING CUT LIFT ONLY AS FAR AS NECESSARY TO ADVANCE MRS
- ADVANCE BLS AS CLOSE AS POSSIBLE TO THE NEXT LIFT
- TAKE NEXT LIFT LEAVING 1.0m WEB (WIDTH DEPENDS ON CONDITION OF DISTURBED GROUND AND ADJACENT STRATA CONDITIONS)
- THE WEB WILL PROVIDE TEMPORARY SUPPORT TO THE ROOF
- RESUME NORMAL LIFTING SEQUENCE AS SOON AS POSSIBLE

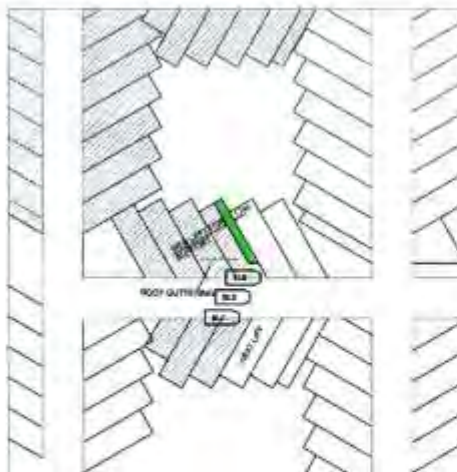
EXAMPLE (B) - ROOF GUTTERING IN GOAF

IT IS IMPORTANT TO SUPPORT DISTURBED OR FRACTURED ROOF ZONES.

- FOR DOUBLE SIDED LIFTING CUT LIFT ONLY AS FAR AS NECESSARY TO ADVANCE MRS
- ADVANCE BLS AS CLOSE AS POSSIBLE TO THE NEXT LIFT
- TAKE NEXT LIFT LEAVING 1.0m WEB (WIDTH DEPENDS ON CONDITION OF DISTURBED GROUND AND ADJACENT STRATA CONDITIONS)
- THE WEB WILL PROVIDE TEMPORARY SUPPORT TO THE ROOF
- RESUME NORMAL LIFTING SEQUENCE AS SOON AS POSSIBLE
- GOAF FLUSH TO THE BACK OF BLS

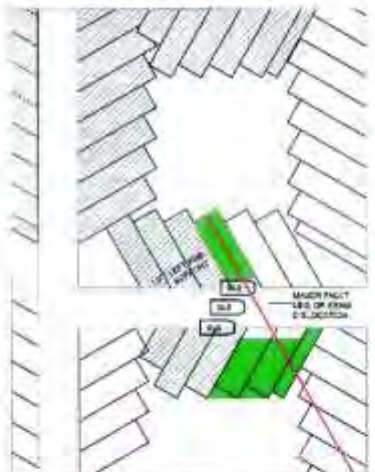
EXAMPLE (C) - MAJOR FAULT LINE OR SEAM DISLOCATION IN LIFT

IT IS IMPORTANT TO SUPPORT DISTURBED OR FRACTURED ROOF ZONES.

- FOR DOUBLE SIDED LIFTING CUT LIFT ONLY AS FAR AS NECESSARY TO ADVANCE MRS
- ADVANCE BLS AS CLOSE AS POSSIBLE TO THE NEXT LIFT
- TAKE NEXT LIFT LEAVING A STOCK 1.0m EACH SIDE OF THE FAULT OR DISLOCATION (WIDTH DEPENDS ON CONDITION OF DISTURBED GROUND AND ADJACENT STRATA CONDITIONS)
- THE STOCK WILL PROVIDE TEMPORARY SUPPORT TO THE ROOF
- RESUME NORMAL LIFTING SEQUENCE AS SOON AS POSSIBLE

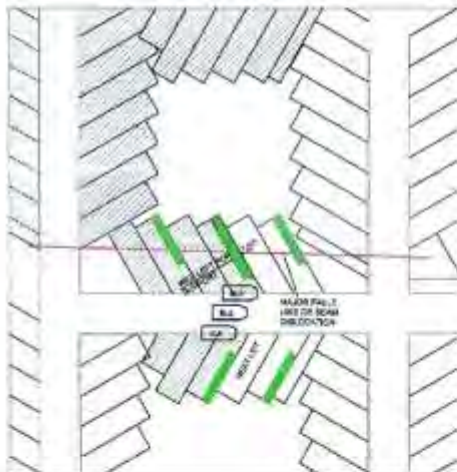
EXAMPLE (D) - MAJOR FAULT LINE OR SEAM DISLOCATION RUNNING SUB-PARALLEL

IT IS IMPORTANT TO SUPPORT DISTURBED OR FRACTURED ROOF ZONES.
