# Appendix 5

## Aquatic Monitoring Report: Autumn 2015 and Spring 2015\*

## Tasman Coal Aquatic Monitoring Report Autumn 2015

## Tasman Coal Aquatic Monitoring Report Spring 2015

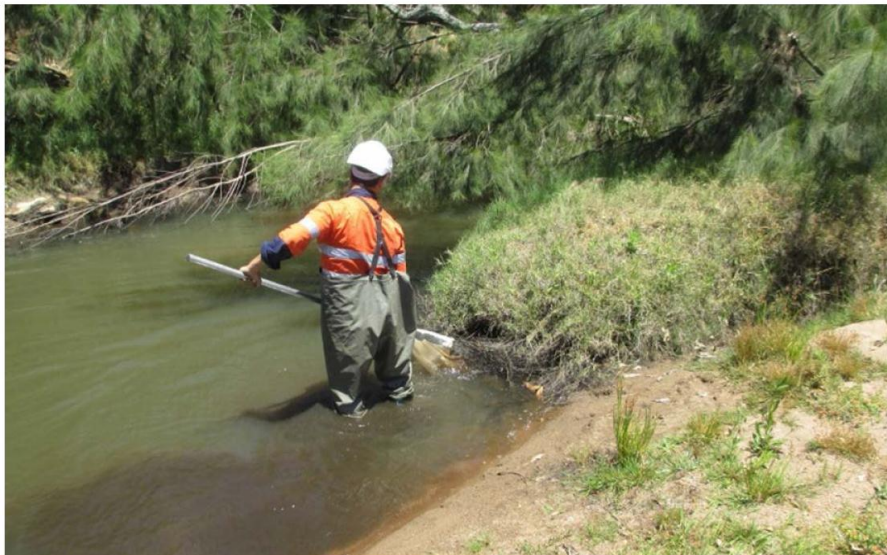
**Plate 1 Sampling method**

Samples were collected from pool edges for a length of 10 metres either as a continuous line or in disconnected segments. Sampling in segments was often undertaken to ensure the sampling of sub-habitats such as macrophyte beds, bank overhangs, submerged branches and root mats. Segmented sampling was also employed where pool length was short and it was logistically difficult to sample in a continuous line (e.g. in-stream logs). A 250  $\mu\text{m}$  dip net was drawn through the water with short sweeps towards the bank to dislodge benthic fauna while scraping submerged rocks and debris, sides of the stream bank and the bed substrate (Plate 1). Further sweeps in the water column targeted the suspended fauna.

Each sample was rinsed from the net onto a white sorting tray from which animals were picked using forceps, pipettes and or paint brushes. Each tray was picked for a minimum period of forty minutes, after which they were picked at ten minute intervals for either a total of one hour or until no new specimens had been found. Care was taken to collect cryptic and fast moving animals in addition to those that were

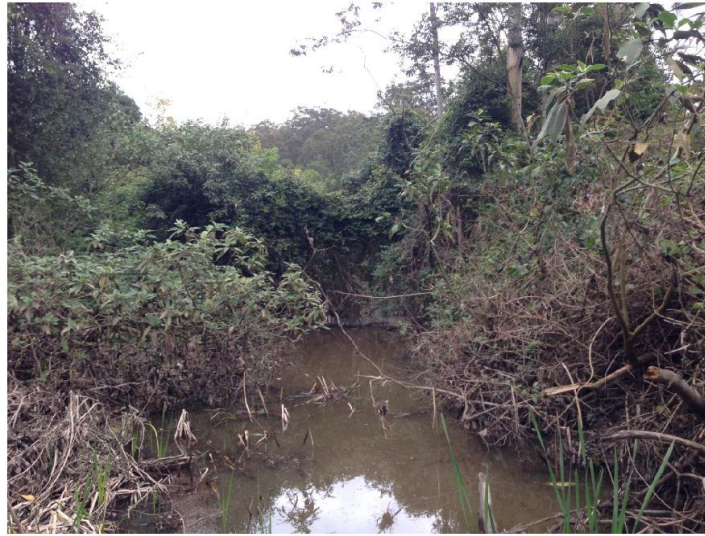
**Plate 2 Blue Gum Creek at Stockrington Road**

The site is located is most upstream site on Blue gum Creek. Catchment landuse at the upstream site at George Booth Drive is predominantly bushland as well as the rehabilitated mine site and Stockrington Quarry to the north and the Hunter Expressway to the south (Figure 2, Plate 2). The stream was in moderate condition (RCE 33), and showed some disturbance through the presence of weeds Lantana (*Lantana camara*), Tobacco Bush (*Solanum mauritanum*) and Crofton Weed (*Ageratina adenophora*) as well as significant erosion. Canopy vegetation included Blue Gum (*Eucalyptus saligna*). The mid-storey was dominated by Lantana, Tobacco Bush, Cheese Tree (*Glochidion ferdinandi*) and the ground cover by native and exotic grasses and herbs. The vegetation provided low shading of the stream.

This stream was mostly shallow (<1 m depth) and had a 5 m modal width. The stream substrate consisted of predominately silt. The macrophytes Typha and Duckweed (Lemnaceae) were observed at this site. There were pools present with some flow at the time of sampling. The water also appeared turbid and extensive stream bank erosion from a recent flood.

Niche recommends that previous macroinvertebrate monitoring data be reviewed for quality control. In performing this review, it is recommended that previous Signal results be updated using Chessman (2003) Signal2 methods to provide greater accuracy of stream health assessment and to ensure that data is comparable for future monitoring assessments.

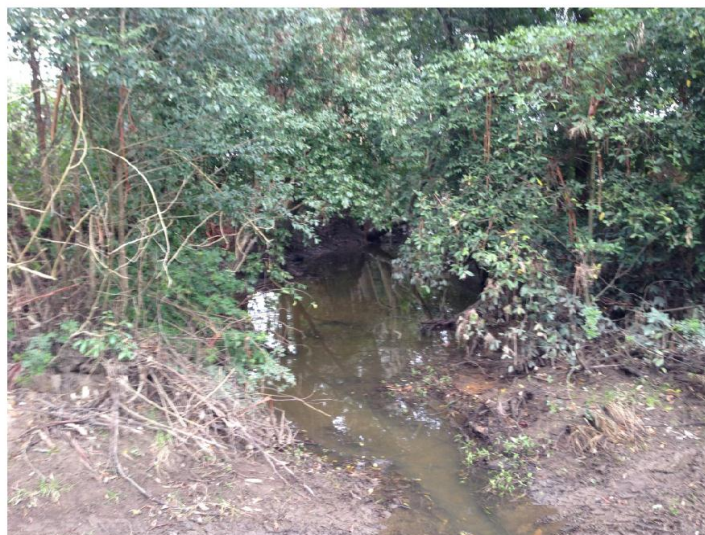
**Plate 3 Blue Gum Creek at Dog Hole Bridge**

The site is located downstream of site BGC@SR and upstream of Dog Hole bridge (Figure 2, Plate 3). The stream was in moderate condition (RCE 36), and showed some disturbance (i.e. presence of weeds such as Lantana). Canopy vegetation included Blue Gum, Lilly Pilly (*Syzygium smithii*) and Cheese Tree. The mid-storey was dominated by Lantana and Cheese Tree and the ground cover by native grasses and herbs. The vegetation provided moderate shading of the stream.

This stream was mostly shallow (<1 m depth) with some deep sections and had a 2.5 m modal width. The stream substrate consisted of predominately silt, with some bedrock and cobbles. No macrophytes were observed at this site. There were pools present; however there was little flow at the time of sampling. The water appeared turbid. There was an anoxic odour present and signs of grazing on both side of the creek.

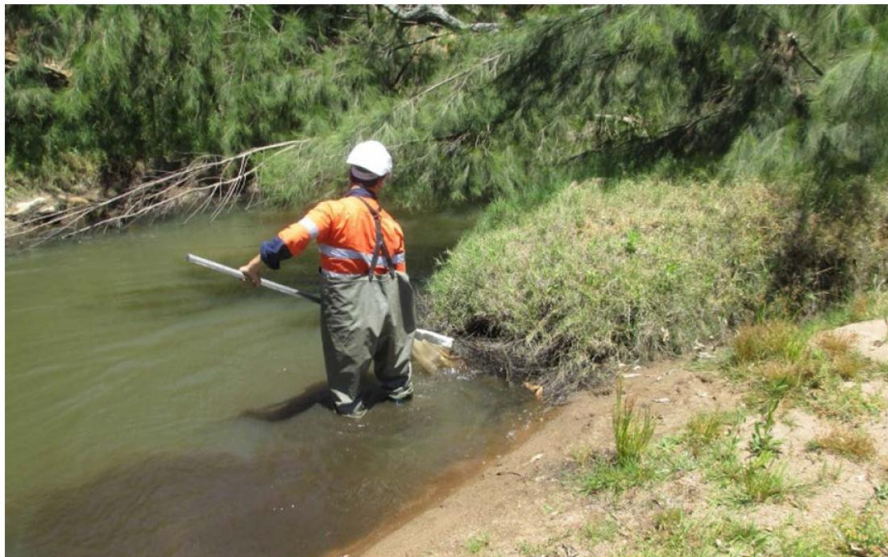
**Plate 1 Sampling method**

Samples were collected from pool edges for a length of 10 metres either as a continuous line or in disconnected segments. Sampling in segments was often undertaken to ensure the sampling of sub-habitats such as macrophyte beds, bank overhangs, submerged branches and root mats. Segmented sampling was also employed where pool length was short and it was logistically difficult to sample in a continuous line (e.g. in-stream logs). A 250  $\mu\text{m}$  dip net was drawn through the water with short sweeps towards the bank to dislodge benthic fauna while scraping submerged rocks and debris, sides of the stream bank and the bed substrate (Plate 1). Further sweeps in the water column targeted the suspended fauna.

Each sample was rinsed from the net onto a white sorting tray from which animals were picked using forceps, pipettes and or paint brushes. Each tray was picked for a minimum period of 40 minutes, after which they were picked at 10 minute intervals for either a total of one hour or until no new specimens had been found. Care was taken to collect cryptic and fast moving animals in addition to those that were

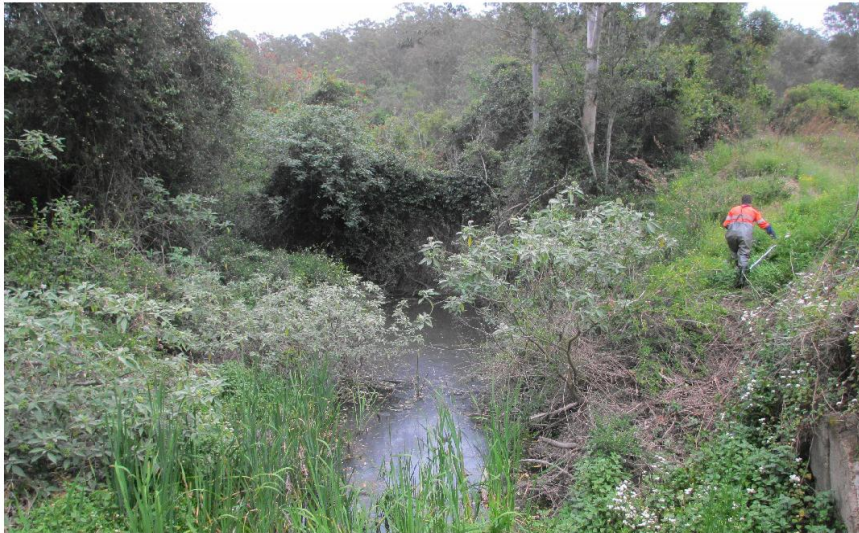
**Plate 2 Blue Gum Creek at Stockrington Road**

The site is located is most upstream site on Blue gum Creek. Catchment landuse at the upstream site at George Booth Drive is predominantly bushland as well as the rehabilitated mine site and Stockrington Quarry to the north and the Hunter Expressway to the south (Figure 2, Plate 2). The stream was in moderate condition (RCE 33), and showed some disturbance through the presence of weeds Lantana (*Lantana camara*), Tobacco Bush (*Solanum mauritianum*) and Crofton Weed (*Ageratina adenophora*) as well as significant erosion. Canopy vegetation included Blue Gum (*Eucalyptus saligna*). The mid-storey was dominated by Lantana, Tobacco Bush, Cheese Tree (*Glochidion ferdinandi*) and the ground cover by native and exotic grasses and herbs. The vegetation provided low shading of the stream.

This stream was mostly shallow (<1 m depth) and had a 5 m modal width. The stream substrate consisted of predominately silt. The macrophytes *Typha sp.* and Duckweed (Lemnaceae) were observed at this site. There were pools present with some flow at the time of sampling. The water also appeared turbid and extensive stream bank erosion was observed, likely from a past flood event.

Niche recommends that the monitoring program for Tasman Coal be reviewed as there are several confounding anthropogenic disturbances affecting macroinvertebrate communities and stream health downstream of the mine. The review should assess: whether the sites are appropriate to monitor stream health and catchment protection measures, whether additional sites are required in closer proximity to Tasman Coal and the value of continuing the program in its current form.

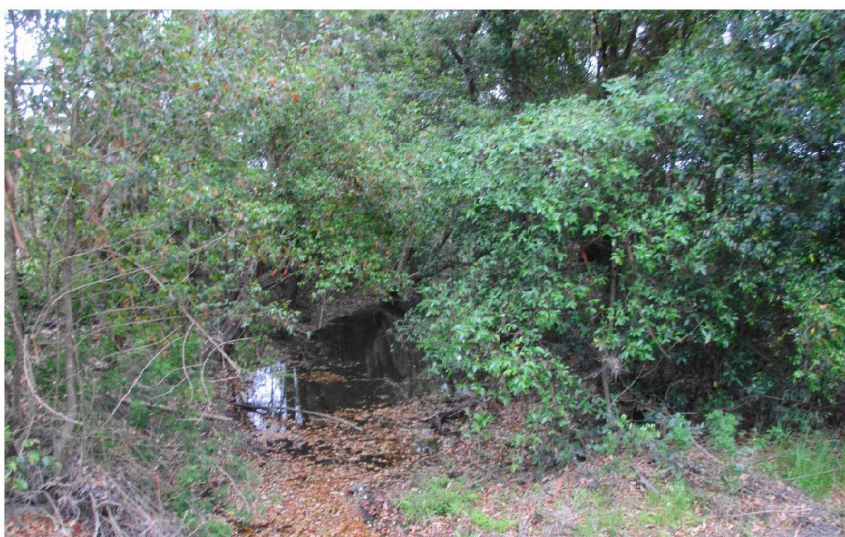
**Plate 3 Blue Gum Creek at Dog Hole Bridge**

The site is located downstream of site BGC (along Stockrington Road) and upstream of Dog Hole Bridge (Figure 2, Plate 3). The stream was in moderate condition (RCE 36), and showed some disturbance (i.e. presence of weeds such as Lantana). Canopy vegetation included Blue Gum (*Eucalyptus sp.*), and Lilly Pilly (*Syzygium smithii*). The mid-storey was dominated by *Lantana camara* and Cheese Tree (*Glochidion ferdinandi*) and the ground cover by native grasses and herbs. The riparian vegetation provided moderate shading of the stream.

This stream was mostly shallow (<1 m depth) with some deep sections and had a 2.5 m modal width. The stream substrate consisted of predominately silt, with some bedrock and cobbles. No macrophytes were observed at this site. There were pools present; however there was little flow at the time of sampling. The water appeared turbid. There was an anoxic odour present and signs of grazing on both side of the creek.
