Annual Environmental Management Report

Abel Underground Coal Mine

7 June 2007 to 1 June 2008

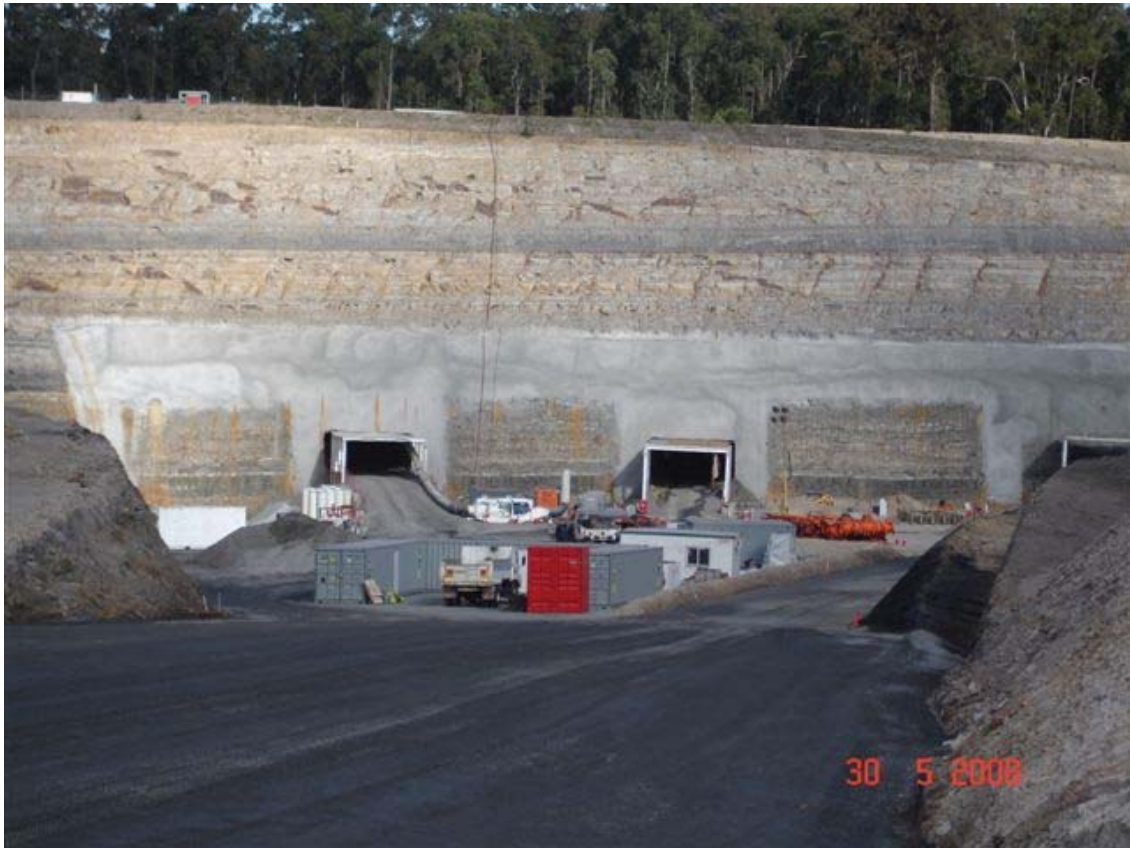
Plate 1
Mine Portals (Ref: DSC01191)

During the reporting period the primary construction activity involved commencement of the mine portals and initial underground roadways in early March 2008 (see **Plate 1.1**). As at the end of this reporting period the roadway extending from the personnel and equipment access portal had progressed approximately 20m south of the box cut whilst the roadway from the conveyor portal had extended approximately 80m. The roadway for the ventilation portal had not yet commenced.
