Annual Environmental Management Report

**Abel Underground Coal Mine
1 June 2008 to 31 May 2009**

Annual Environmental Management Report for the Abel Underground Coal Mine 1 June 2008 to 31 May 2009

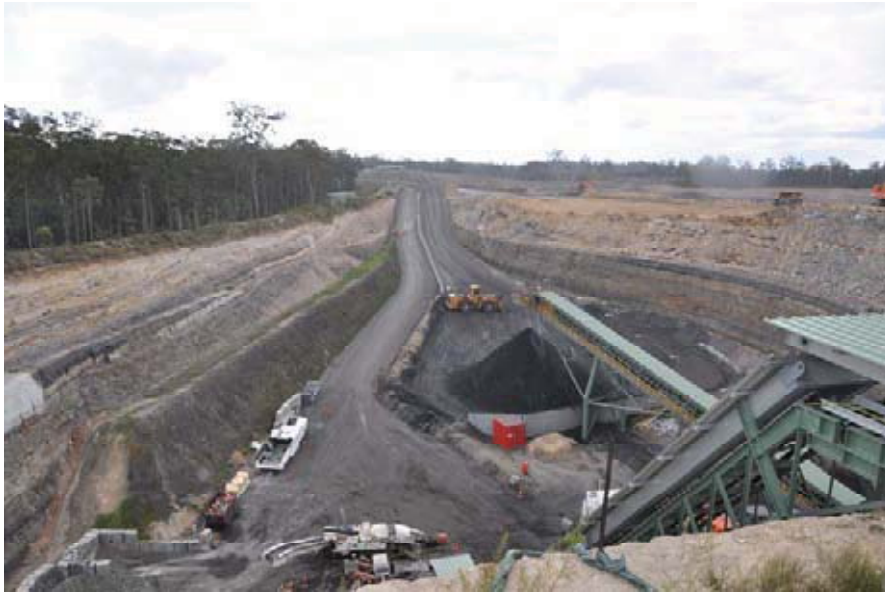
Plate 1

View North across the Portal and Coal Handling Area (Date of Photography 8 September 2009) (Ref DSC_0135)

All ROM coal was stockpiled within the mine's portal and coal handling area. The ROM stockpile, which is situated under the conveyor outfeed, has a capacity of 3000t. Generally between 1500t and 2800t of ROM coal was stockpiled at any one time with an average of approximately 2500t. During the reporting period, material was removed from site and transported to the Bloomfield CHPP.

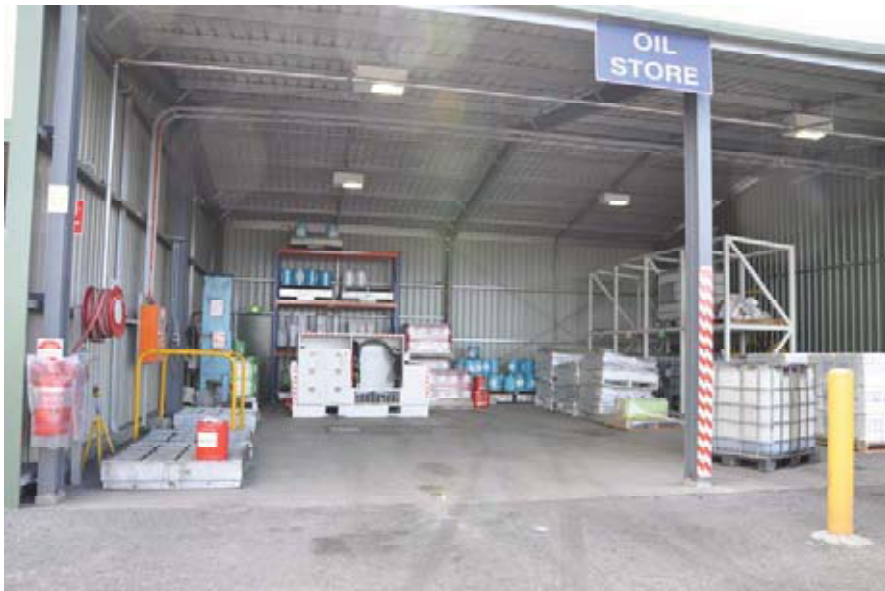
Plate 2

Oil Store in Newly Constructed Workshop (Date of Photography 8 September 2009) (Ref DSC_0107)

All waste oil was stored within 205L drums within the oil store before being removed from site, along with used oil filters and oily rags, by Australian Waste Oils. Used tyres are removed from site during servicing by Marathon for repair or disposal.

One hydrocarbon spill involving an overflow from an oil drum occurred on 21 April 2009 in the Oil Store. This was not a reportable incident and did not lead to hydrocarbon contamination or pollution of land or water. Rectification measures included stoppage of the leak and clean up of the area. The existing hydrocarbon management practices have been considered adequate with no further improvements planned during the next reporting period.

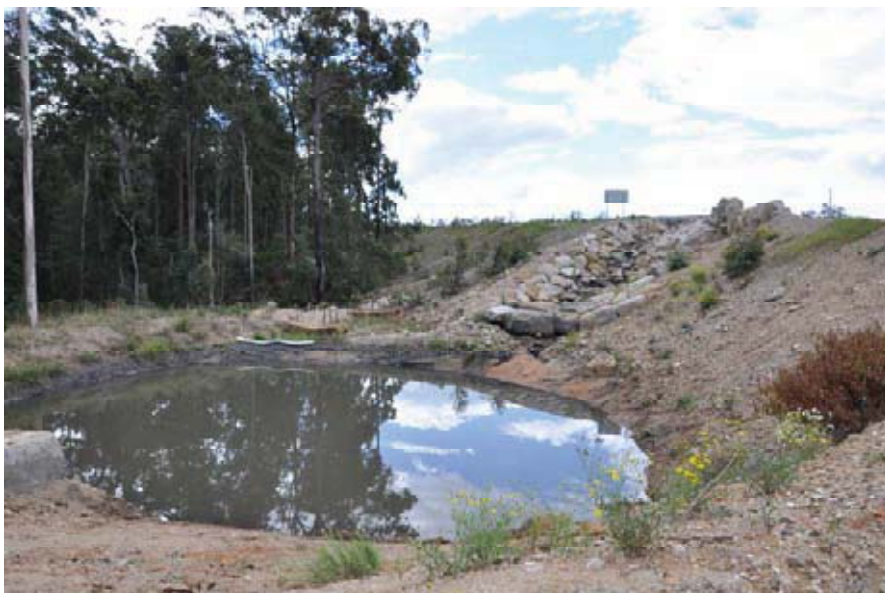
Plate 3

Newly Constructed Dirty Water Dam (Date of Photography 8 September 2009) (Ref DSC_0147)

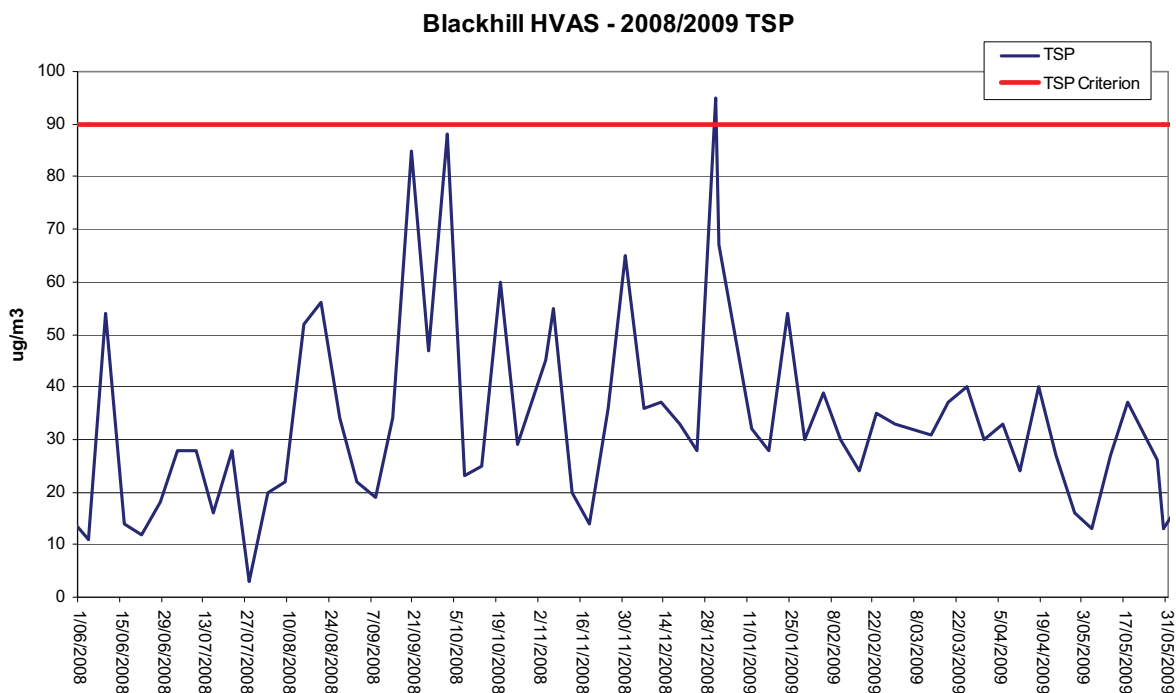
Figure 3.2 Suspended Particulate Monitoring Results – 2008/2009

The suspended particulate monitoring results show that the highest 24-hour average PM₁₀ concentration was 43µg/m³, measured on 21 August 2008. On no occasion did the measured PM₁₀ concentrations exceed the 50µg/m³ 24-hour *National Environment Protection Measures* (NEPM) goal. The highest TSP was 95µg/m³ recorded on 31 December 2008. It should be noted that the *National Health and Medical Research Council* (NHMRC) goal refers to an annual average and not a 24-hour average as measured by the high volume air sampler.

The annual average PM₁₀ concentration for Blackhill was 18µg/m³ for the 12 months to May 2009. The annual average TSP concentration for the 12 months to May 2009 was 35µg/m³. The monitoring results indicate that suspended particulate concentrations are well below the annual average criteria.
