# Annual Review

## Abel Underground Coal Mine

1 January 2019 – 31 December 2019

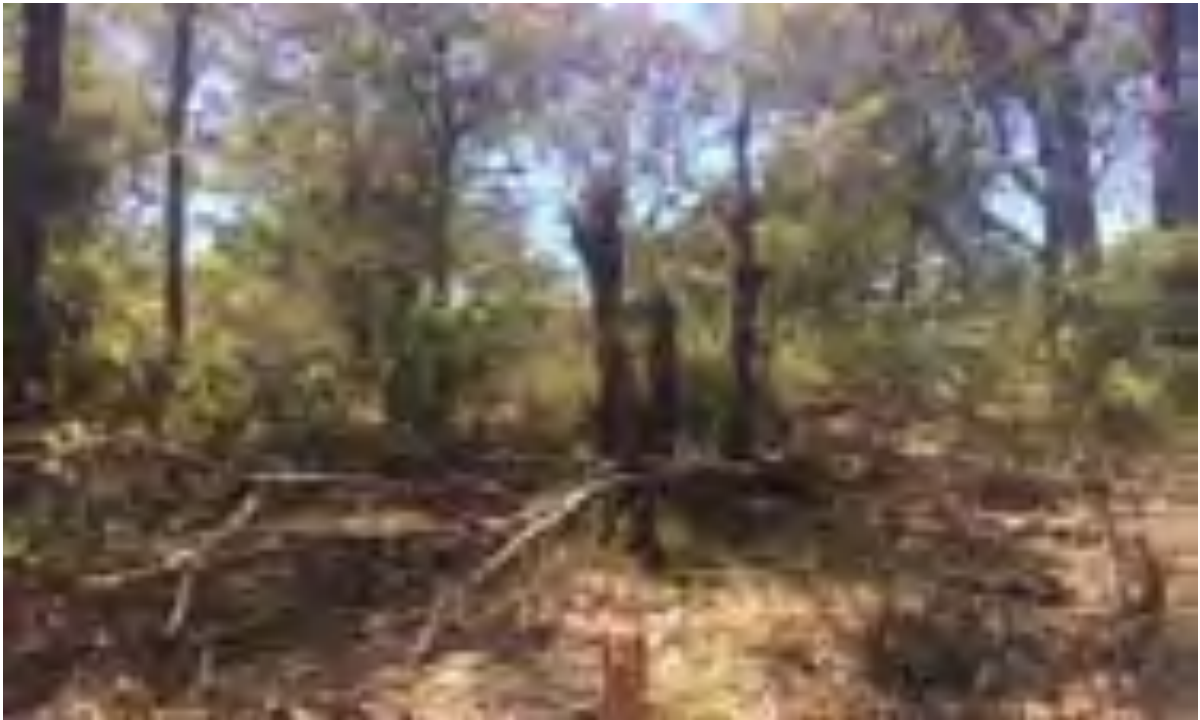
During the 2018 survey, six exotic species were recorded within Quadrat 1; *Bidens pilosa* (Cobblers Peg), *Senecio madagascariensis* (Fireweed), *Sida rhombifolia* (Paddy's Lucerne), *Ehrharta erecta* (Panic Veldtgrass), *Lantana camara* (Lantana) and *Paspalum dilatatum* (Paspalum) - a new species recorded this survey. Five of these species were observed to comprise less than 5% coverage with Lantana increasing to a coverage score of 3 (5-<25%) – a considerable increase from the previous survey.

The vegetation community appears to be in good overall health evident by the increase in species diversity. This could be due to natural fluctuations and/or climatic conditions. However, the increase in Lantana requires control action.

**Plate 1: Flora quadrat 1 (Q1) located in Coastal Foothills Spotted Gum - Ironbark Forest (Photograph taken in 2018)**

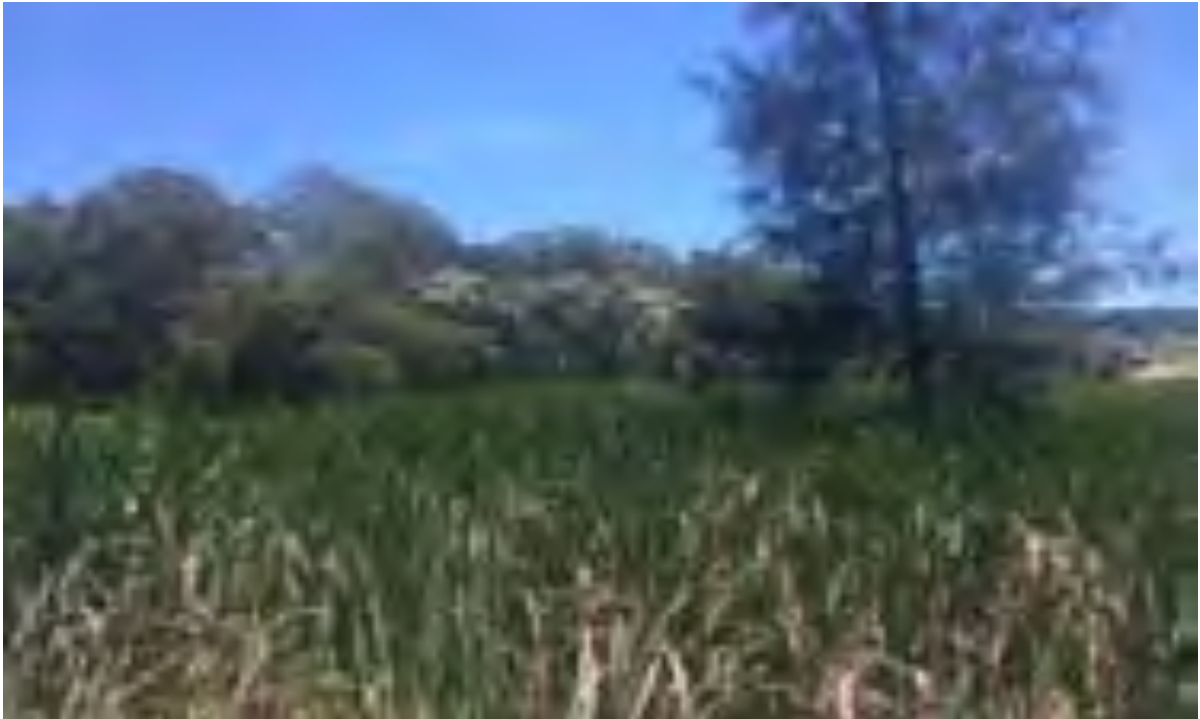
All but Kikuyu (increased to between 5% - <25%) were recorded at less than 5 percent coverage. The increase in the exotic species diversity, and the appearance of Crofton Weed indicate that the weeds are beginning to encroach in to the wetland. Whether this trend will be reversed with an increase in water levels following increased rainfall will be determined by subsequent years' monitoring. The weeds have most likely been sourced from the adjacent road side.

Overall, the wetland appears to still be in good health with native species dominating the wettest areas (*Typha orientalis*, *Schoenoplectus subulatus*, *Bolboschoenus caldwellii* and *Eleocharis equisetina*).

**Plate 2:** Flora quadrat 2 (Q2) located in Freshwater Wetland Complex dominated by Typha (Photograph taken in 2018)

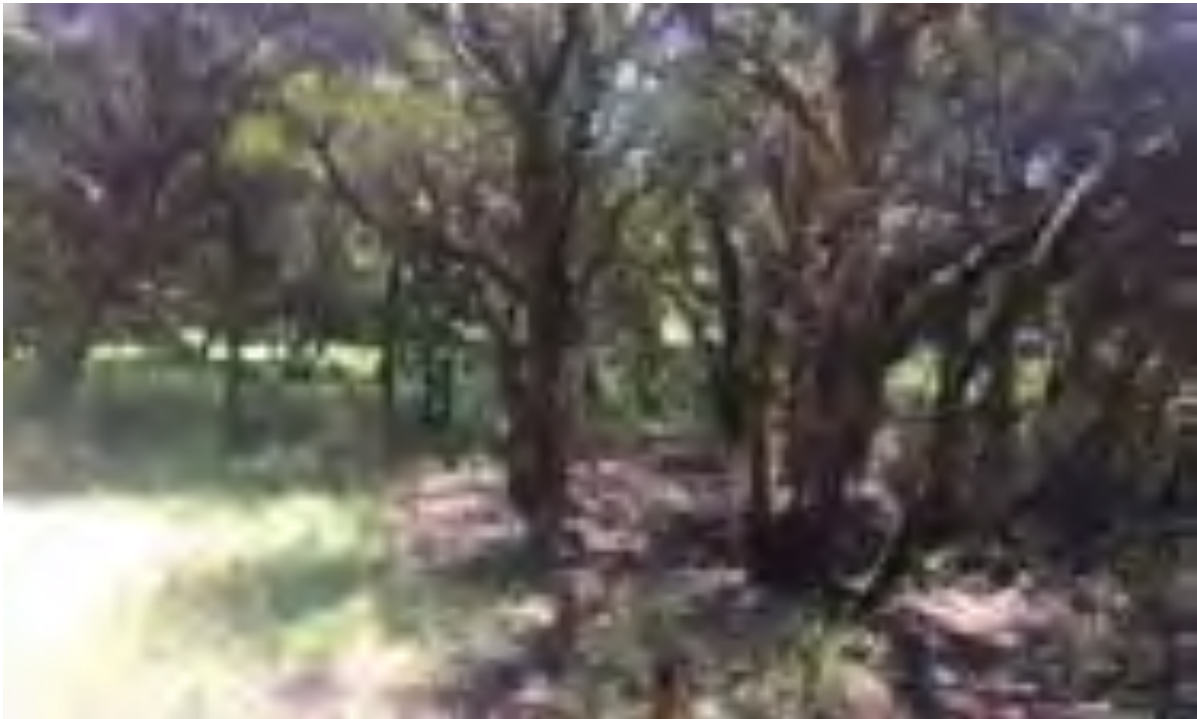
Twenty-three species were recorded in the 2018 survey; of these, 12 were exotic. Exotic species recorded this survey (but not 2017) were *Brassica juncea*, *Bidens pilosa* (Cobblers Pegs), *Cirsium vulgare* (Black Thistle), *Conyza spp.* (Fleabane), *Phytolacca octandra* (Inkweed) and *Solanum nigrum* (Blackberry Nightshade). The 2017 survey noted that the exotic species *Atriplex prostrata* (Hastate Orache) had increased dramatically over the previous three surveys. This survey recorded a substantial decrease in cover from 5 (50 - <75%) to 2 (<5%, but many individuals). *Cenchrus clandestinus* (Kikuyu) and *Rubus fruticosus* (Blackberry) remain abundant adjacent to Q3 in the north-east corner of the reserve. One exotic species *Aster subulatus* (Wild Aster) was not recorded this survey.

Native species richness and their cover remain largely unchanged between surveys at Q3.

**Plate 3:** Flora quadrat 3 (Q3) located in Paperbark Swamp Forest (Photograph taken in 2018)

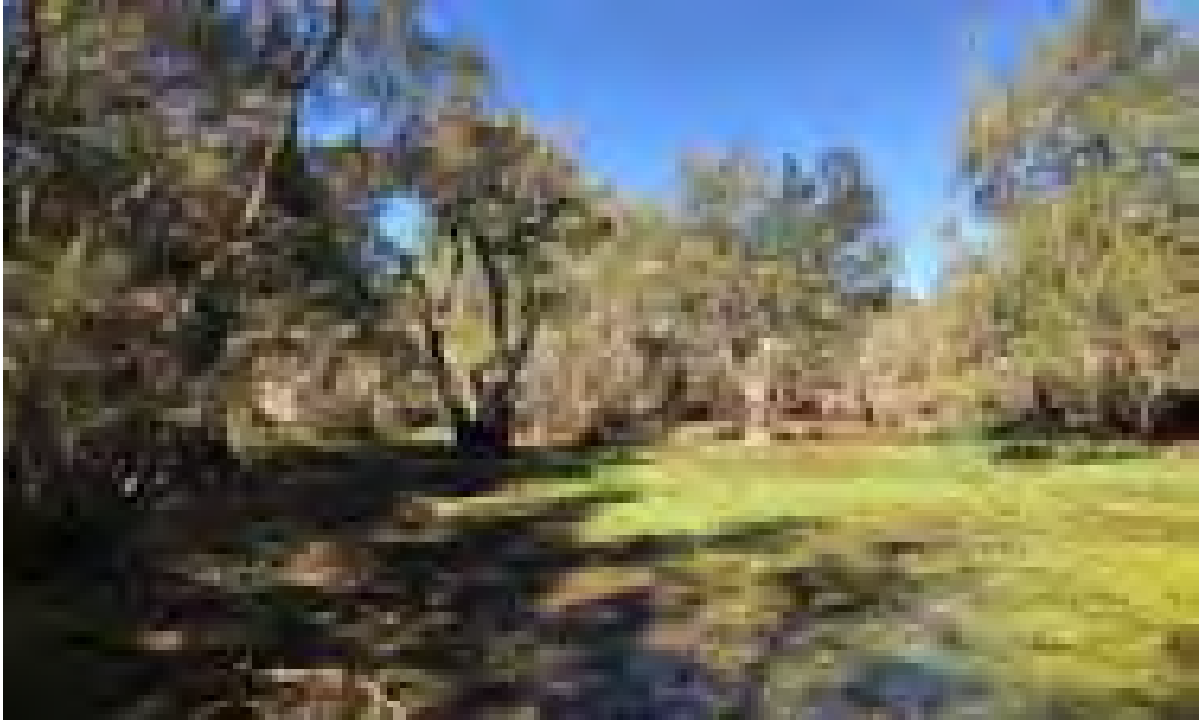
The environmental weed *Alternanthera philoxeroides* (Alligator Weed) was first recorded in 2011. The abundance of this weed has fallen somewhat to a cover of two (<5%, many individuals).

**Plate 4:** Flora quadrat 4 located in Paperbark Swamp Forest (Photograph taken in 2017). Alligator Weed dominates in the foreground.

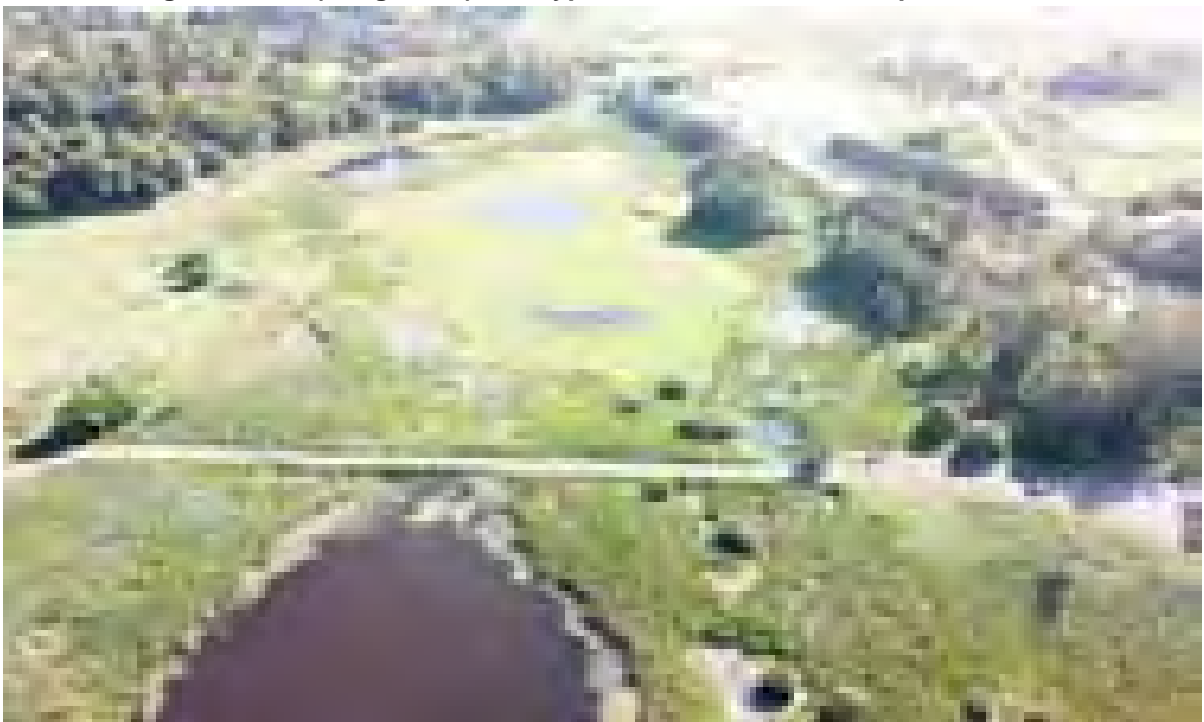
- Aerial drone photography shows the extent of the Water Hyacinth in the north swamp (**Plate 18**).
- Water Hyacinth is an environmental weed that should be controlled under the General Biosecurity Duty of the *Biosecurity Act 2015* due to its potential biosecurity risk. The NPWS Hunter Region Pest Management Strategy (2002) has identified control of Water Hyacinth

**Plate 18: Aerial photography showing the extent of the Water Hyacinth on the north swamp in 2018.**

at Pambalong Nature Reserve as a “high priority” and an active program has been operating in the reserve since 2002.

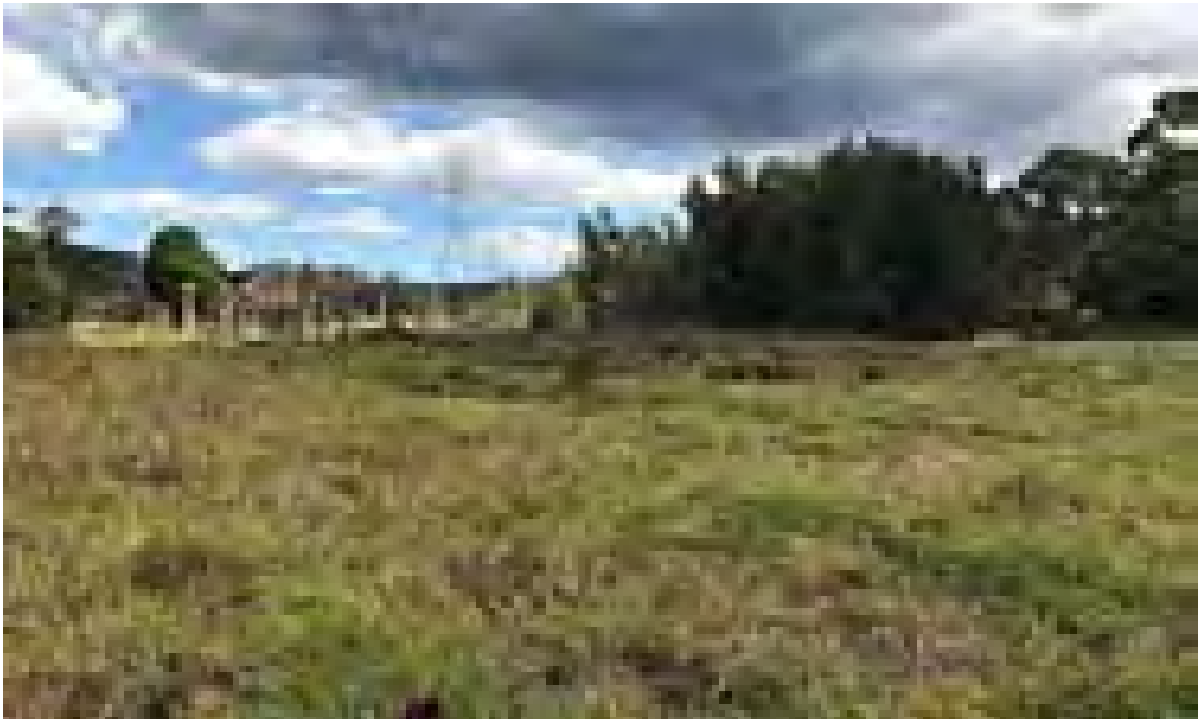
*Cenchrus clandestinus* (Kikuyu) forms dense, monoculture grassy thickets within disturbed areas of the subject site (**Plate 19**). The thickets are so dense in some areas that they are suppressing native vegetation from regenerating.

**Plate 19:** *Cenchrus clandestinus* (Kikuyu) in the north-west corner of the reserve

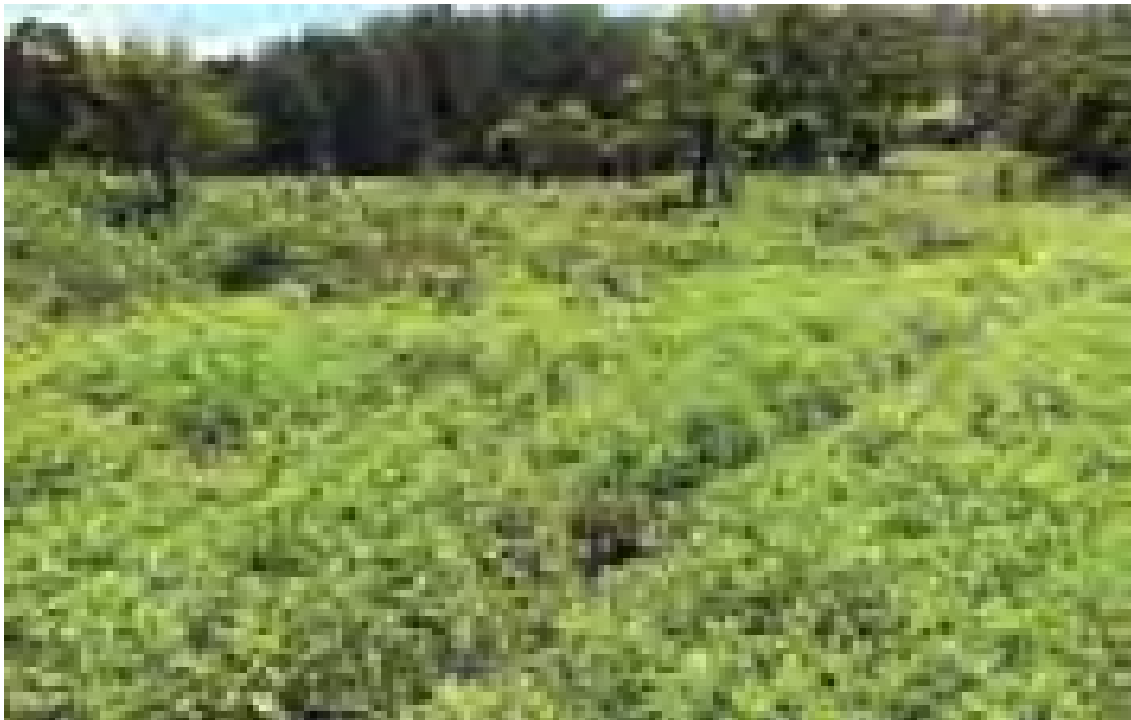
*Rubus fruticosus* sp. aggregate. (Blackberry) is found in areas of previous disturbance within the reserve, and forms a dense thicket to 1 m high, suppressing natural regeneration. Blackberry thickets can restrict fauna access to the wetland areas and provide shelter for feral animals. Blackberry is listed as a prohibited matter under the *Biosecurity Act 2015* in Newcastle, Cessnock and Maitland local government areas and the growth and spread of the plant must be controlled according to the measures specified in a management plan published by the local control authority (the plant may not be imported into the state or sold).

**Plate 21:** *Rubus fruticosus* (Blackberry) – background in the north-west corner of the reserve. *Ambrosia tenuifolia* (Lacy Ragweed) in the foreground.

- The NPWS Hunter Region Pest Management Strategy (2002) identifies Blackberry as a “high priority” weed. This species was initially treated by weed control efforts in 2008; however, it was still recorded at low densities on Transect 1 in 2013. Ongoing treatment is required to eradicate/suppress this species and prevent re-establishment as it is still present in patches in certain sections of the reserve (**Plate 21** and **Figure 11**).

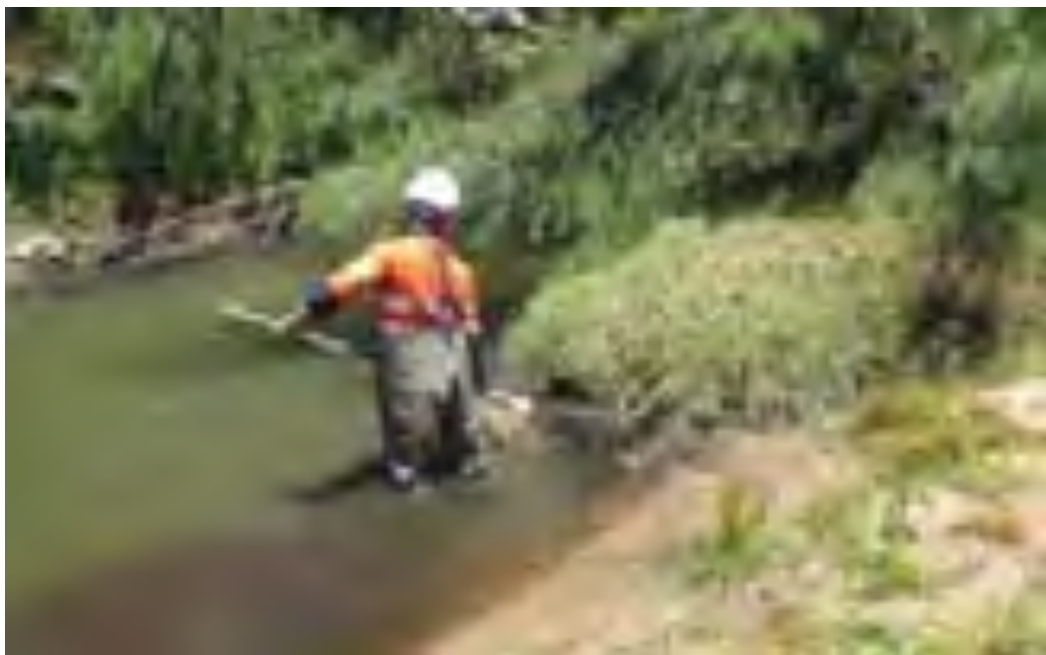
Samples were collected from pool edges for a length of 10 metres, either as a continuous line or in disconnected segments. Sampling in segments was often undertaken to ensure the sampling of sub-habitats such as macrophyte beds, bank overhangs, submerged branches and root mats. Segmented sampling was also employed where pool length was short and it was logistically difficult to sample in a continuous line (e.g. in-stream logs). A 250  $\mu\text{m}$  dip net was drawn through the water with short sweeps towards the bank to dislodge benthic fauna while scraping submerged rocks and debris, sides of the stream bank and the bed substrate (Plate 1). Further sweeps in the water column targeted the suspended fauna.

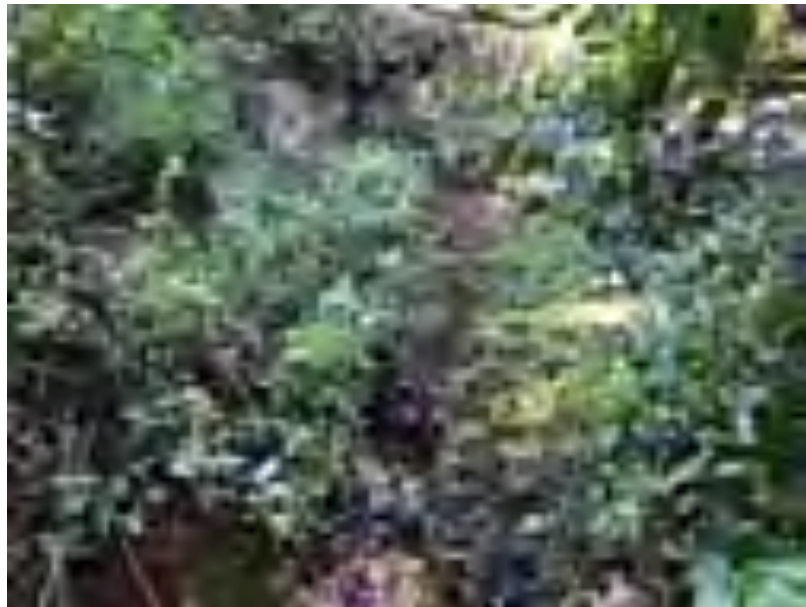
Plate 2. Blue Gum Creek at Stockrington Road.

The aquatic habitat of Blue Gum Creek at Stockrington Road (BGC@SR) (Plate 2) at the time of the Autumn 2019 monitoring surveys is detailed in Table 5.

<b>Comments</b>		Similar to previous sampling conditions, although water quality appears to have deteriorated and appears soupy.

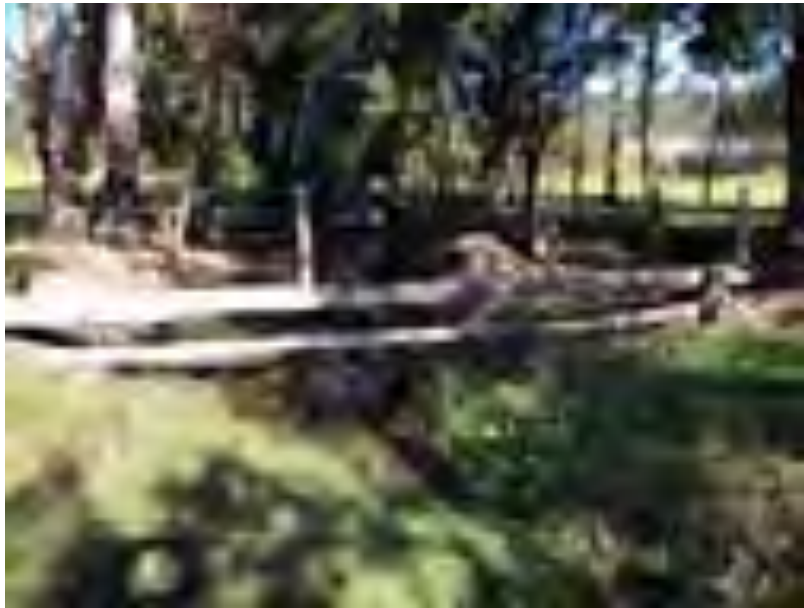
Plate 3. Blue Gum Creek at Dog Hole Bridge

The aquatic habitat of Blue Gum Creek at Dog Hole Bridge (BGC@DHB) (Plate 3) at the time of the Autumn 2019 monitoring surveys is detailed in Table 6.

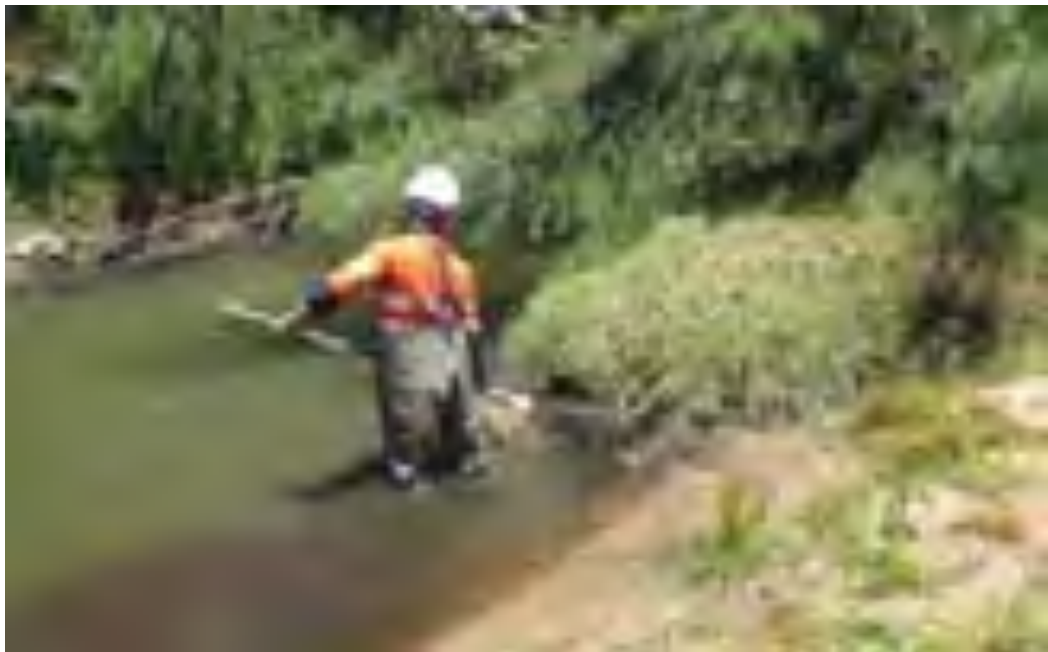
#### Plate 1: Sampling method

Samples of macroinvertebrates were collected from pool edges for a length of 10 metres, either as a continuous line or in disconnected segments. Sampling in segments was often undertaken to ensure the sampling of sub-habitats such as macrophyte beds, bank overhangs, submerged branches and root mats. Segmented sampling was also employed where pool length was short and it was logistically difficult to sample in a continuous line (e.g. in-stream logs). A 250  $\mu\text{m}$  dip net was drawn through the water with short sweeps towards the bank to dislodge benthic fauna while scraping submerged rocks and debris, sides of the stream bank and the bed substrate (Plate 1). Further sweeps in the water column targeted the suspended fauna.

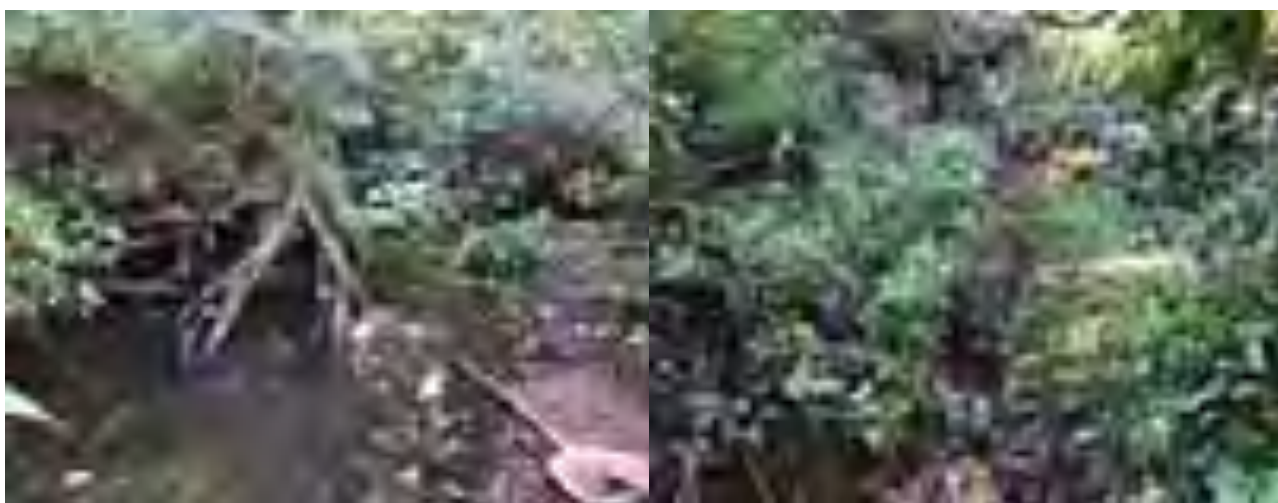
The aquatic habitat at Blue Gum Creek at Stockrington Road (Plate 2) at the time of the spring 2019 monitoring surveys is detailed in Table 5.

Blue Gum Creek at Stockrington (Downstream)

Blue Gum Creek at Stockrington (Upstream)

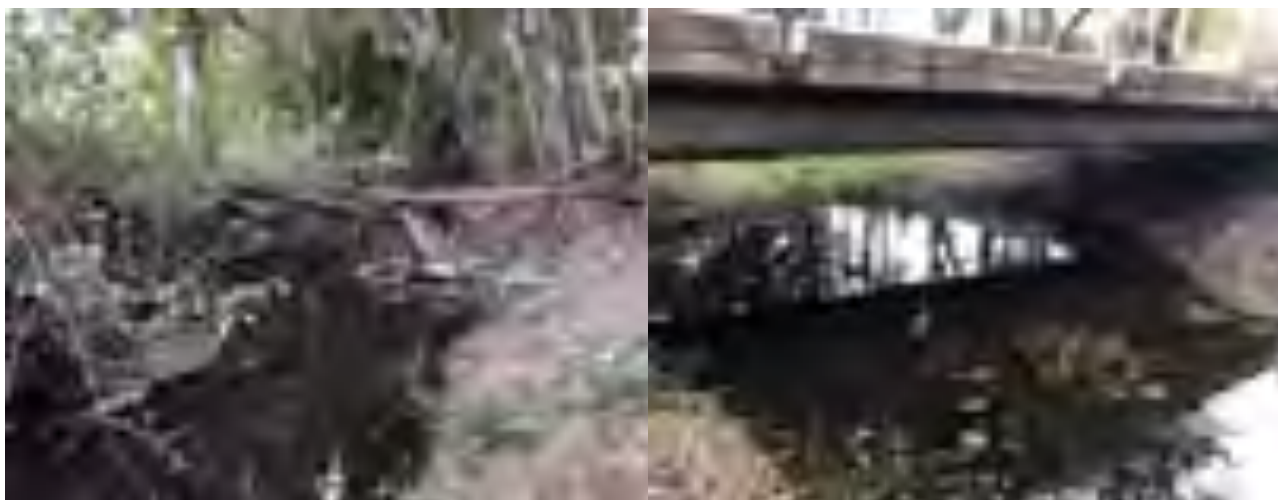
The aquatic habitat at Blue Gum Creek at Dog Hole Bridge (Plate 3) at the time of the spring 2019 monitoring surveys is detailed in Table 6.

Blue Gum Creek at Dog Hole Bridge (Downstream)

Blue Gum Creek at Dog Hole Bridge (Upstream)
