**Annual Environmental
Management Report**

**Abel Underground Coal Mine
1 June 2011 to 31 May 2012**

Annual Environmental Management Report for the Abel Underground Coal Mine 1 June 2011 to 31 May 2012

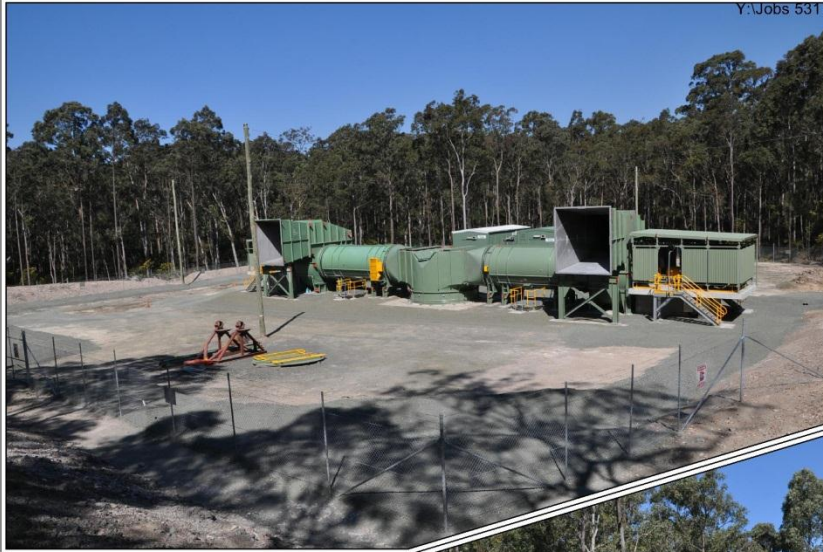
Plate 1: New Upcast Ventilation Shaft and Fans
(Date of Photography 5 September 2012)
(Ref: E737E/051)

During the reporting period the principal construction activities for the Abel Underground Coal Mine related to extension of the bathhouses (completed in June 2012) and construction of the upcast ventilation shaft and relocation of the ventilation fan (see **Plan 1** and **Plate 1**). Work for the construction of the upcast ventilation fan commenced December 2011 and was completed during May 2012. A simple colorbond shelter was also erected above the downcast ventilation shaft during May 2012 to reduce the ingress of water during rainfall events (see **Plate 2**).

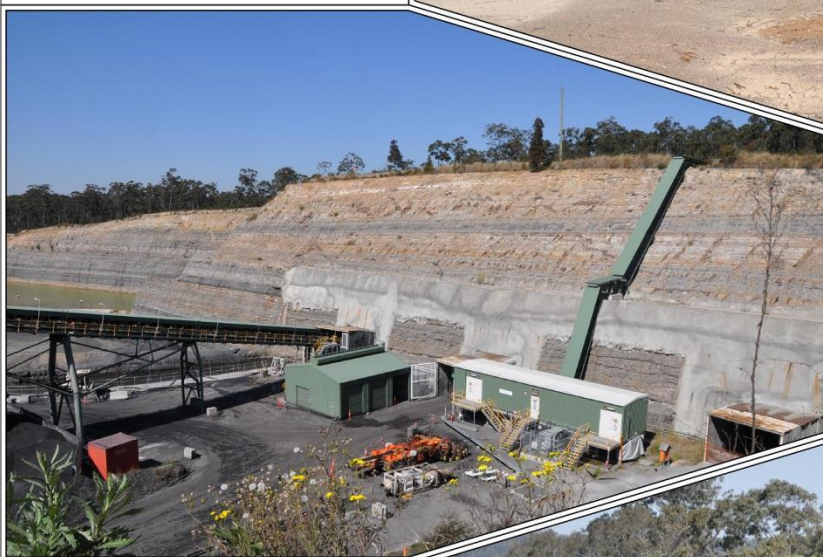
Plate 3: Portal and Coal Handling Area
(Date of Photography 5 September 2012)
(Ref: E737E/025)

All ROM coal was stockpiled within the mine's portal and coal handling area. The ROM stockpile, which is situated under the conveyor outfeed, has a capacity of approximately 3000t. During the reporting period, ROM coal continued to be transported to the Bloomfield CHPP by private road.

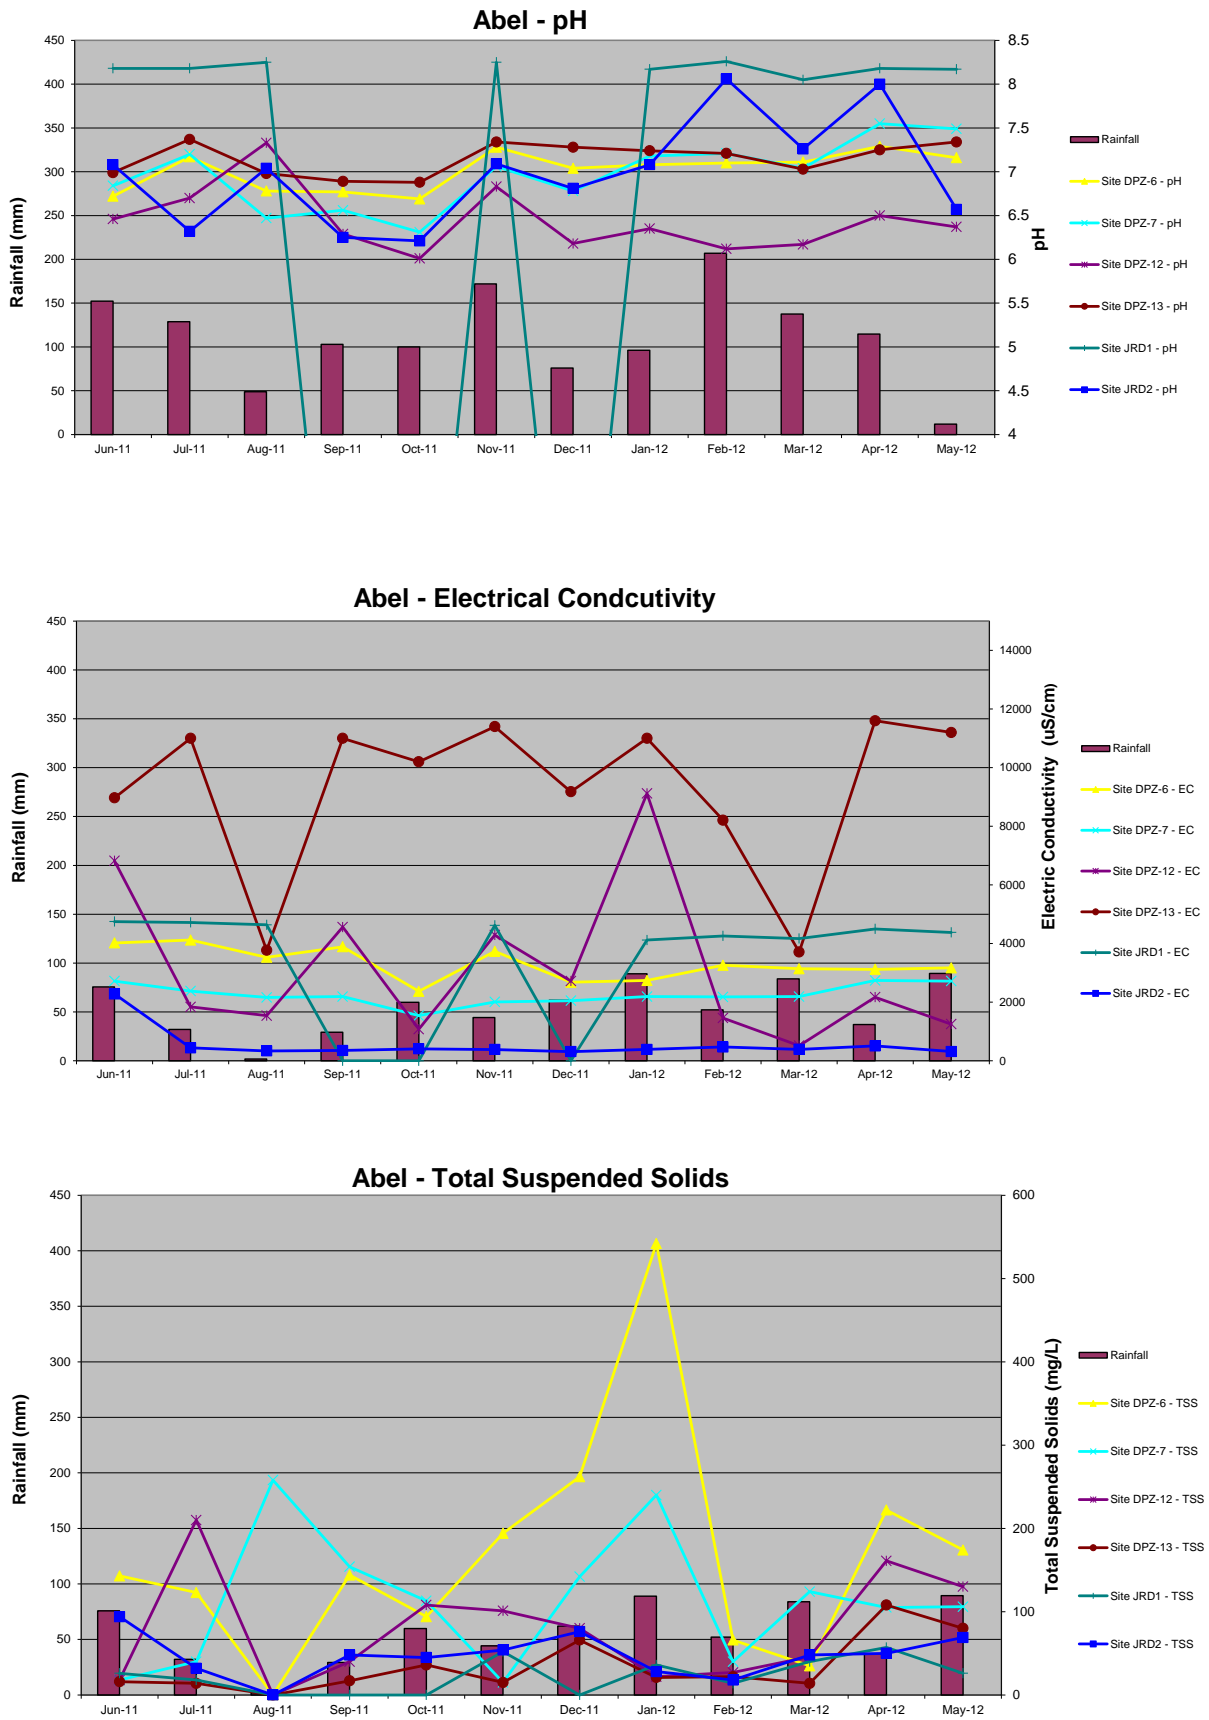
Figure 3.4 Groundwater Quality Monitoring Results 2011/2012

The results recorded during 2011/2012 reporting period are also largely within the same ranges recorded during the previous 2010/2011 reporting period. It is noted, however, that the lower pH range for DPZ-7 and JRD2 has increased by approximately 1.5 pH units to 6.31 and 8.05 respectively whilst the lower EC range for DPZ-12 has decreased to 517µS/cm.

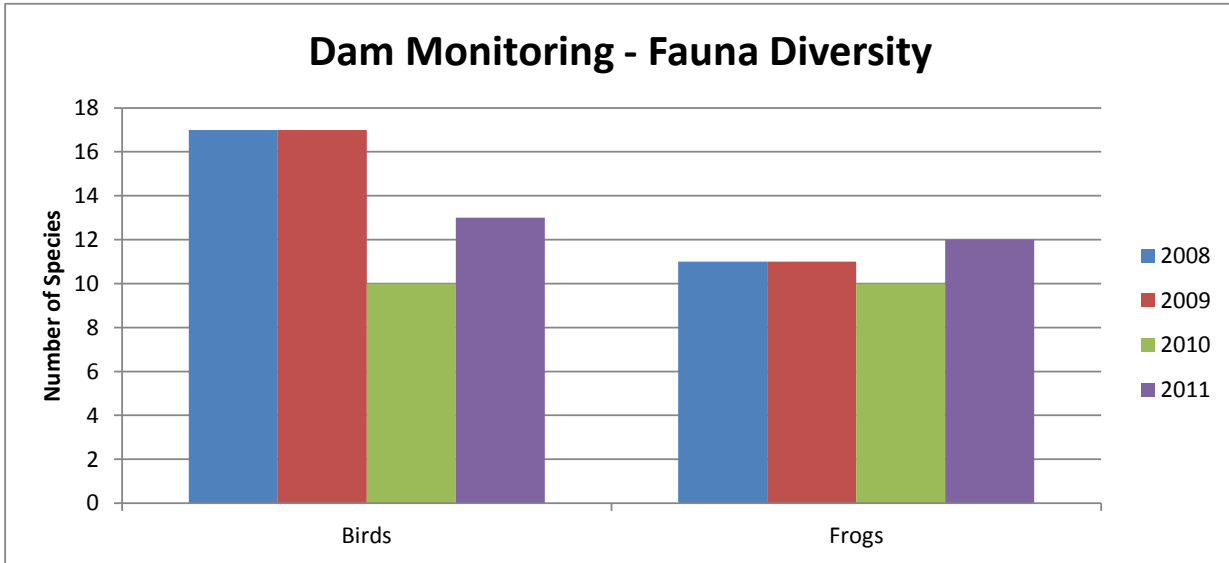
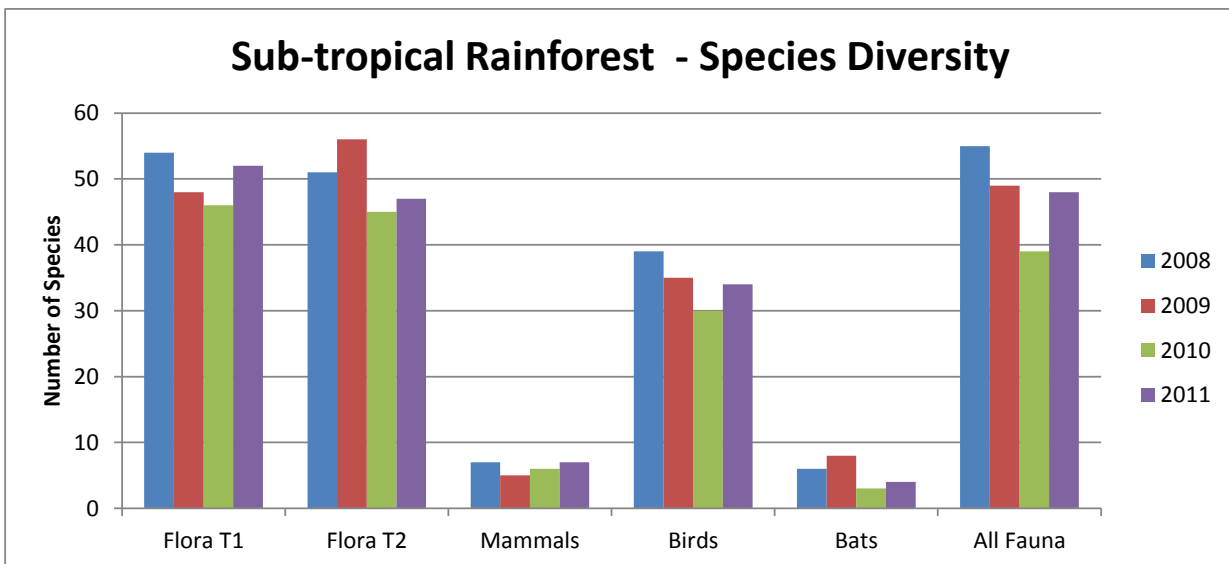
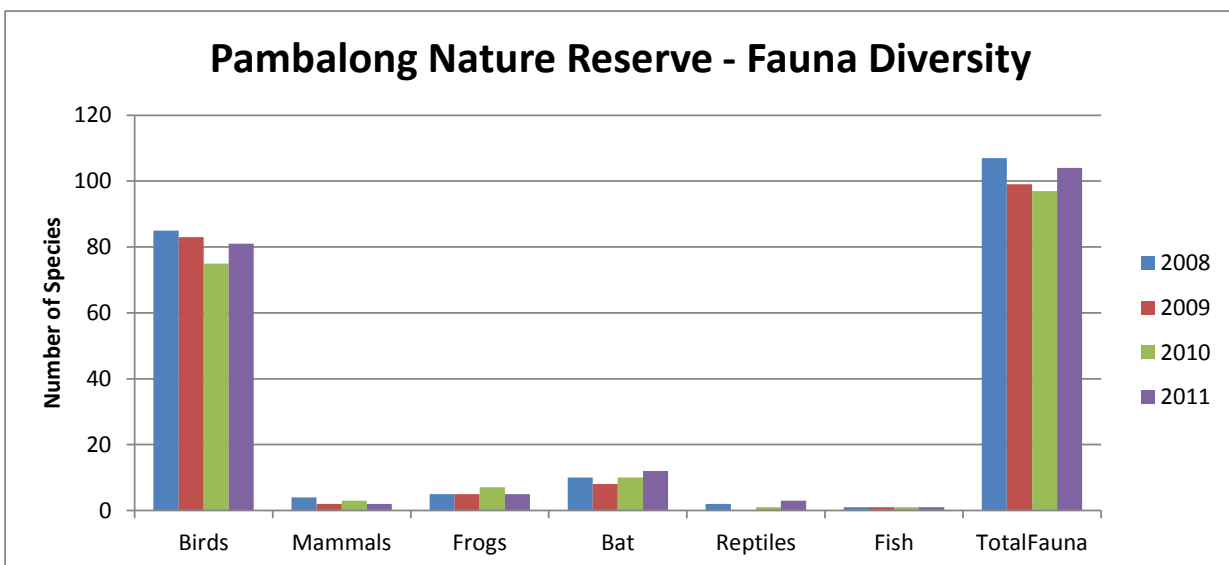
Figure 3.5 Ecological Monitoring Results

The 2011 sub-tropical rainforest monitoring results indicated no substantial change in floral diversity compared to the 2008 baseline monitoring. Specifically, 52 and 47 flora species were identified on the two monitoring transects in 2011 compared to 54 and 51 species in 2008, 48 and 56 in 2009 and 46 and 45 in 2010 (see **Figure 3.5**). No threatened flora species were recorded. Monitoring also indicated no significant change in rainforest width with transitional zones remaining similar to those recorded in the baseline study.

A total of 48 fauna species were recorded in 2011 compared to 55 species in 2008, 49 in 2009 and 39 in 2010. Almost all arboreal and terrestrial mammal species recorded during the 2008 baseline monitoring program were recorded again during 2011. Bird species diversity increased during 2011 compared to the 2010 survey but remains similar to that recorded during the 2008 baseline monitoring. Bat species diversity in 2011 remained relatively low (four species) compared to 2008 (six species) and 2009 (eight species). Two species listed as threatened under the NSW *Threatened Species Conservation Act 1995* were detected during the 2011 survey, namely the Little Bentwing-bat *Miniopterus australis* and Powerful Owl *Ninox strenua*. No undermining of sub-tropical rainforest occurred during the reporting period or will occur for a number of years.
