# Appendix 5

## Aquatic Monitoring Report: Autumn 2018 and Spring 2018

## Tasman Coal Aquatic Monitoring Report Autumn 2018

## Tasman Coal Aquatic Monitoring Report Spring 2018

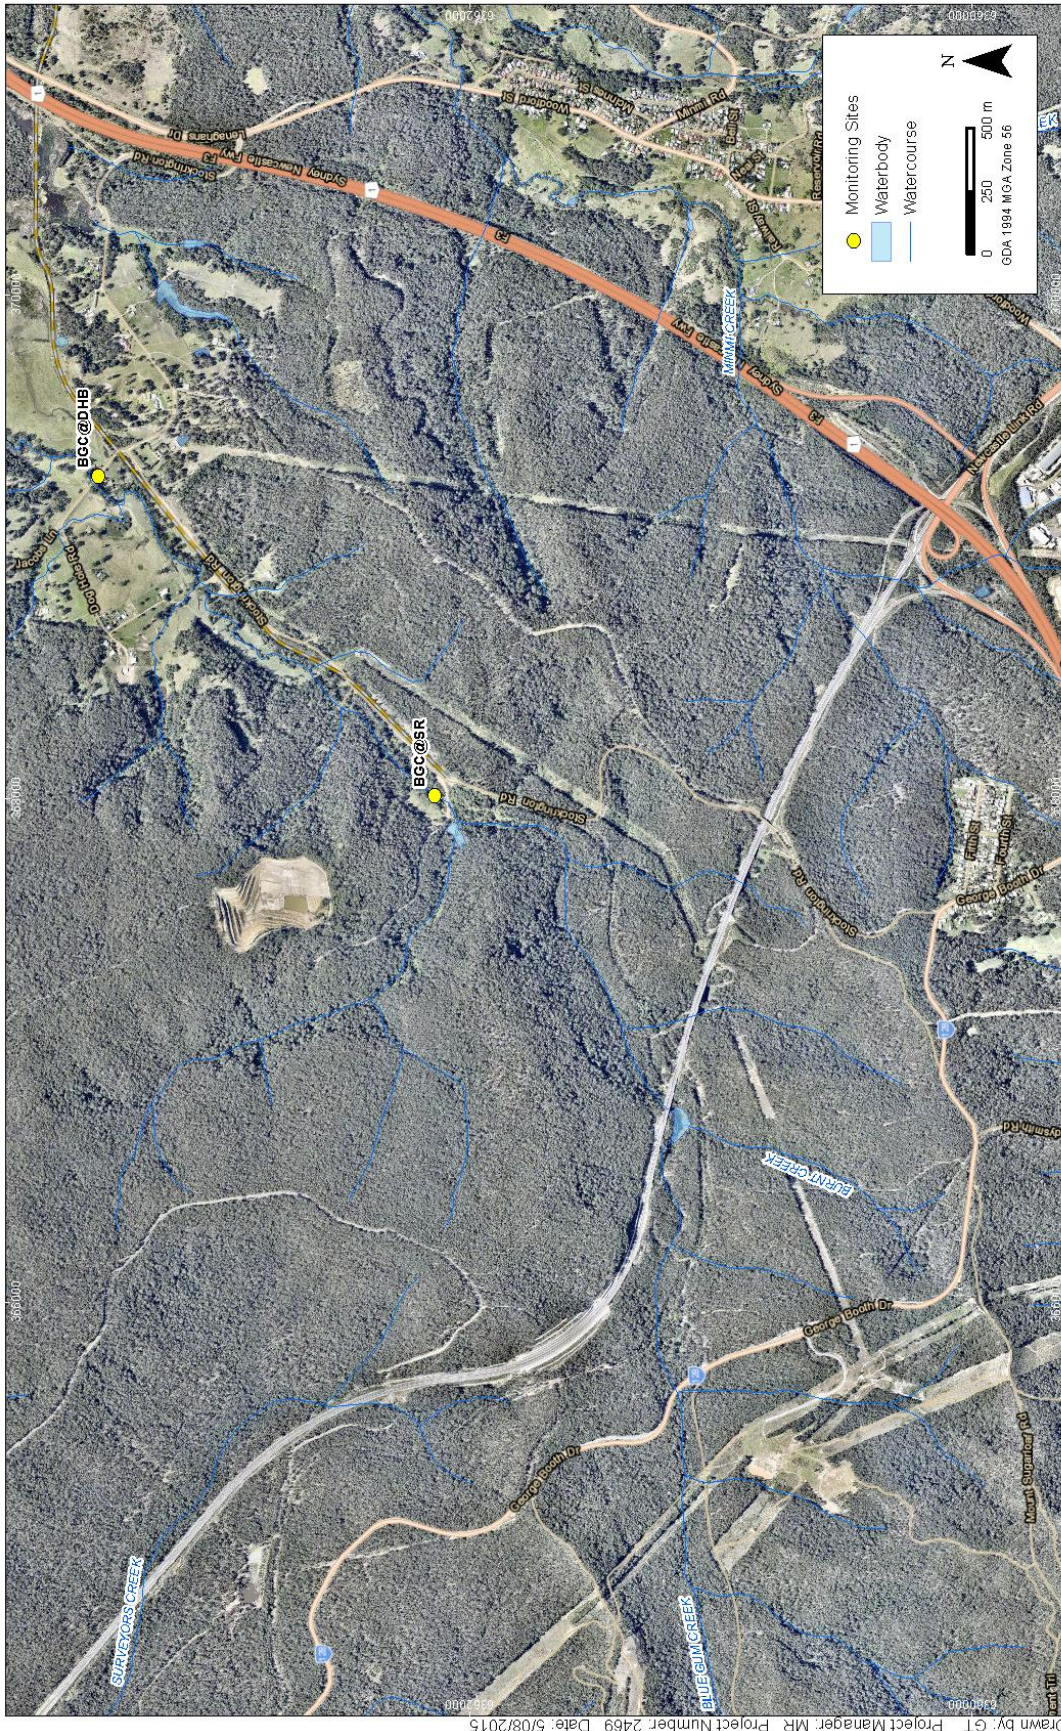
FIGURE 2

Two sites are required to be sampled on Blue Gum Creek (Figure 2, Table 1). These are located downstream of the Tasman Coal rehabilitation area. There is no upstream site to determine reference condition for these streams.

Location of study sites  
Tasman Coal - Aquatic Monitoring

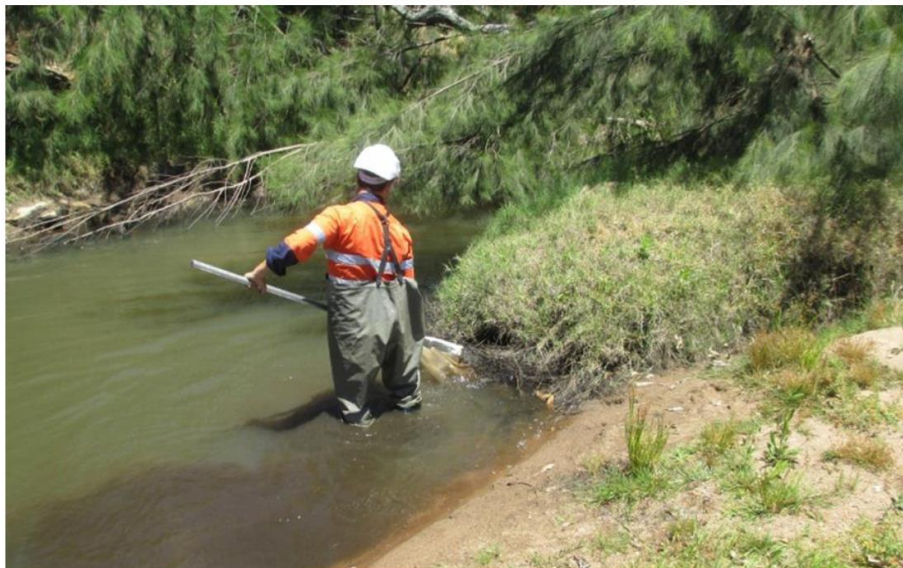
Samples were collected from pool edges for a length of 10 metres, either as a continuous line or in disconnected segments. Sampling in segments was often undertaken to ensure the sampling of sub-habitats such as macrophyte beds, bank overhangs, submerged branches and root mats. Segmented sampling was also employed where pool length was short and it was logistically difficult to sample in a continuous line (e.g. in-stream logs). A 250  $\mu\text{m}$  dip net was drawn through the water with short sweeps towards the bank to dislodge benthic fauna while scraping submerged rocks and debris, sides of the stream bank and the bed substrate (Plate 1). Further sweeps in the water column targeted the suspended fauna.

Plate 1. Sampling method

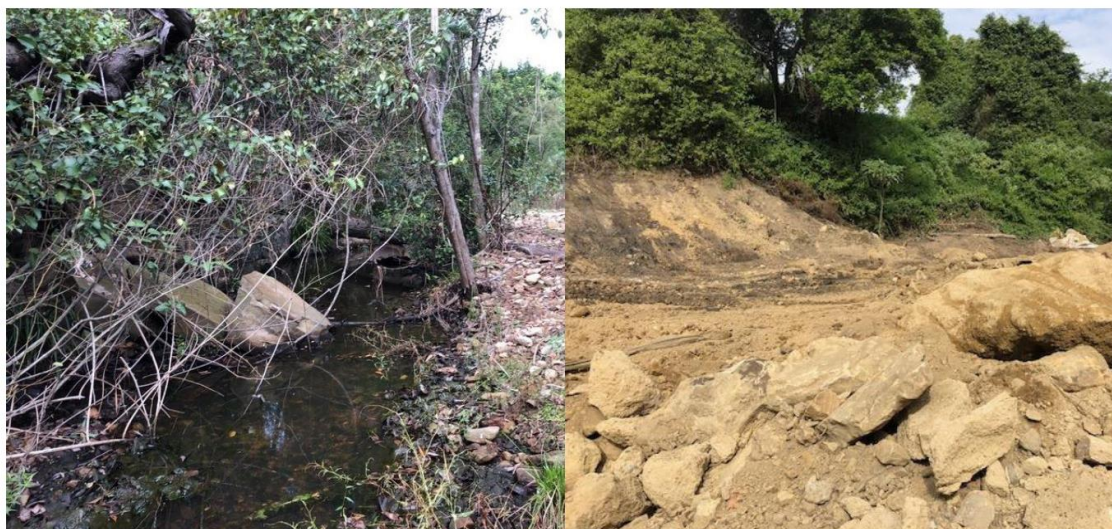
The aquatic habitat of Blue Gum Creek at Stockrington Road (Plate 2) at the time of the autumn 2018 monitoring surveys is detailed in Table 5.

Plate 2. Blue Gum Creek at Stockrington Road. Left: sampling site. Right: Bridge repair work upstream.

Water quality observations	Poor, Lots of filamentous algae
Comments		Similar to previous sampling conditions, although water quality appears to have deteriorated. Bridge work occurring upstream.

Blue Gum Creek continues to exhibit degradation and poor stream health. This is indicated by pollution tolerant macroinvertebrate communities present, presence of weeds and stream bank stability. Ongoing issues with siltation and erosion appear to be continuing to impact on this waterway. As discussed in previous reports, these disturbances appear unrelated to the mines previous operations, but rather ongoing land use management issues. The current work involving the upgrade of the upstream bridge is having an impact on the stream, however on completion is likely to ameliorate erosion in this section of the stream and may improve stream health immediately downstream.

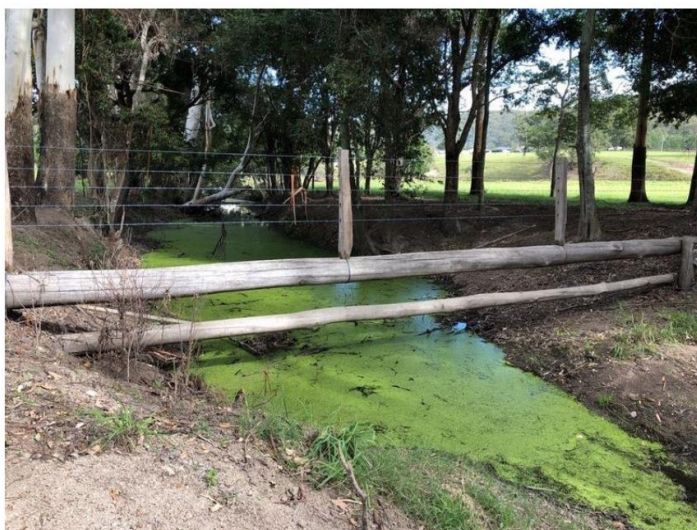
The aquatic habitat of Blue Gum Creek at Dog Hole Bridge (Plate 3) at the time of the autumn 2018 monitoring surveys is detailed in Table 6.

Plate 3. Blue Gum Creek at Dog Hole Bridge

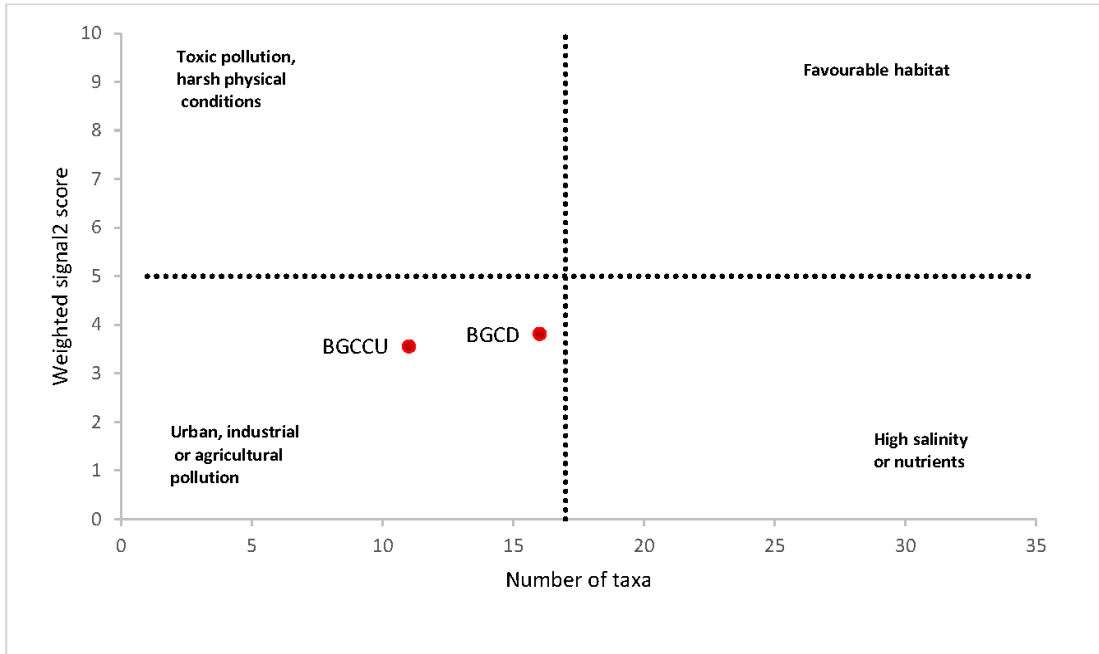
The sites had a low diversity of macroinvertebrate families (9-16) (Table 8). SIGNAL2 and weighted SIGNAL 2 scores indicated that the sites had severe pollution (<4 SIGNAL), with a dominance of pollution tolerant macroinvertebrate families. However, pollution sensitive mayflies i.e. Leptophlebiidae (SIGNAL 8) were recorded at both sites as well as beetle Elmidae (SIGNAL 7) upstream. There has been a slight increase in SIGNAL 2 score since sampling in spring 2017 (Table 9). The SIGNAL bi-plot (Figure 4) indicates that the sites are suffering from urban, industrial or agricultural pollution.

Figure 4. SIGNAL 2 Bi-plot

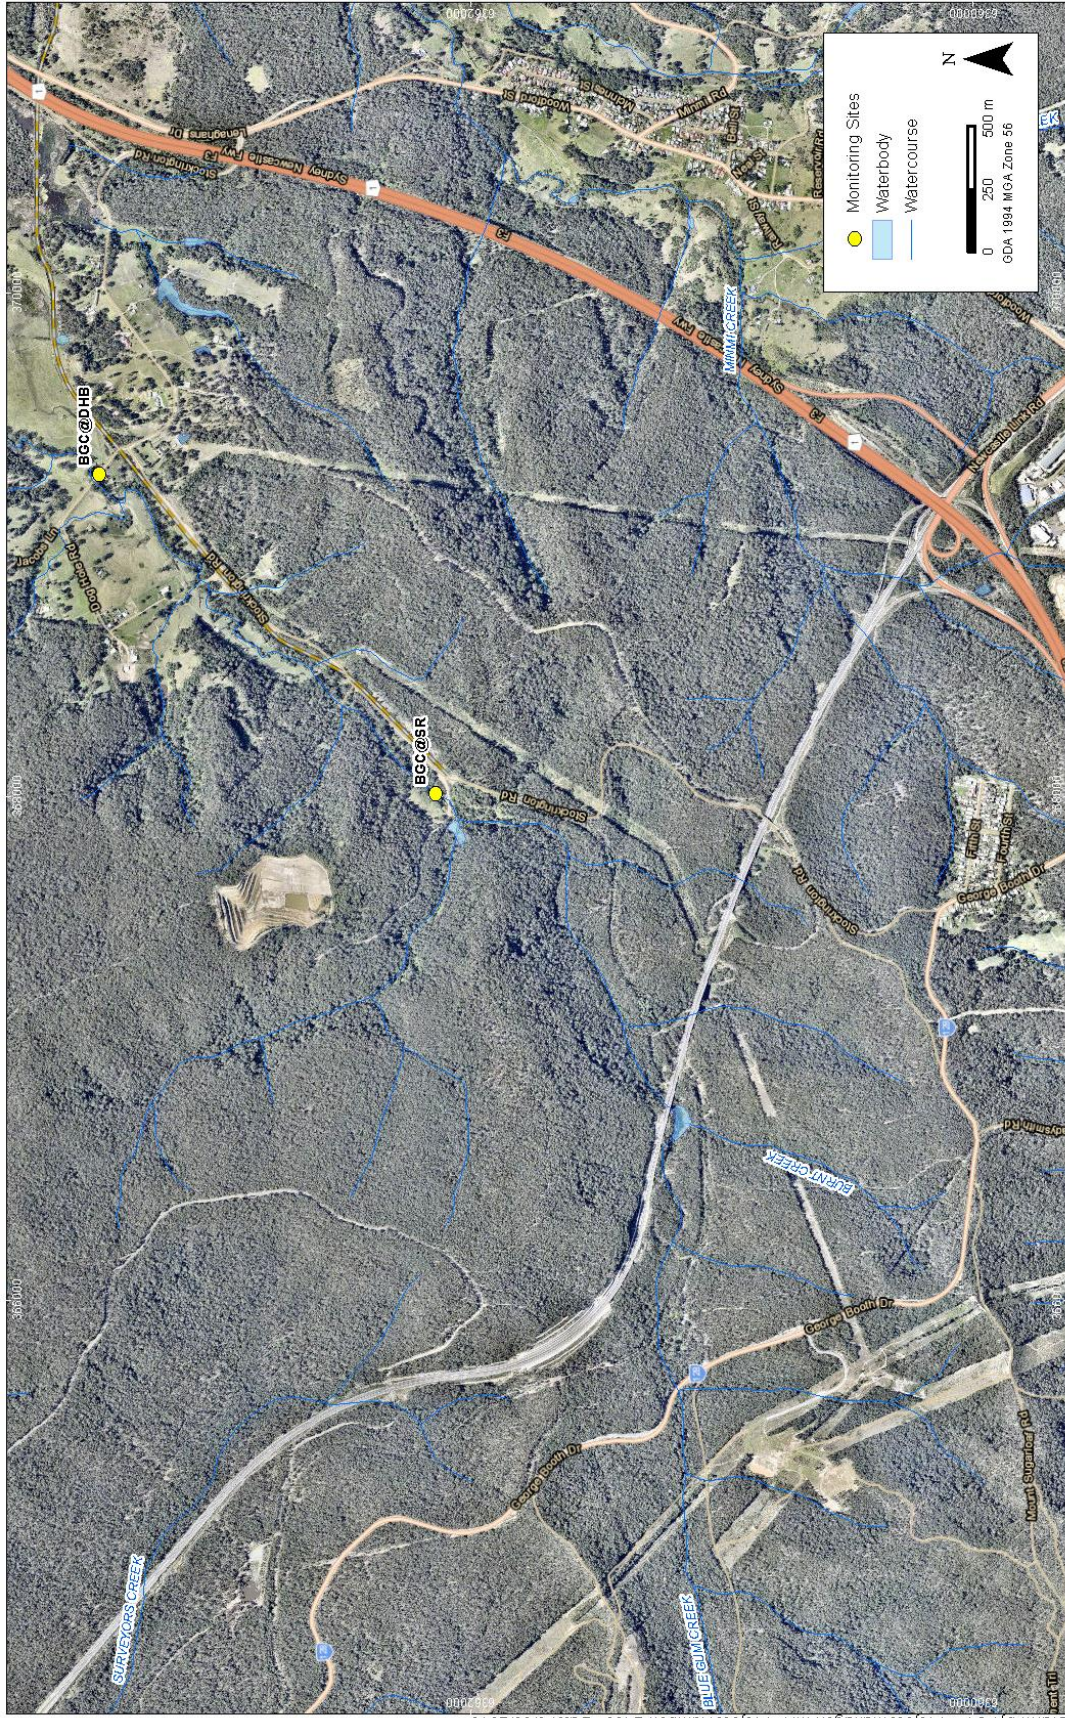
FIGURE 2

Two sites are required to be sampled on Blue Gum Creek (Figure 2, Table 1). These are located downstream of the Tasman Coal rehabilitation area. There is no upstream site to determine reference condition for these streams.

Location of study sites  
Tasman Coal – Aquatic Monitoring

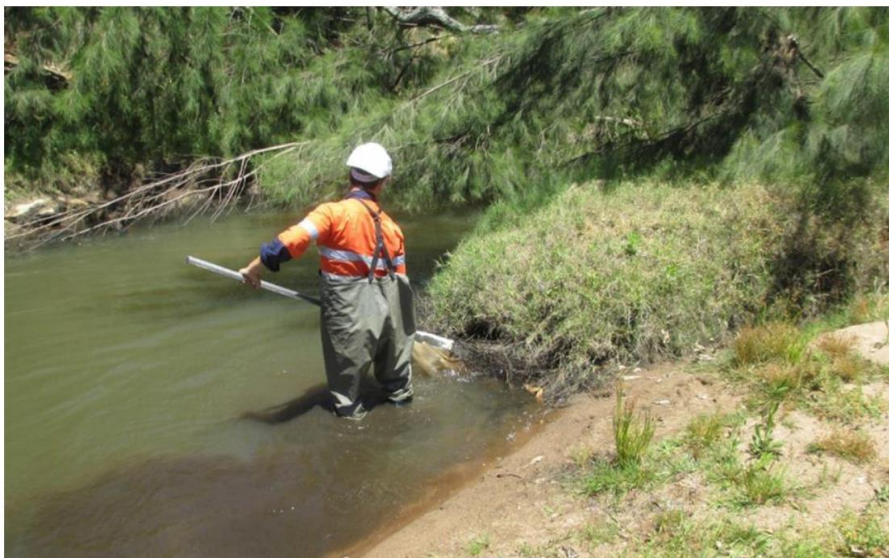
Samples were collected from pool edges for a length of 10 metres, either as a continuous line or in disconnected segments. Sampling in segments was often undertaken to ensure the sampling of sub-habitats such as macrophyte beds, bank overhangs, submerged branches and root mats. Segmented sampling was also employed where pool length was short and it was logistically difficult to sample in a continuous line (e.g. in-stream logs). A 250  $\mu\text{m}$  dip net was drawn through the water with short sweeps towards the bank to dislodge benthic fauna while scraping submerged rocks and debris, sides of the stream bank and the bed substrate (Plate 1). Further sweeps in the water column targeted the suspended fauna.

**Plate 1: Sampling method – dip netting**

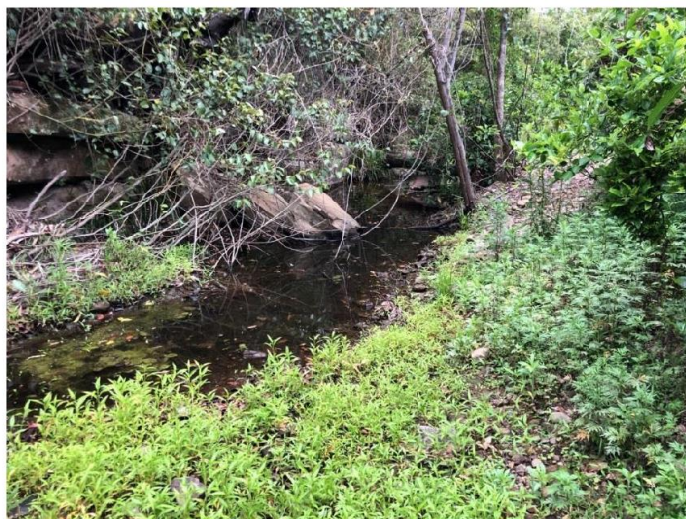
The aquatic habitat of Blue Gum Creek at Stockrington Road (BGC@SR)(Plate 2) at the time of the Spring 2018 monitoring surveys is detailed in Table 5.

Plate 2. Blue Gum Creek at Stockrington Road.

Water quality observations	Poor, Lots of filamentous algae
Comments		Similar to previous sampling conditions, although water quality appears to have deteriorated. Bridge work occurring upstream.

Blue Gum Creek continues to exhibit degradation and poor stream health. This is indicated by pollution tolerant macroinvertebrate communities present, presence of weeds and stream bank stability. Ongoing issues with siltation and erosion appear to be continuing to impact on this waterway. The completion of the bridge upstream site has improved bank stability and erosion at this location, however, has not led to measurable improvements in stream ecology. As discussed in previous reports, these disturbances appear unrelated to the mines previous operations, but rather ongoing land use management issues.

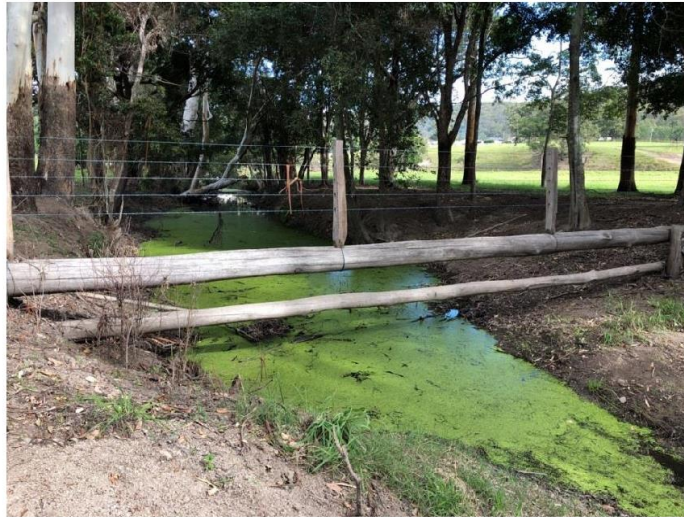
The aquatic habitat of Blue Gum Creek at Dog Hole Bridge (BGC@DHB)(Plate 3) at the time of the Spring 2018 monitoring surveys is detailed in Table 6.

Plate 3. Blue Gum Creek at Dog Hole Bridge

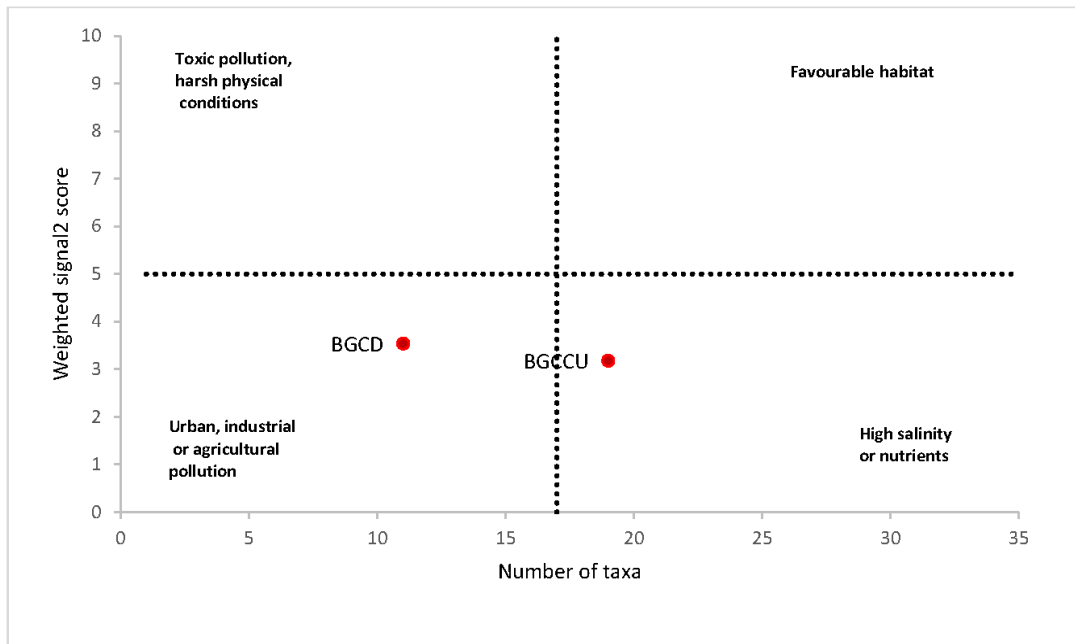
The sites had a low- moderate diversity of macroinvertebrate families (11-19) (Table 8). SIGNAL2 and weighted SIGNAL 2 scores indicated that the sites had severe pollution (<4 SIGNAL), with a dominance of pollution tolerant macroinvertebrate families. However, pollution sensitive mayflies i.e. Leptophlebiidae (SIGNAL 8) were recorded at both sites. There has been a slight decrease in SIGNAL 2 score since sampling in autumn 2018 (Table 9). The SIGNAL bi-plot (Figure 4) indicates that the downstream sites are potentially suffering from urban, industrial or agricultural pollution and upstream high nutrients or salinity.

Figure 4. SIGNAL 2 Bi-plot
