DONALDSON COAL **ANNUAL ENVIRONMENTAL MANAGEMENT** **REPORT**

DONALDSON COAL MINE

1st November 2008 to 31st October 2009

Annual Environmental Management Report (AEMR) 2008-2009

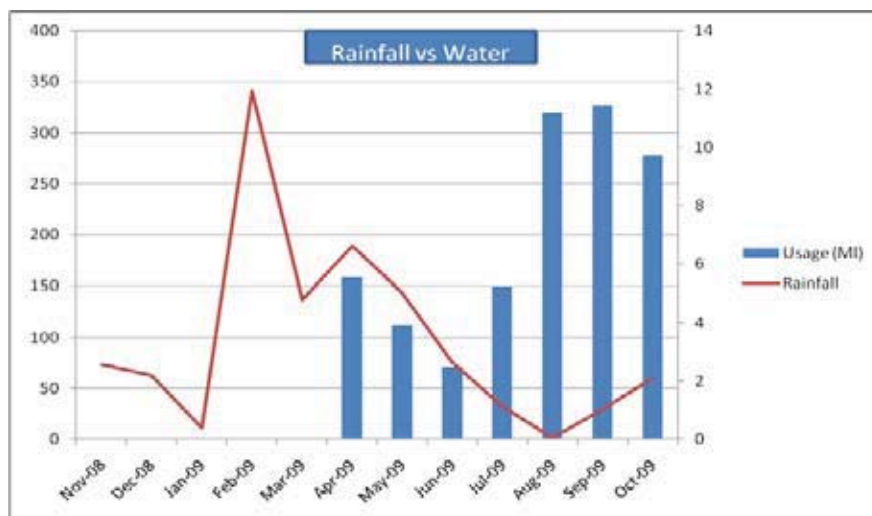
FIGURE 1: WATER CONSUMPTION AND SITE RAINFALL

The site Environmental Manager maintains a site water balance based on water consumed at the mine. It includes recording the amount of water that is available in various water holding structures around the mine. The following chart, **Figure 1**, shows the water consumption and site rainfall for the Donaldson Mine. All water for this monitoring period was obtained from site supplies.

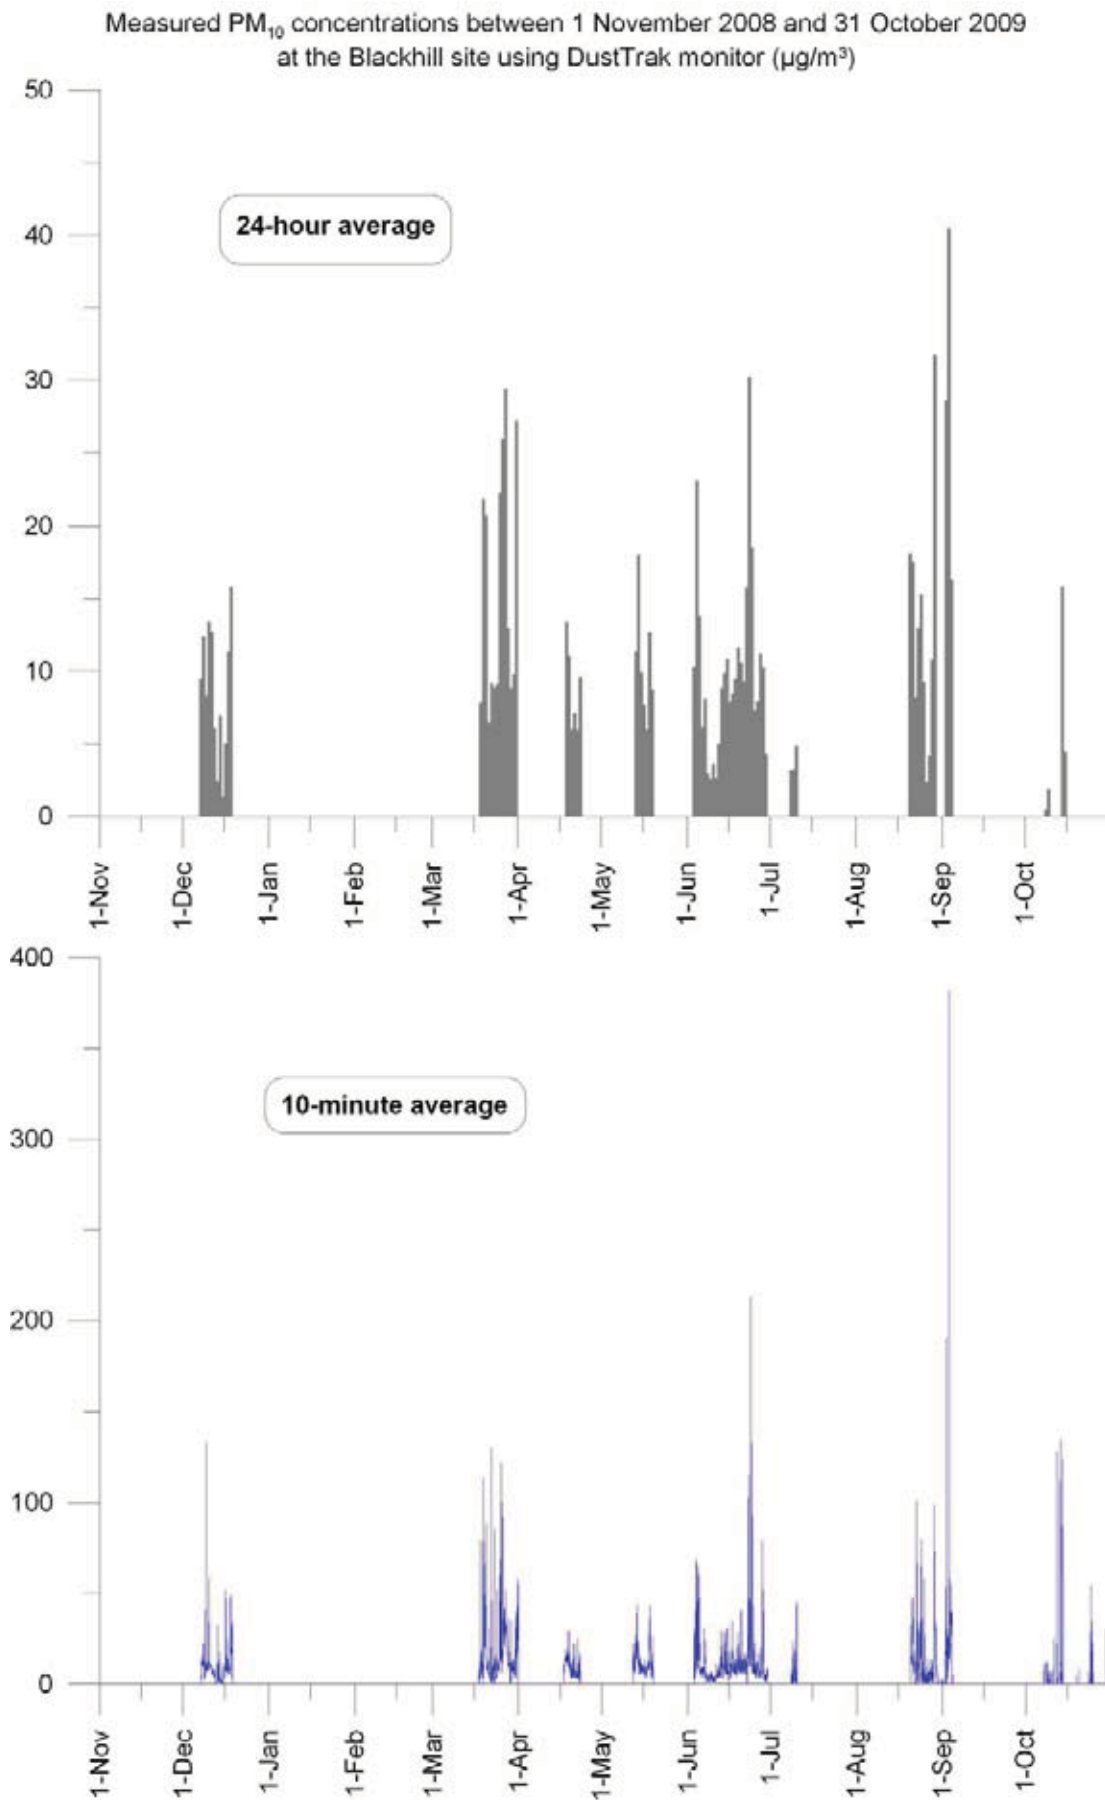
Figure 3: DustTrak Monitoring 1 November 2008 to 31 October 2009 at the Blackhill Site

The results from DustTrak monitoring are comparable to those obtained from the PM₁₀ High Volume Air Sampling at the Barter site and the annual averages were again, below the maximum NEPM annual average criteria.

Table 14 summarises the DustTrak monitoring data and the data capture rate. The measurements of PM₁₀ by optical methods (such as the DustTrak monitors) are known to be particularly sensitive to rainfall or high humidity events. Monthly inspections of the DustTrak monitors and regular servicing of the instruments assist with reducing occasions when the measurements become unstable or drift from sensible values. It was considered appropriate to exclude non-valid data from the calculations of the highest 24-hour average PM₁₀, annual average PM₁₀ and the lowest 24-hour average PM₁₀. Despite this, the valid data recovery rate, refer **Table 14**, upon which the PM₁₀ averages are based are still substantial.

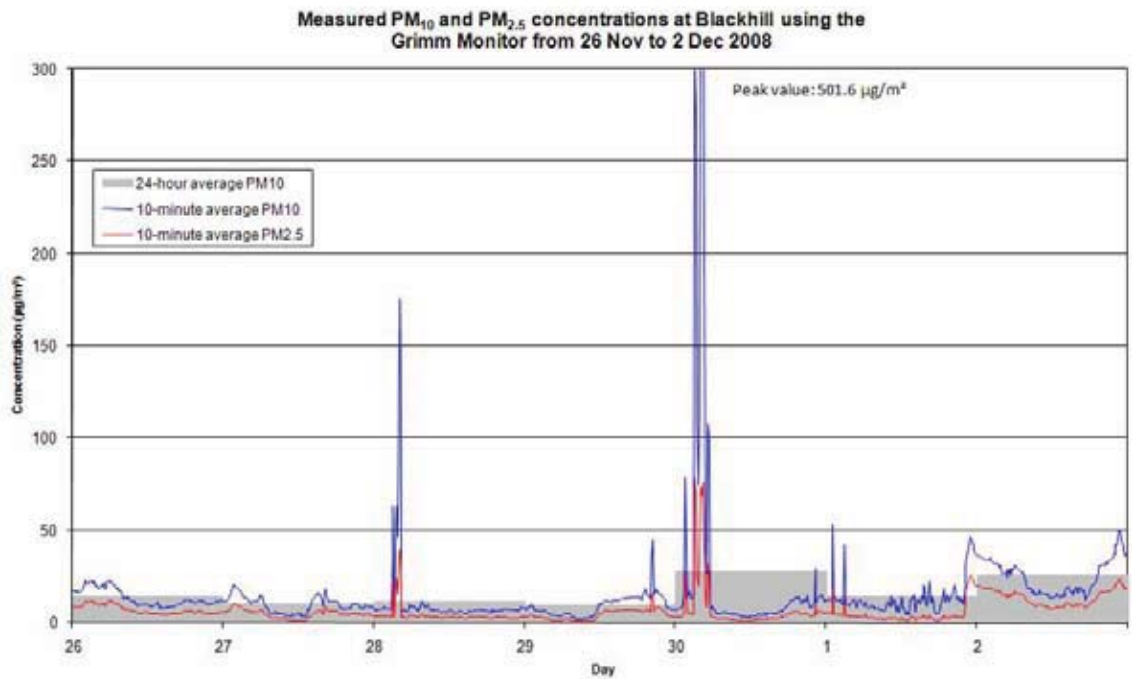
Figure 5: PM10 and PM2.5 chart for the period 26th of November and 2nd of December 2008

Data collected during the November 2008, March 2009, June 2009 and August 2009 sampling events showed that PM₁₀ measured at the site consisted of approximately 44%, 30%, 49% and 47% PM_{2.5} particles respectively. This is similar to previous recorded results and is typical of a semi-rural area such as where the particulate matter is likely to be crustal (dust particles) rather than from the combustion process such as the burning of fuel in motor cars. There is however likely to be some contribution from motor vehicles due to the proximity of major roads to the monitoring location.

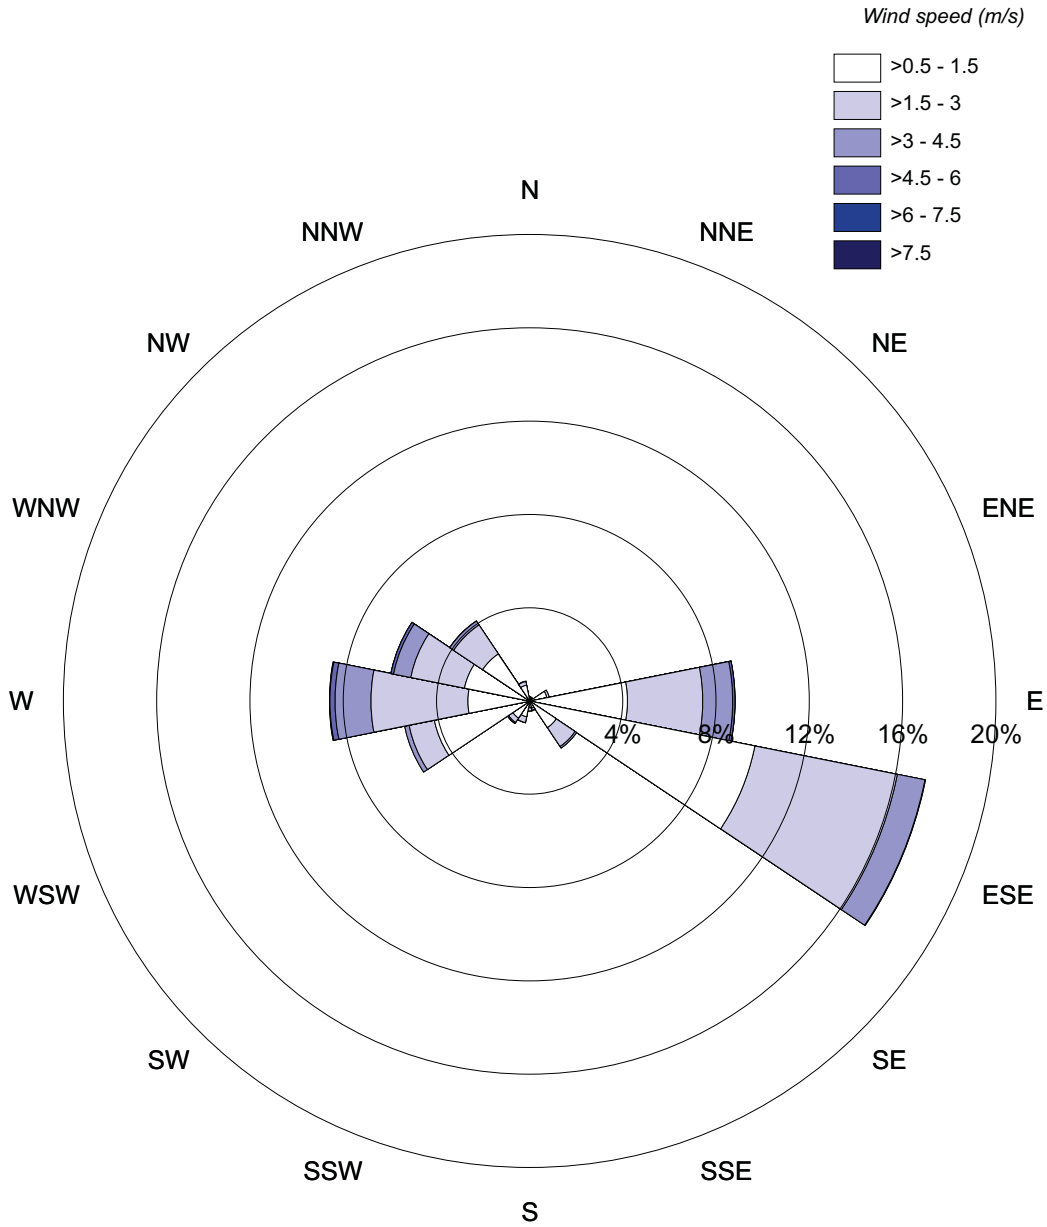
Windrose for Donaldson November 2008 to October 2009

Calms = 42.1%
