# Tasman Extension Project Environmental Impact Statement

# AQUATIC ECOLOGY ASSESSMENT

# **Tasman Extension Project: Aquatic Ecology Assessment**

**Donaldson Coal Pty Ltd**

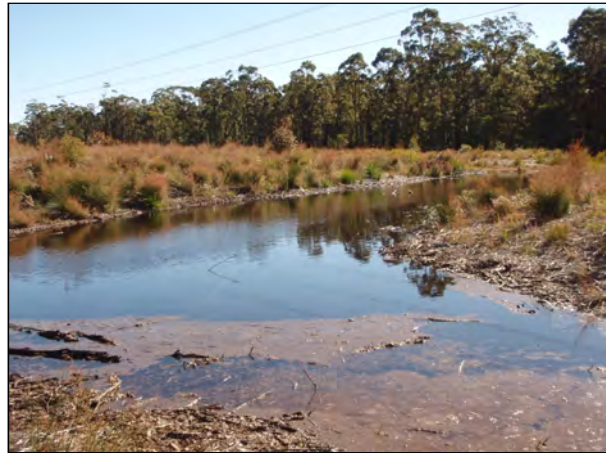
Vegetation clearing downstream of site 2.

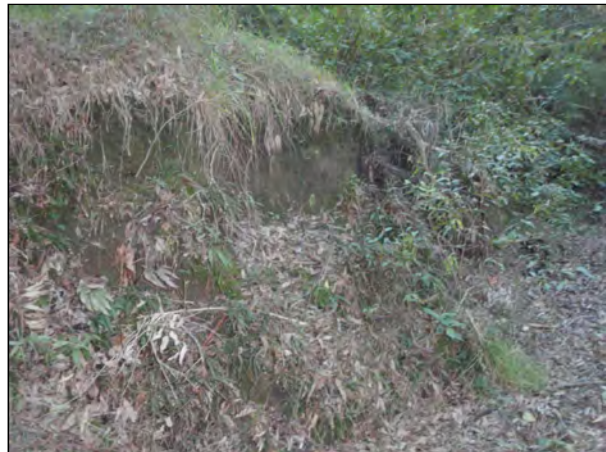
Figure 3.2

Steep banks with the potential for erosion at site 8.

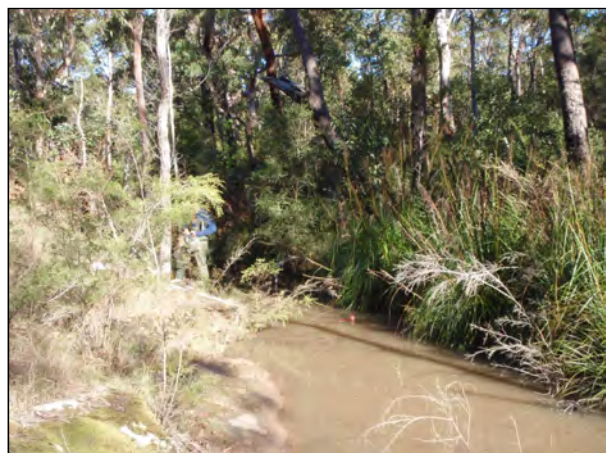
Figure 3.3

Overhanging and trailing bank vegetation at site 6.

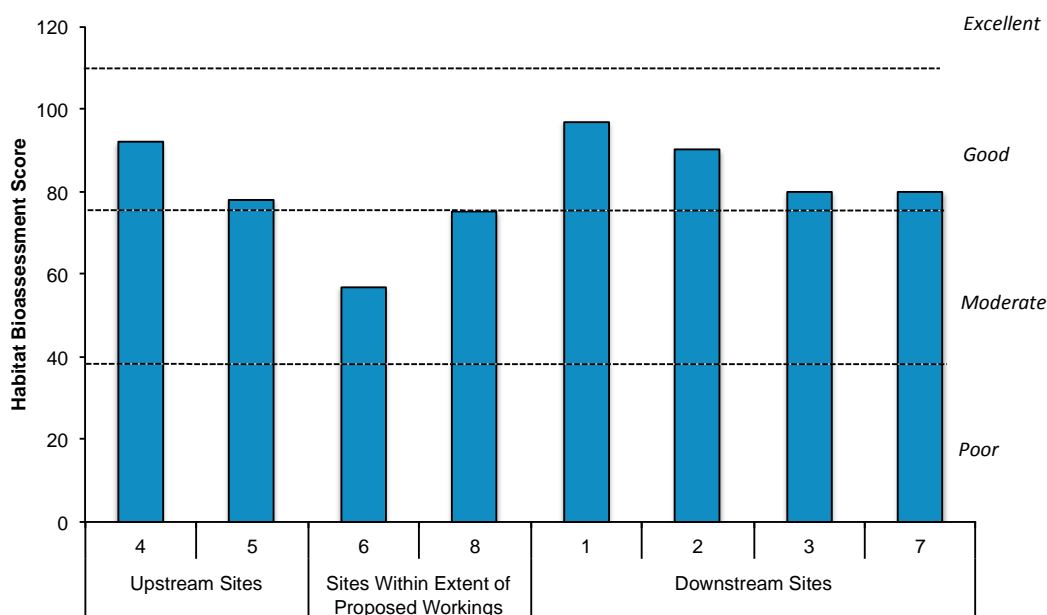
- more diverse habitat (e.g. woody debris and vegetation)
- good riparian vegetation cover, and
- stable banks and channels.

Figure 3.4 Habitat bioassessment scores at each site.

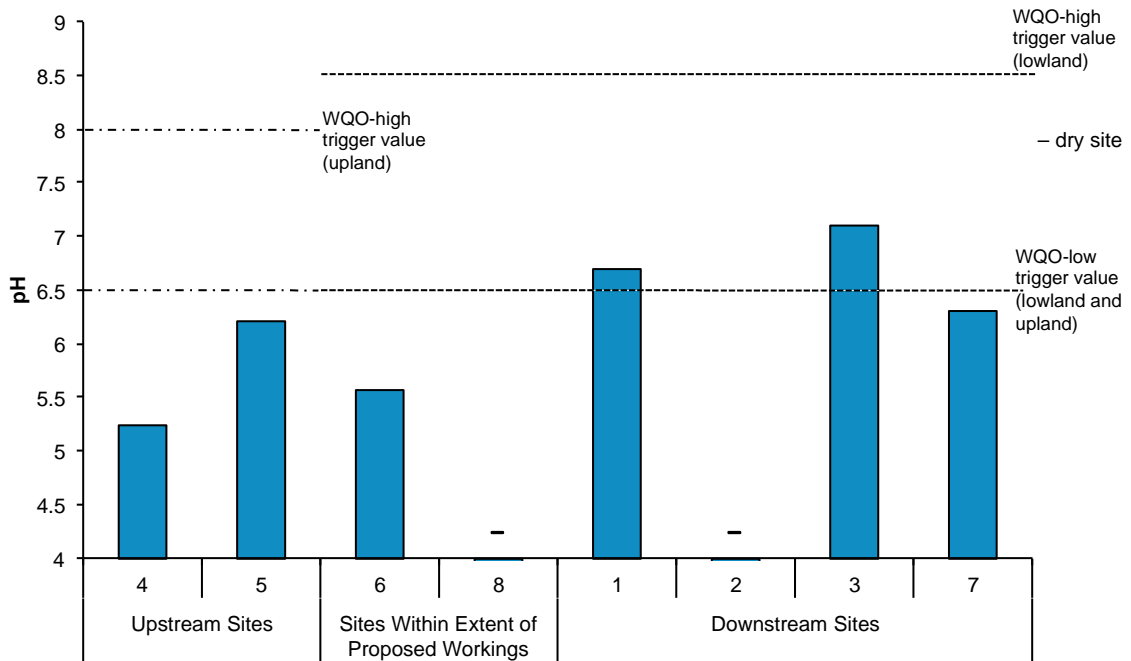
Figure 3.6 The pH at each site, and the Hunter River Catchment Water Quality Objective trigger values.

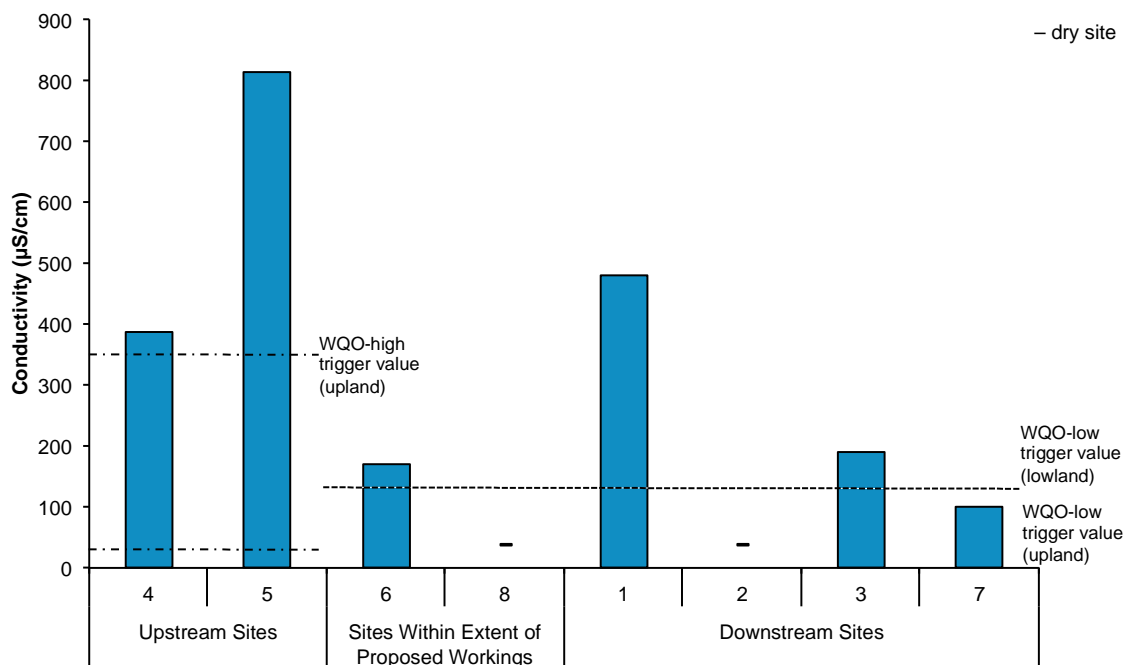
Figure 3.7 Electrical conductivity at each site, and the Hunter River Catchment Water Quality Objective trigger values.

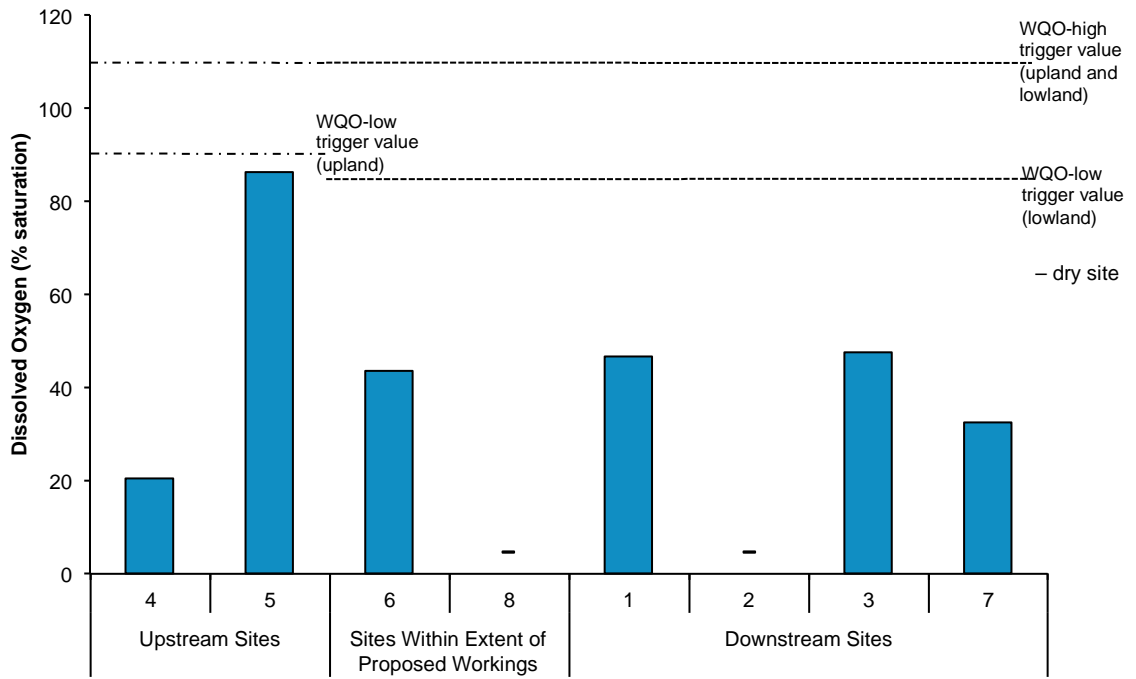
Figure 3.8 Dissolved oxygen at each site, and the Hunter River Catchment Water Quality Objective trigger values.

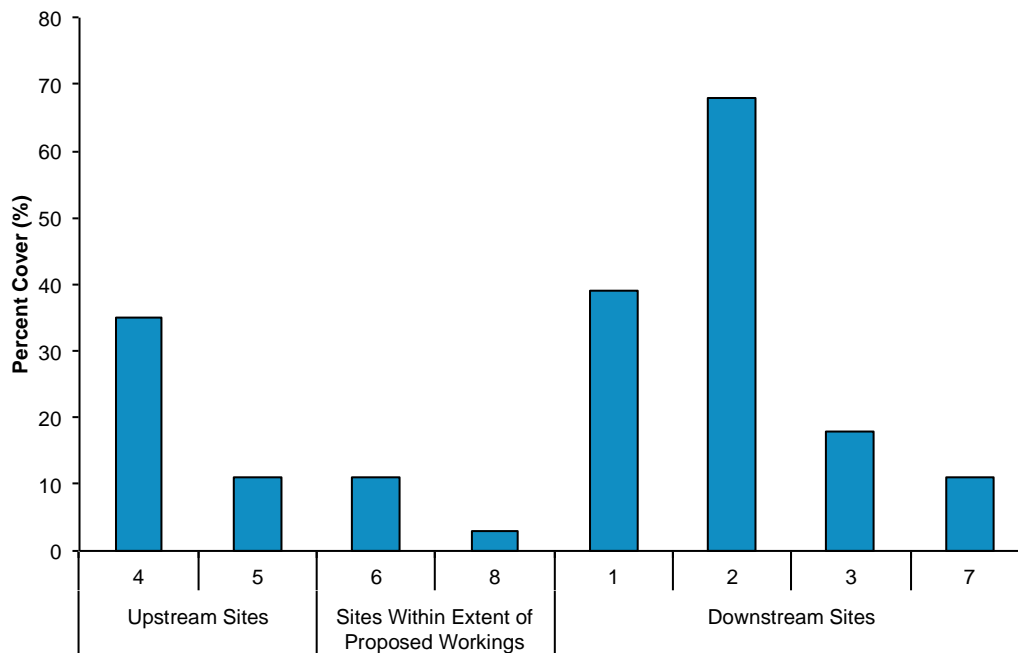
In general, the percent cover of macrophytes at each site within and downstream of the proposed West Borehole Seam workings was similar to those upstream. Site 8 had the lowest percent of macrophytes at 3% and site 2 had the highest at 68% (Figure 4.2).

Figure 4.2 Percent cover of macrophytes at each site.

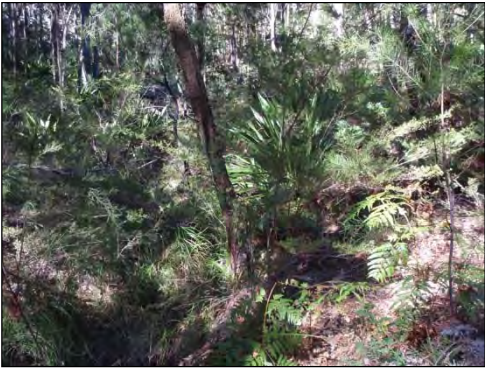
Reach	Description	Photograph
<b>Sites Upstream of the extent of the proposed West Borehole Seam workings</b>		
<b>Site 4</b> first order tributary of Surveyors Creek 2 (S2CB)	Site comprised a steep un-defined channel with a shallow, isolated pool. Both the left and right banks were steep and moderately high (0.5 to 3.5 m) with high stability. The riparian zone was 20 m wide on each bank and dominated by grass, shrubs, ferns and Eucalypt trees. In-stream habitat included woody debris, detritus, boulder, undercut banks and vegetation. In-stream substrate was dominated by bedrock and sand, with some boulder, silt/clay, pebbles and gravel. Overall disturbance was very low. This site was approximately 170 m downstream of Sugarloaf Range Road.

View upstream at site 4
<b>Site 5</b> first order tributary of Surveyors Creek 2 (S2)	Site comprised a relatively steep, well-defined channel with several shallow (0.1 m), isolated pools. Both the left and right banks were steep and relatively low (0.5 to 2.5 m high) with low to moderate stability. The riparian zone was 10 m wide on each bank and dominated by grass, shrubs and Eucalypt trees. In-stream habitat was dominated by woody debris and boulders, with some cobbles, undercut banks, vegetation and detritus. In-stream substrate was dominated by bedrock, with some sand, gravel and pebble. Overall disturbance was very low.

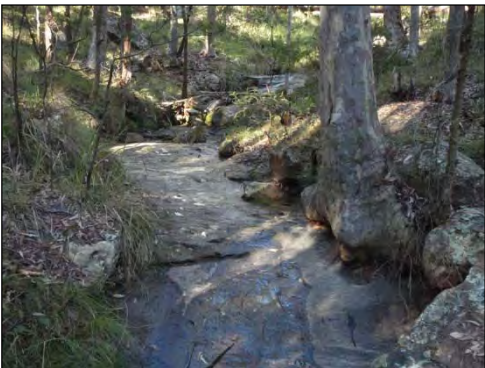
View upstream at site 5
<b>Sites Within the extent of the proposed West Borehole Seam workings</b>		
<b>Site 6</b> first order tributary of Surveyors Creek 2 (S2E)	Site comprised a shallow (0.5 m), isolated pool in a well-defined narrow channel. Both the left and right banks were low (0.5 to 2 m high) with moderate stability. The riparian zone was 5 to 10 m wide on each bank and dominated by grass, shrubs, Eucalypt and Melaleuca trees. In-stream habitat was dominated by woody debris and detritus, with some vegetation, cobble and man-made structures. In-stream substrate was dominated by silt/clay, with some sand and bedrock. Overall disturbance was low.

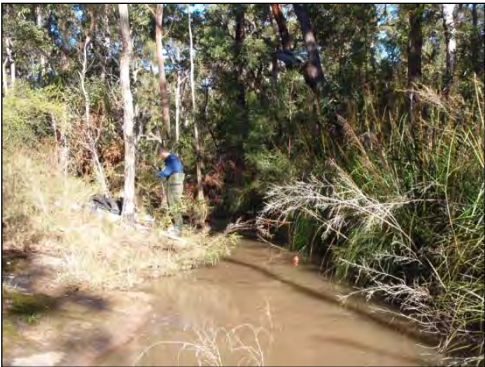
View upstream at site 6

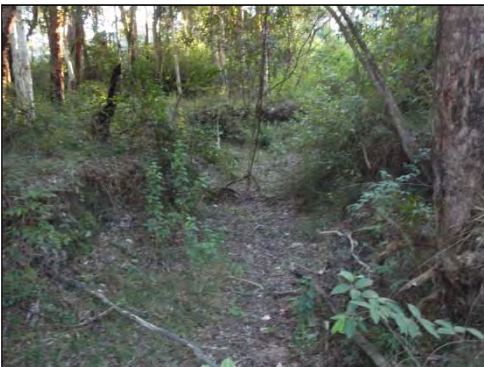
Reach	Description	Photograph
<p><b>Site 8</b> second order tributary of Surveyors Creek 2 (S2D)</p>	<p>Site comprised a narrow, meandering channel that was dry at the time of survey. Both the left and right banks were low (0.3 to 2.5 m high) with low to moderate stability. The riparian zone was 5 to 10 m wide on each bank and dominated by grass, shrubs, Eucalypt and Melaleuca trees. Lantana was also present on the right bank. In-stream habitat was dominated by small woody debris and detritus, together with vegetation. In-stream substrate was dominated by sand with small amounts of silt/clay and gravel. Overall disturbance was low.</p>

View downstream at site 8		
<b>Sites Downstream of the extent of the proposed West Borehole Seam workings</b>		
<p><b>Site 1</b> wet area approximately 0.2 km west of third order tributary of Surveyors Creek 2 (S2)</p>	<p>Site comprised an unconfined, relatively deep (1.2 m) area. Both banks were sloping and low (0.3 m high), with moderate to high stability. The riparian zone was 20 to 30 m wide on both banks and was dominated by grass, shrubs and Melaleuca trees. In-stream habitat included woody debris, vegetation and detritus, with some undercut banks and deep pools. In-stream substrate was dominated by sand and silt/ clay. Overall disturbance was low, although vegetation had been cleared upstream of the site for access to a power transmission line. Area appears to likely retain water most of the time, with the possible exception of following extended dry periods.</p>

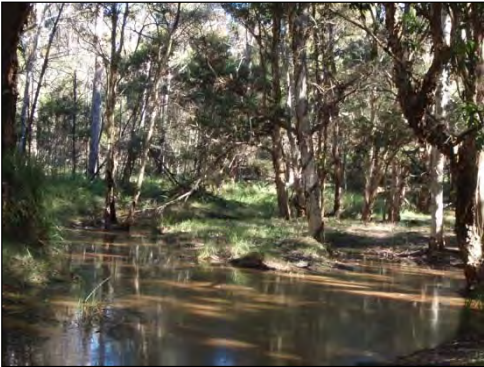
View upstream at site 1		
<p><b>Site 2</b> first order stream approximately 0.2 km west of first order stream of Surveyors Creek (S2G)</p>	<p>Site comprised a straight gently sloping channel that was dry at the time of the survey. This site likely held water after prolonged heavy rainfall. Both banks were low (0 to 2 m high) with high stability. The riparian zone was 10 m wide on each bank and dominated by grass, shrubs, Eucalypt and Melaleuca trees. In-stream habitat included extensive woody debris, vegetation and detritus. In-stream substrate was dominated by sand and silt/clay. Disturbance was low, although vegetation had been cleared downstream of the site for access to a power transmission line.</p>

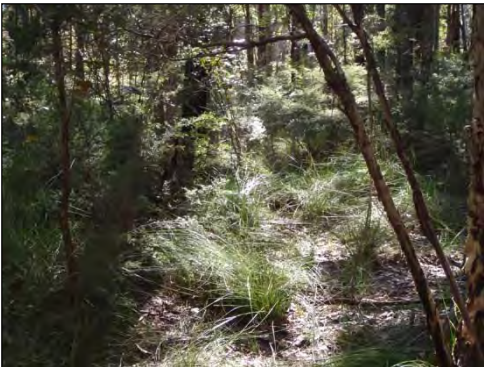
View upstream at site 2

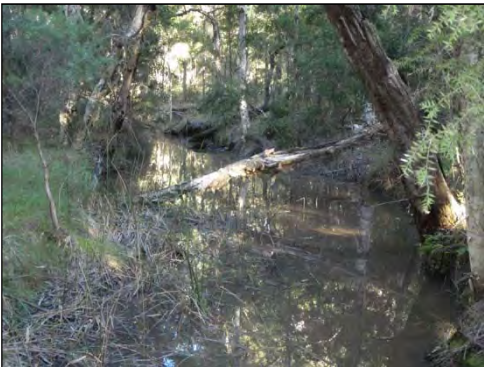
Reach	Description	Photograph
<p><b>Site 3</b> second order tributary of Surveyors Creek 1 (SB1)</p>	<p>Site comprised a chain of narrow and relatively shallow (0.6 m) isolated pools in an irregular channel. Both the left and right banks were vertical and low (0 to 1 m high) with low to moderate stability. The riparian zone was &gt;30 m wide on each bank and dominated by grass, shrubs and Eucalypt and Melaleuca trees. In-stream habitat included woody debris, detritus, undercut banks and detritus. There was also some overhanging and trailing bank vegetation and deep pools. In-stream substrate was dominated by sand with some silt/clay. Overall disturbance was low. George Booth Drive was approximately 100 m downstream of the site.</p>

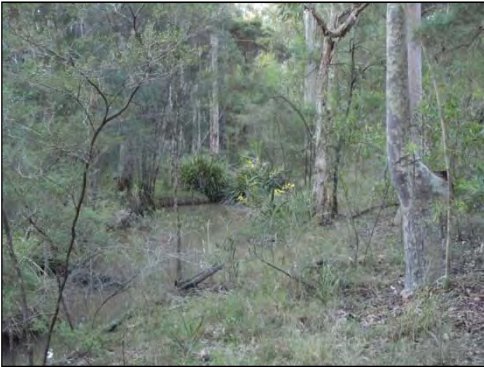
<p><b>Site 7</b> first order tributary of Surveyors Creek 1 (S1C)</p>	<p>Site comprised a narrow channel with a chain of several small, relatively deep (1 m) pools. Both the left and right banks were low (0.3 to 1 m high) and vertical, with moderate to high stability. The riparian zone was 20 to 30 m wide on each bank and dominated by grass, shrubs and Eucalypt and Melaleuca trees. In-stream habitat was dominated by woody debris, undercut banks and detritus, together with vegetation. In-stream substrate was dominated by silt/clay, with some sand and gravel. Overall disturbance was low, although vegetation had been cleared approximately 40 m upstream of the site for access to a power transmission line.</p>

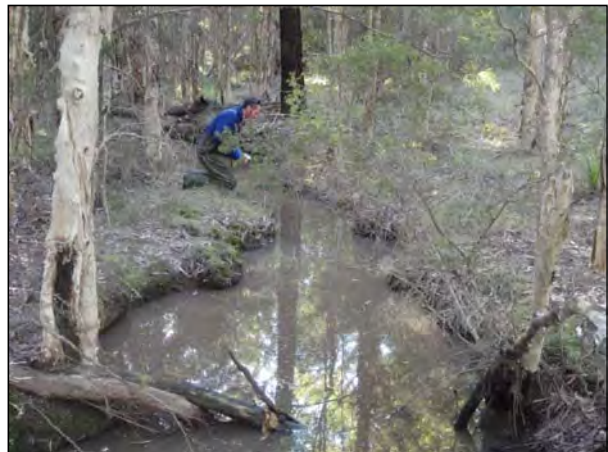
Steep and undercut banks at site 3.

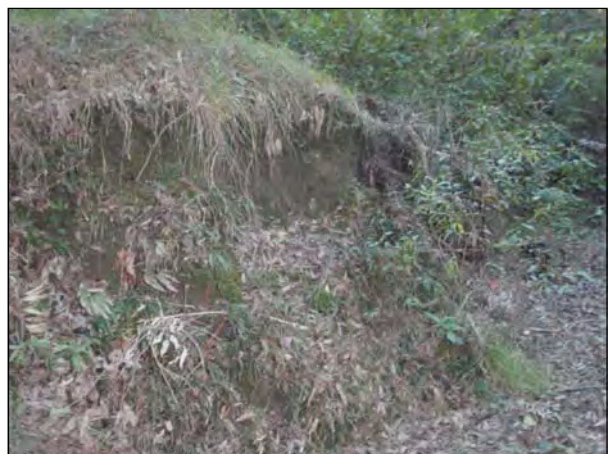
Figure 2.5

Steep banks with the potential for erosion at site 8.

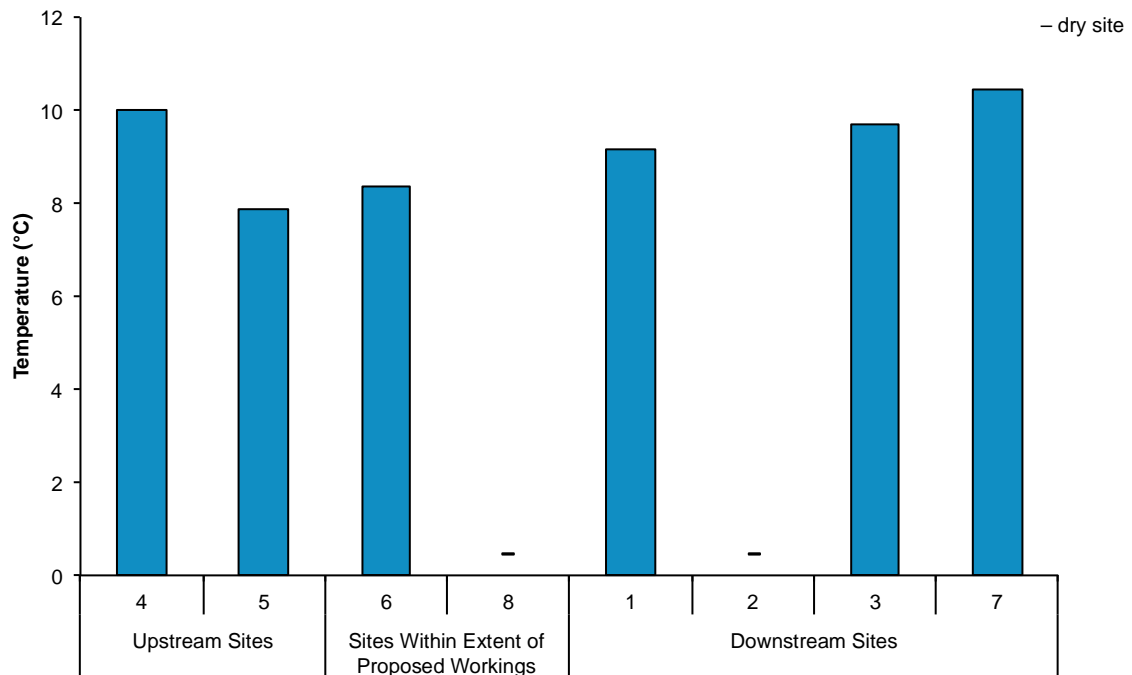
There are no Hunter River WQO for water temperature (DECCW 2006). The range in water temperature was 8.3 to 10.4 °C (Figure 2.11).

Figure 2.11 Water temperature at each site.

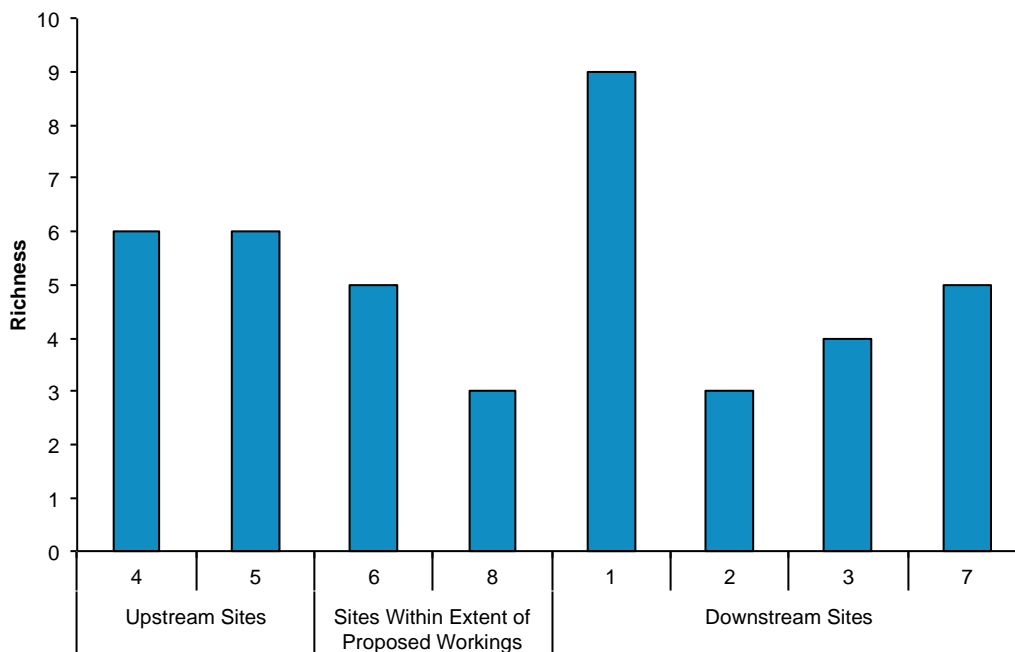
A total of 23 species of macrophyte were identified within the survey area. The number of macrophytes found within the 100 m reach at each site ranged from three species at sites 2 and 8 (downstream and within the extent of the proposed West Borehole Seam workings) to nine species at site 1 (wet area downstream of the extent of the proposed West Borehole Seam workings, respectively). Sites 2 and 8, which had the lowest taxonomic richness, were both dry at the time of survey. Except at site 1, the number of species at sites within and downstream of the extent of the proposed West Borehole Seam workings was lower than the number of species at the upstream sites (Figure 2.1). Taxonomic richness in the current survey was similar to richness at sites in the Abel Underground Mine survey, which ranged from 2 to 11 species at each site (frc environmental 2010).

Figure 2.1 Taxonomic richness at each site.

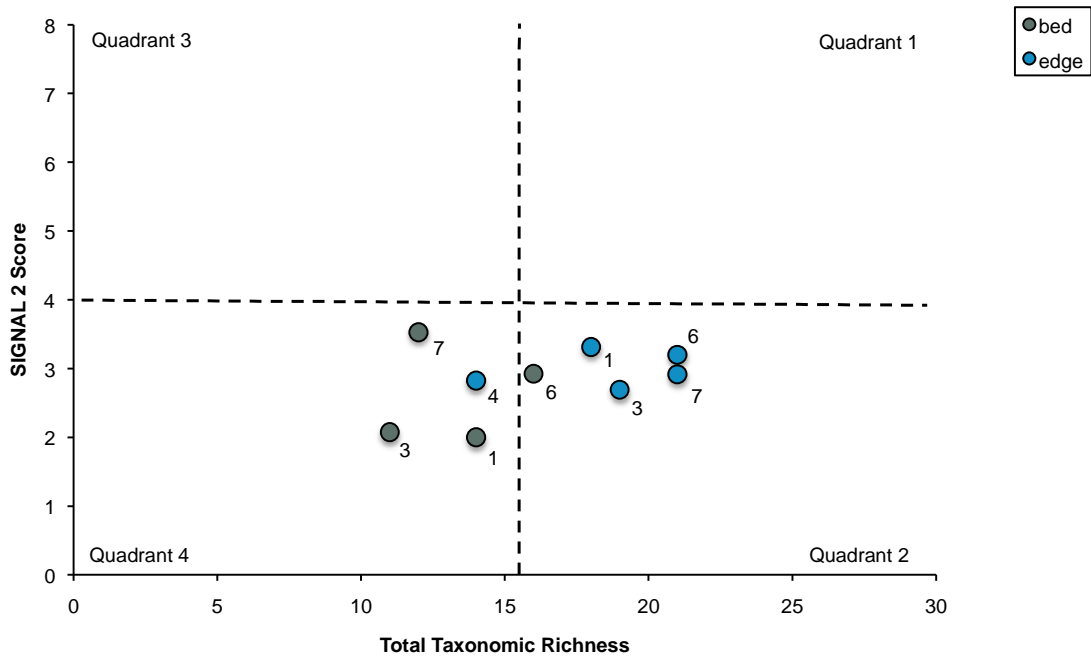
Figure 2.9 SIGNAL 2/family bi-plot in bed and edge habitat at each site.
