2015 Annual Groundwater Review*

Dundon Consulting Pty Limited

Re: Abel Coal Project – Annual Groundwater Review – 2015 Year

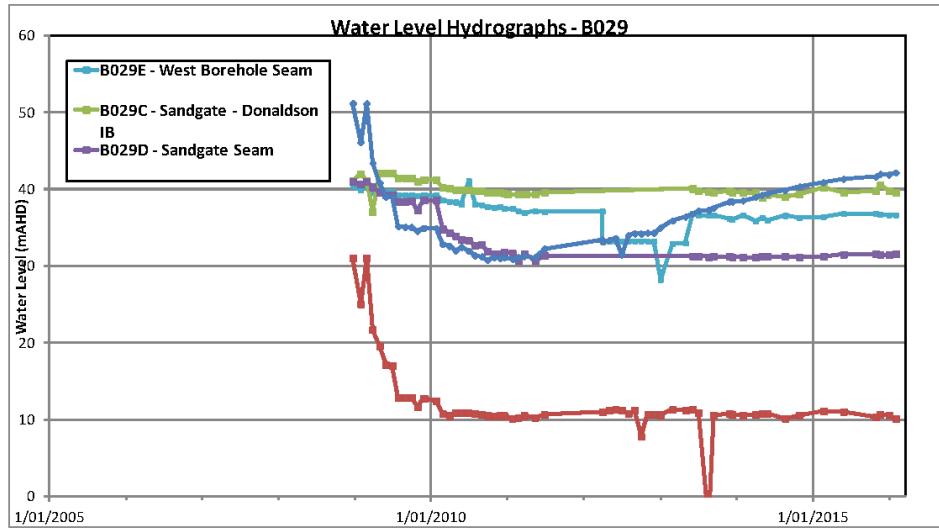
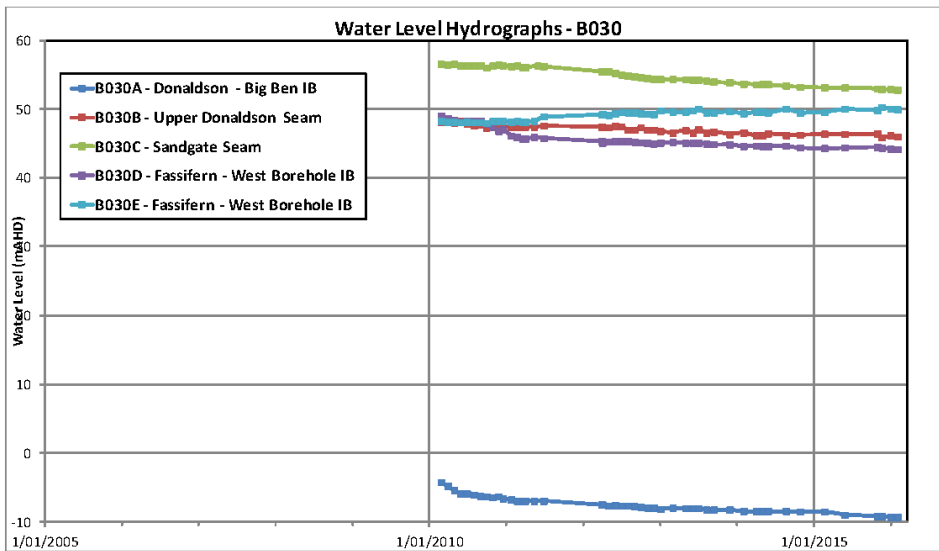
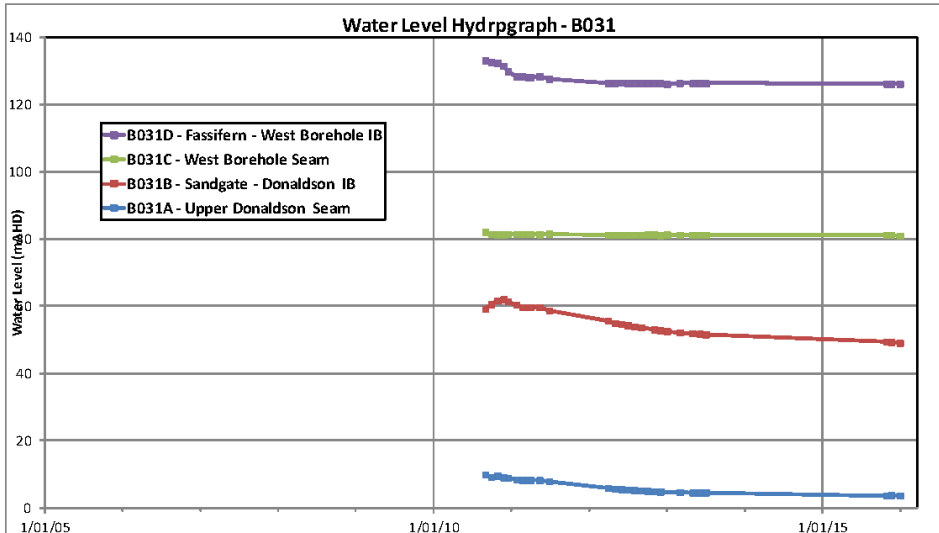
DATE: 15 February 2016	SCALE: N/A	Donaldson Coal Pty Ltd ABEL UNDERGROUND MINE WATER LEVEL HYDROGRAPHS - B029, B030 and B031
AUTHOR: PD CHECKED: PD	PROJECT NO: 16-0313	
DRAWING NO: 0313-012	REVISION:	
Dundon Consulting Pty Ltd		Figure 12

- C140 and C148 (**Figure 11**) – Responses occur before mining started at Abel, and are probably related to mining at Bloomfield. Water levels are relatively stable through 2015.
- TA28 (**Figure 11**) – Bore shows gradual drawdown in Donaldson Seam from 2006, believed to be in response to Donaldson OC, the pronounced drawdown from April 2010, coinciding with the start of secondary extraction from Panel 1.
- B029, B030 and B031 (**Figure 12**) – All three bores show drawdowns in the Donaldson Seam and some of the overburden strata. Early responses from 2008 to 2010 at B029 are probably slow adjustment to ambient heads in very low permeability strata.
