**Abel Mine
Subsidence Management Plan
End of Year Report 2010**

31 March 2011

Technical Services Manager- UG Operations
Donaldson Coal

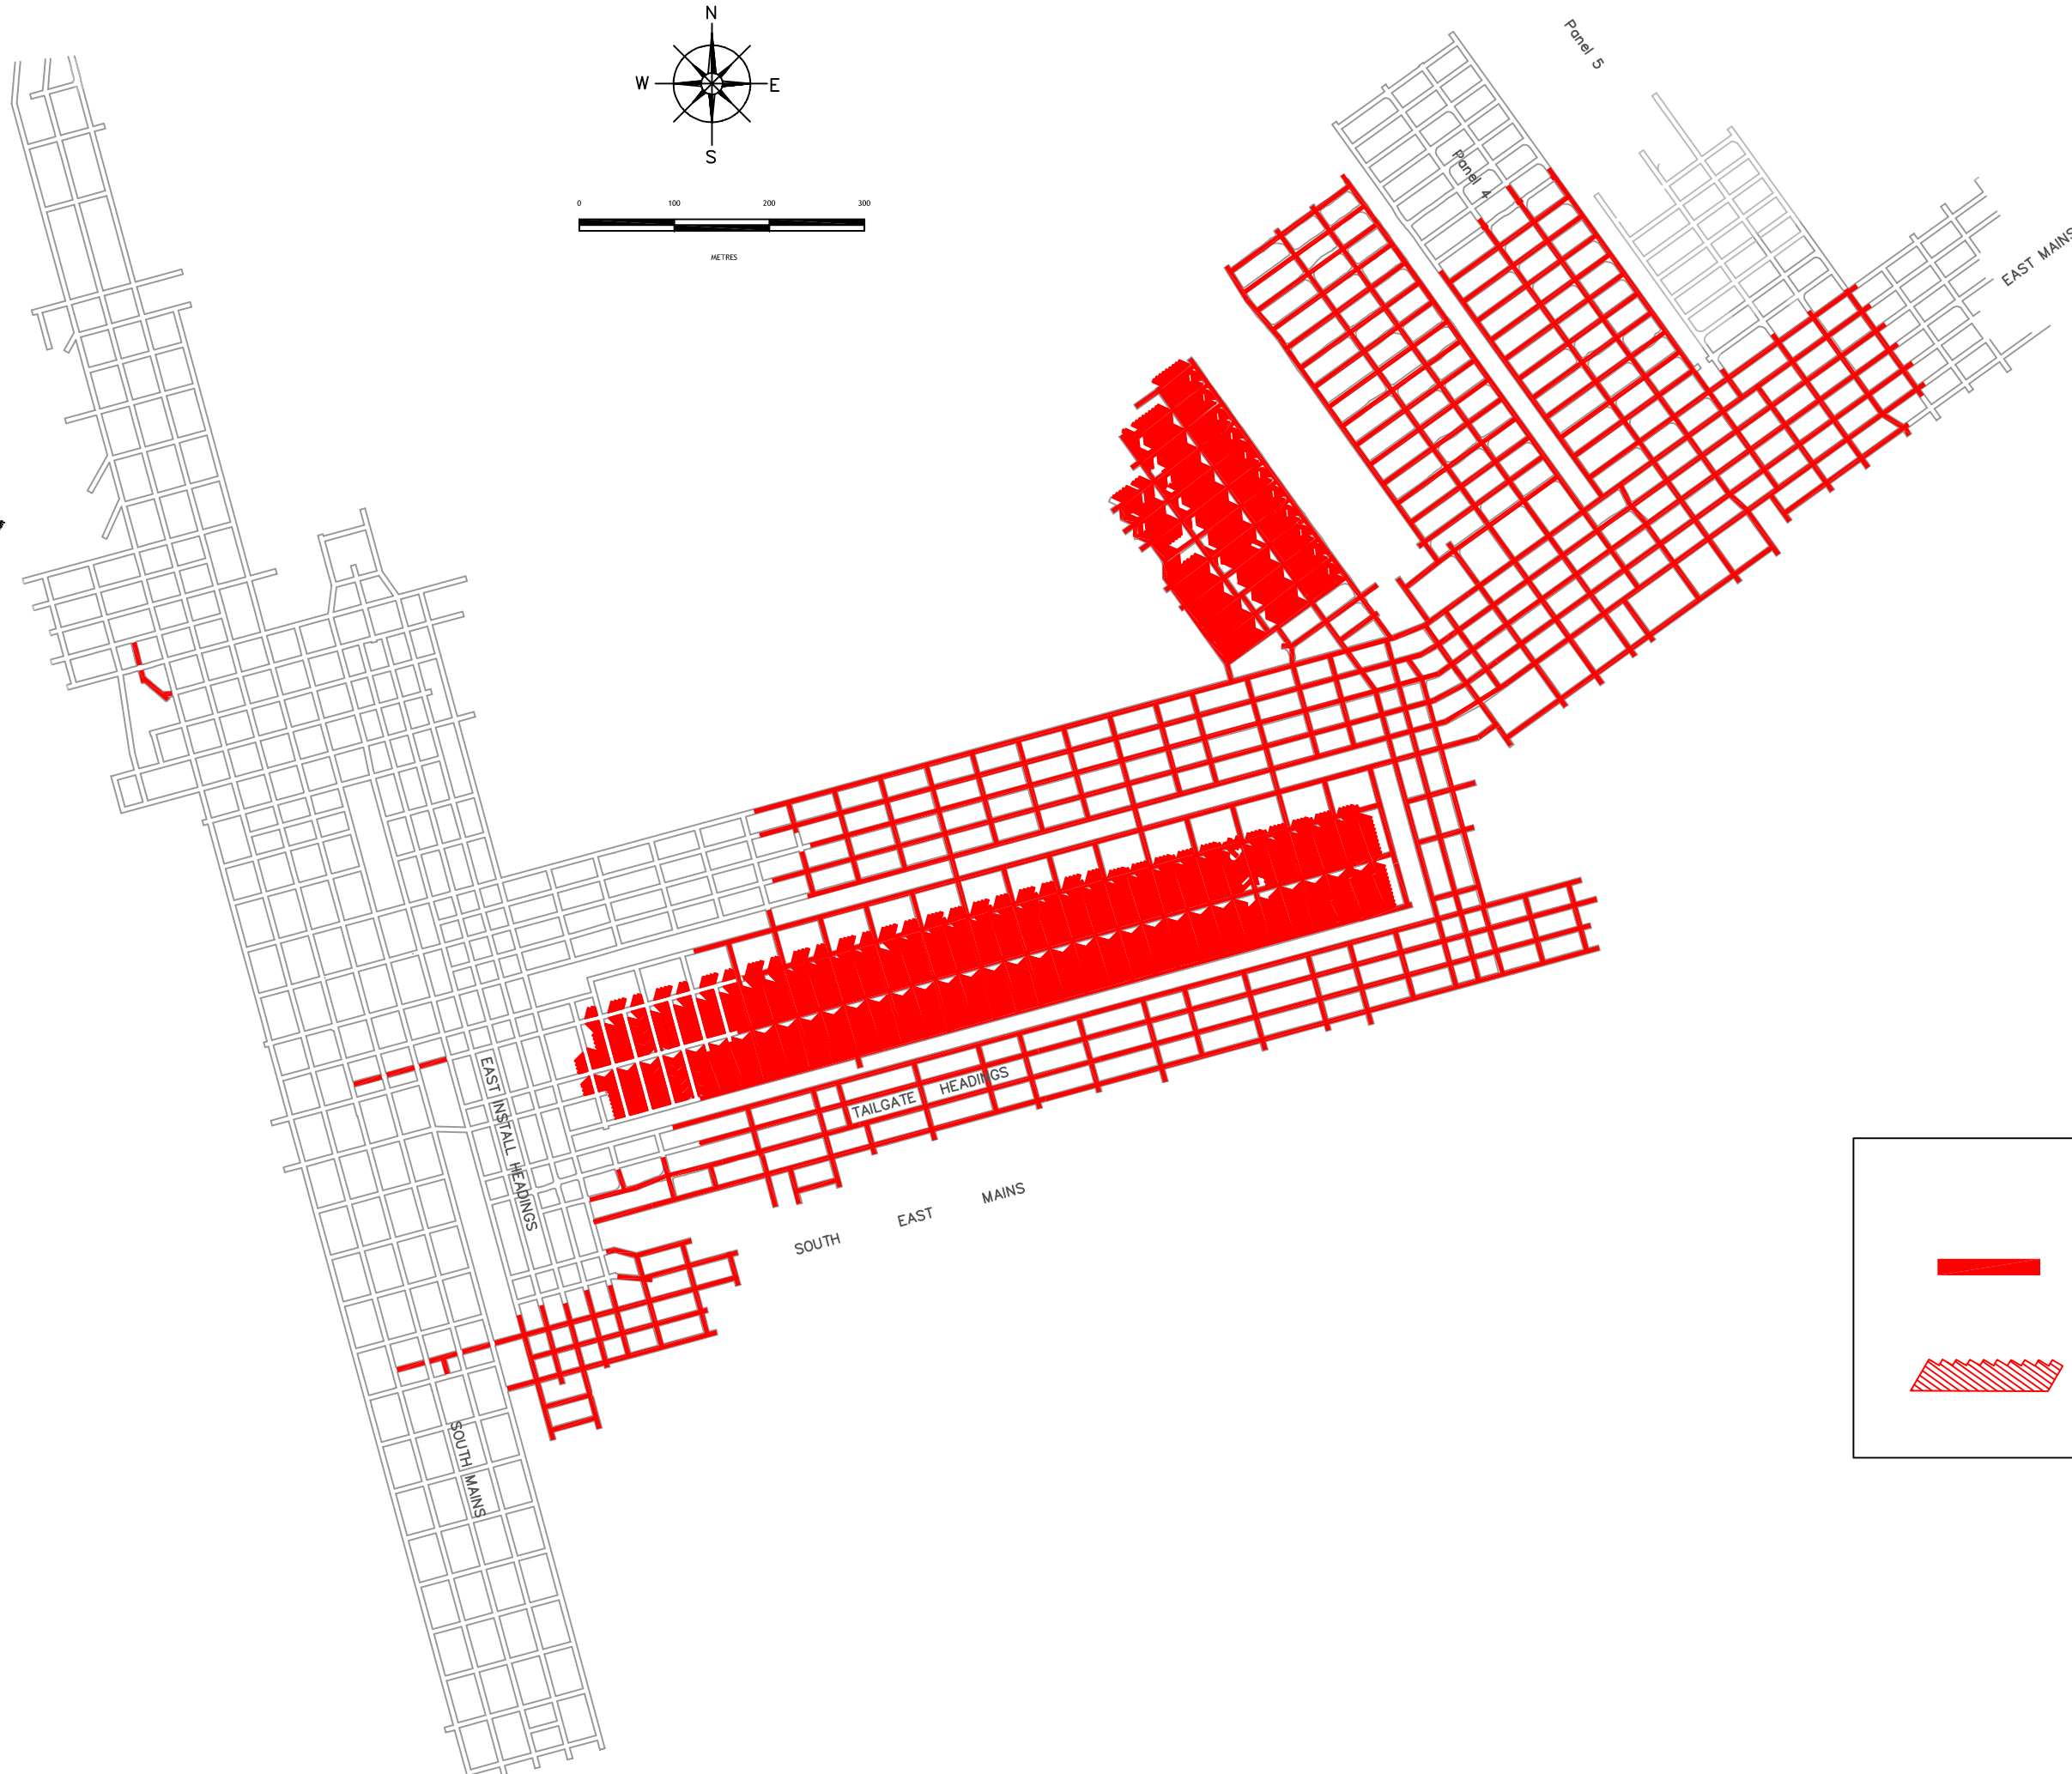
Minor cracking was observed over Abel Panel 1 area (see attached plan Dwg No a1d0025.dwg) and this cracking increased to a current maximum of 200mm width across an access track where the depth of cover is 105 metres.

This exceeded the SMP Application predictions relating to cracking, where cover was in excess of 80 metres, which were "likely to be in the order of 30 to 150 mm."

Table 4 of the Trigger Actions and Management Responses (Environmental Management Plan) in relation to surface cracking / erosion on roads & access tracks (by visual inspection) notes surface cracking 100-400mm as an irregular result / minor impact trigger requiring notification.
