DONALDSON COAL

ABEL MINE

Mine Design SMP Compliance Audit

Panel 21

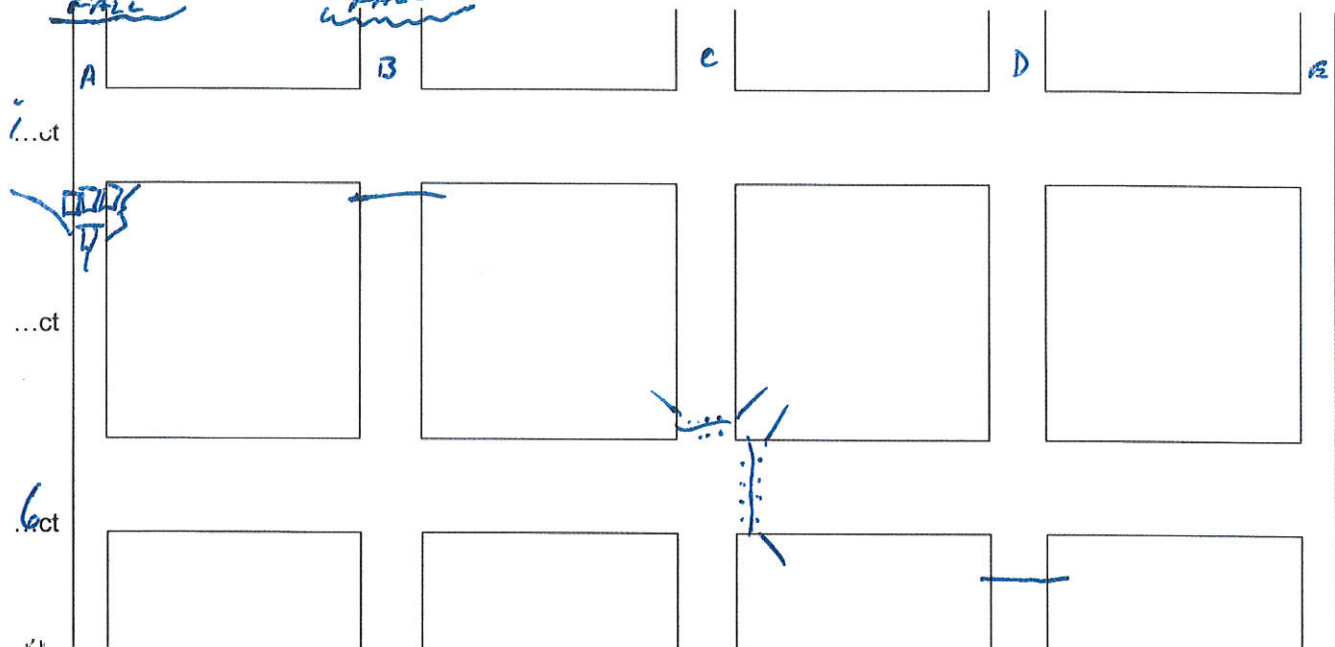
Coal Tops	Joints	Cornices	Floor Heave	Rib Height <input checked="" type="checkbox"/>
Broken Roof	Gutters	Faults	Dykes	Coal Cleat
Cutters	Rib Spall <input checked="" type="checkbox"/>	Soft Floor	Soft Roof	Greasybacks
Tell-tale	Bolt Loading	Off-centre Driveage	Housekeeping

3x GOAF FALL DURING SHIFT BETWEEN
 7ct AND 8ct B HDG
 POOR RIBS AT C HDG 6ct INTERSECTION
 RIBS SPALLING ON RUN INS
