DONALDSON COAL ANNUAL ENVIRONMENTAL MANAGEMENT REPORT

DONALDSON COAL MINE

1st November 2005 to 31st October 2006

Annual Environmental Management Report (AEMR) 2005-2006

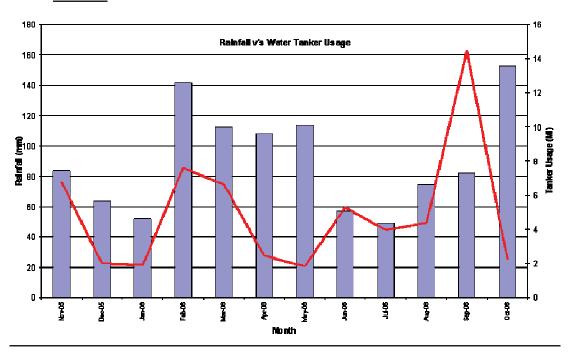
FIGURE 1: WATER CONSUMPTION AND SITE RAINFALL.

The site Environmental Manager maintains a site water balance based on water consumed at the mine. It includes recording the amount of water that is available in various water holding structures around the mine. The following chart, **Figure 1**, shows the water consumption for the Donaldson Mine. All water for this monitoring period was obtained from site supplies.

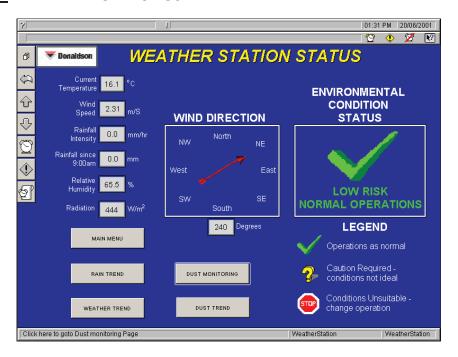
FIGURE 2: WEATHER STATION SCREEN.

An automatic weather station has been in operation at the site since 3rd December 1999. The station is supplied and serviced by Holmes Air Sciences. The station is a Unidata system with instrumentation installed to measure solar radiation (W/m²), temperature (°C), wind speed (m/s), wind direction and rainfall (mm). Data from the Unidata station was recorded continuously and reported as ten-minute averages. In May 2001 the monitoring data was integrated with a Citect operating system to provide real time and meteorological data and trending functions. This feature has allowed operational staff the ability to make up-to-date decisions about the influence of meteorological conditions on mining operations. **Figure 2** shows a typical screen that is displayed both in the Donaldson Coal Communication's office and the Shift Foreman office.

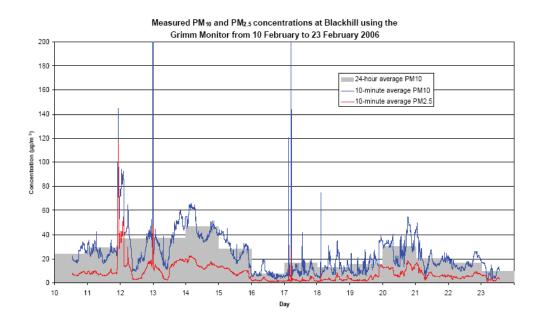
Figure 3: PM10 and PM2.5 chart for the period 10th February 2006 to 24th February 2006

PM_{2.5} dust monitoring was undertaken by a GRIMM monitor for two campaign events during this reporting period at the Bartter (Blackhill) site. Monitoring was conducted continuously over the period 10th February to 24th February 2006 and the 3rd August 2006 to 10th August 2006. 10-minute averages were obtained and are provided in **Figures 3 and 4**.

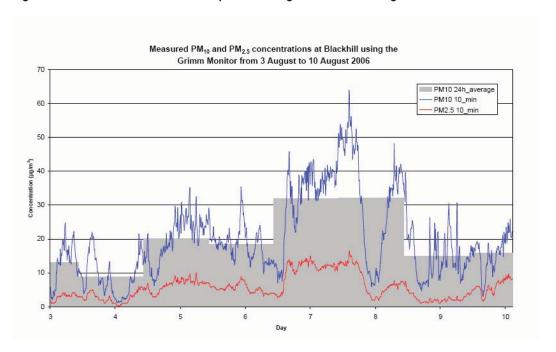
Figure 4: PM10 and PM2.5 chart for the period 3rd August 2006 to 10th August 2006

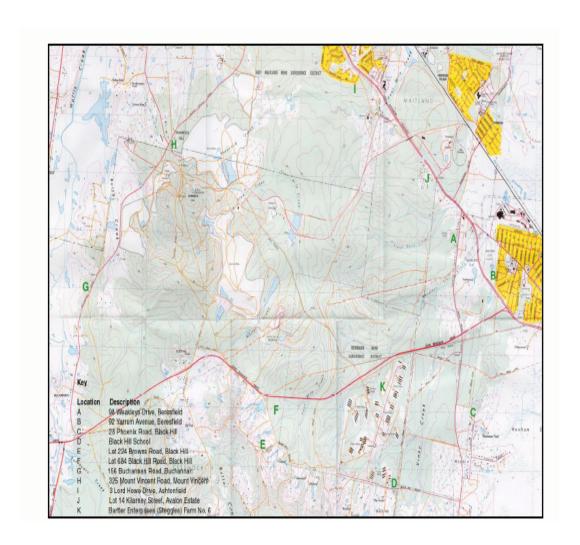
Locations of Air Pollution Monitoring Equipment.

Refer to **Appendix 2** for dust monitoring locations. It is noted that measurements taken at any of these locations will include all background air pollution relevant to those locations, as well as any contribution occurring from the Donaldson Coal Mine.
