Rehabilitation Management Plan

Donaldson Coal Mine

October 2023

R.W. CORKERY & CO. PTY. LIMITED

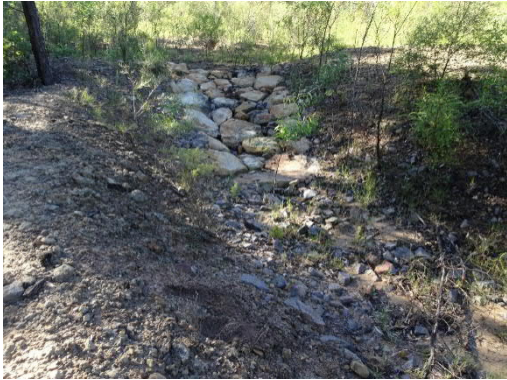
Site description	Photograph
<p>D1</p> <ul style="list-style-type: none"> • Field observations: <ul style="list-style-type: none"> • Contour drain • Bank is slightly dispersive • Natural subsoil which is non-disturbed • Soil results: Strongly acidic (5.3), non-saline, dispersive on remoulding, low CEC, Ca deficient, marginally sodic, very high Mg (41.8%)

Table 2 Sediment Dam A field observations and soil results

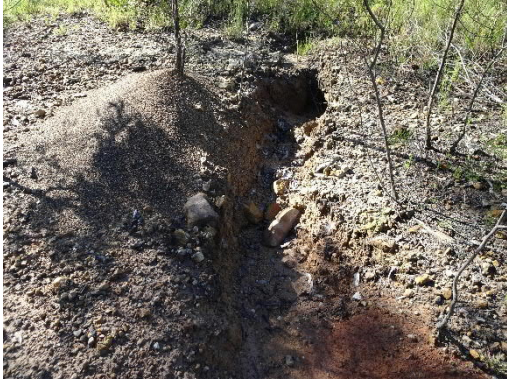
<p>D1b</p> <ul style="list-style-type: none"> • Field observations: <ul style="list-style-type: none"> • Erosion area above drain • Dispersive • Soil results: Moderately acidic (5.7), non-saline, not dispersive, moderate CEC, Ca deficient, non-sodic, very high Mg (62%)

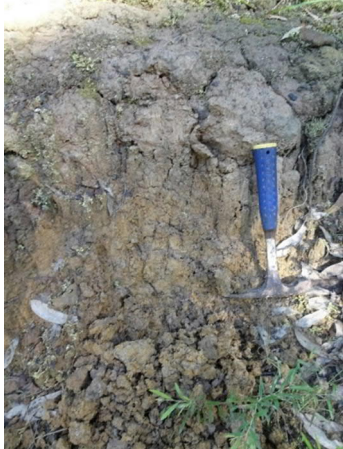
<p>D2</p> <ul style="list-style-type: none"> • Field observations <ul style="list-style-type: none"> • Drain inflow is dispersive • Soil profile has a bleached A2 horizon • Natural soil profile photographed • Soil results: Moderately acidic (5.6), non-saline, moderately to slightly dispersive, low CEC, Ca deficient, non-sodic, very high Mg (54.8%)

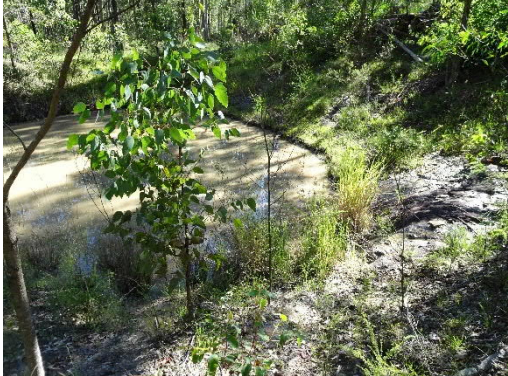
Site description	Photograph
<p>D3</p> <ul style="list-style-type: none"> • Field observations: <ul style="list-style-type: none"> • Dam inflow/spilling influenced by natural landform • Dispersive subsoil • Soil results: Moderately acidic (5.7), non-saline, moderately to slightly dispersive, low CEC, Ca deficient, non-sodic, very high Mg (59.6%)

Table 3 Sediment Dam B field observations and soil results

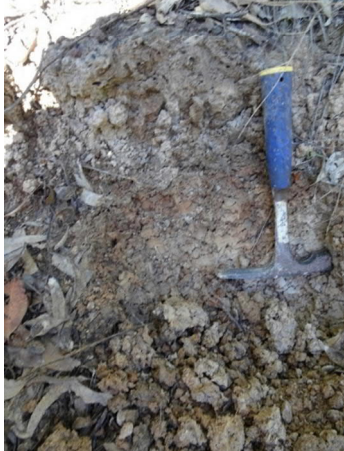
<p>D3b</p> <ul style="list-style-type: none"> • Field observations: <ul style="list-style-type: none"> • Natural soil profile • A1 – Loam • A1 – Bleached • B21 – Light clay • B22 – Medium clay • Soil results: Strongly acidic (5.3), non-saline, dispersive on remoulding, moderate CEC, Ca deficient, non-sodic, very high Mg (67.3%)

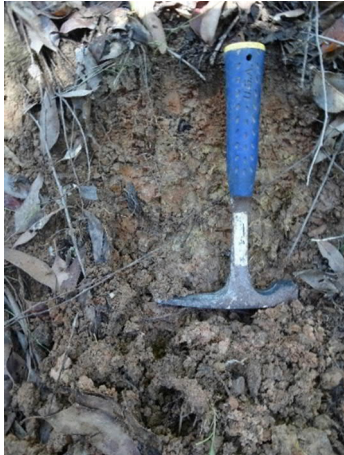
Site description	Photograph
<p>D4</p> <ul style="list-style-type: none"> • Field observations: <ul style="list-style-type: none"> • Small dam • Dispersive subsoil • Soil results: Strongly acidic (5.1), non-saline, not dispersive, moderate CEC, Ca deficient, non-sodic, very high Mg (48.2%)

Table 4 Sediment Dam C field observations and soil results

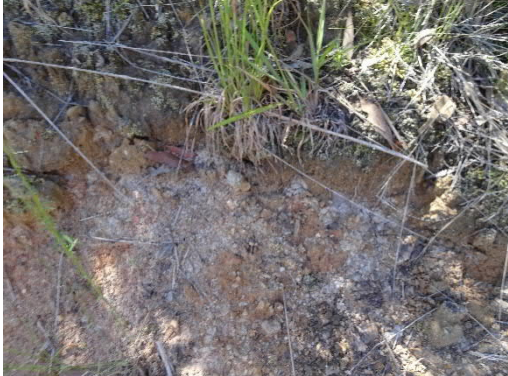
Site description	Photograph
<p>D6</p> <ul style="list-style-type: none"> • Field observations: <ul style="list-style-type: none"> • Very weak pedality • Water is very turbid • Dispersive subsoil • Soil results: Strongly acidic (5.3), non-saline, moderately to slightly dispersive, very low CEC, Ca deficient, non-sodic, very high Mg (31%)

Table 5 Sediment Dam D field observations and soil results

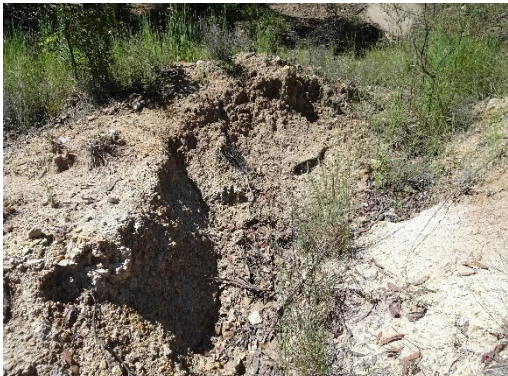
<p>D6b</p> <ul style="list-style-type: none"> • Field observations: Dispersive subsoil • Soil results: Strongly acidic (5.4), non-saline, moderately to slightly dispersive, moderate CEC, Ca deficient, marginally sodic, very high Mg (56%)

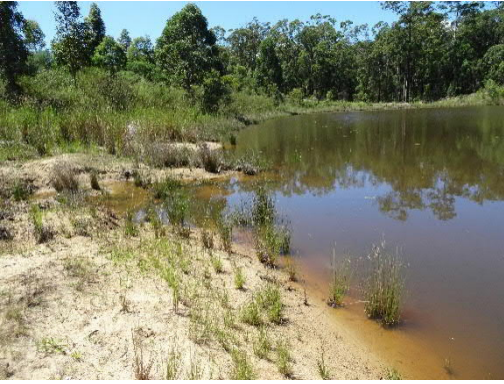
Site description	Photograph
<p>D7</p> <ul style="list-style-type: none"> • Field observations: <ul style="list-style-type: none"> • Sandy bank – loamy sand • Water fairly clear • Water being filtered by a sandy bank/bar before entering dam

Table 6 Sediment Dam E field observations and soil results

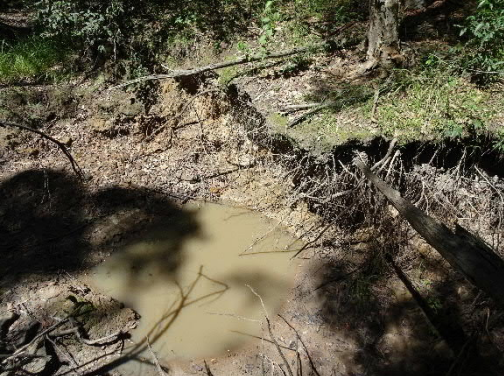
<p>D7b</p> <ul style="list-style-type: none"> • Field observations: <ul style="list-style-type: none"> • Spillway cut into natural dispersive subsoil • Scouring in creek below spillway • Subsoil exposed in creek bank erosion • Water in drainage line pools is very turbid • Soil results: Strongly acidic (5.2), non-saline, dispersive on remoulding, very low CEC, Ca low, non-sodic, very high Mg (9.1%)

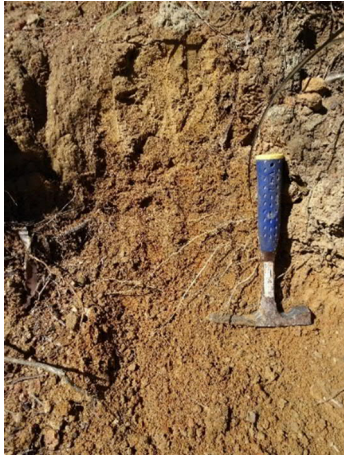
Site description	Photograph
<p>D5</p> <ul style="list-style-type: none"> • Field observations: <ul style="list-style-type: none"> • Rehabilitated soil profile photographed • Dispersive subsoil • Soil results: Strongly acidic (5.3), non-saline, moderately to slightly dispersive, low CEC, Ca deficient, non-sodic, very high exchangeable Mg (45.4%)

Table 7 Ted's Hole field observations and soil results

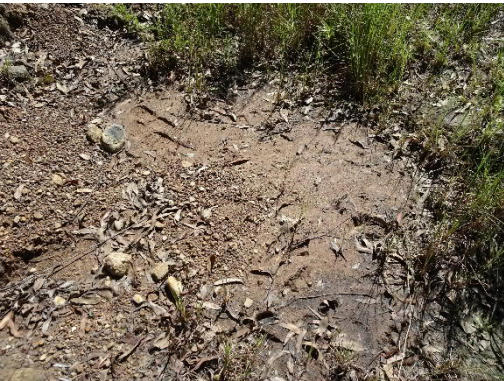
<p>D5b</p> <ul style="list-style-type: none"> • Field observations: <ul style="list-style-type: none"> • Sediment in dam sampled • Soil results: Very strongly acidic (5.0), non-saline, moderately to slightly dispersive, low CEC, Ca deficient, non-sodic, very high exchangeable Mg (53%)

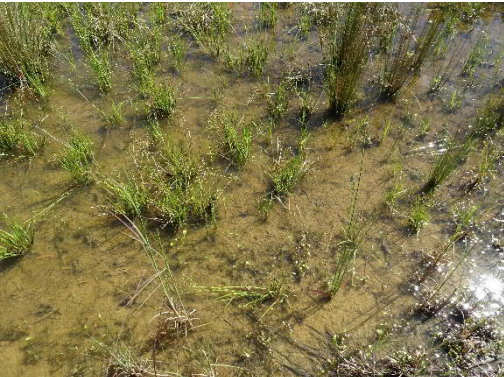
<p>D5c</p> <ul style="list-style-type: none"> • Field observations: <ul style="list-style-type: none"> • Dispersive drain into dam • Dam water is clear • Vegetation and reeds acting as a filter • Water is not stagnant • Soil results: Very strongly acidic (4.9), non-saline, not dispersive, moderate CEC, Ca deficient, non-sodic, very high exchangeable Mg (24.9%)

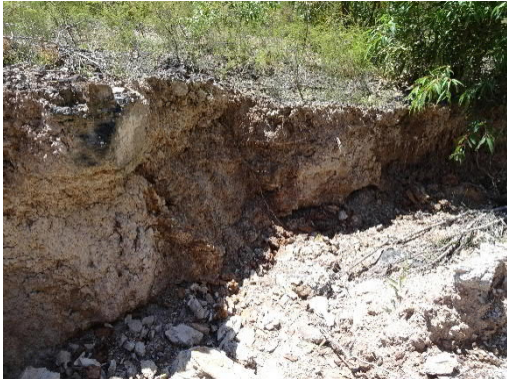
Site description	Photograph
<p>D8</p> <ul style="list-style-type: none"> • Field observations: <ul style="list-style-type: none"> • Eroded drain reporting directly to Rumbles Dam • Exposed dispersive subsoil contributing directly to turbidity • Soil results: Strongly acidic (5.3), non-saline, moderately to slightly dispersive, moderate CEC, Ca deficient, strongly sodic, very high Mg (47.8%)

Table 8 Rumbles Dam field observations and soil results

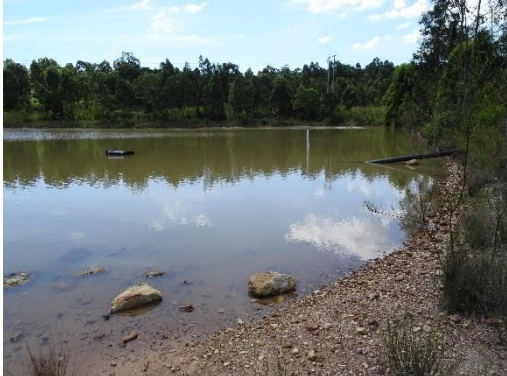
<p>D9</p> <ul style="list-style-type: none"> • Soil results: Strongly acidic (5.0), non-saline, not dispersive, low CEC, Ca deficient, non-sodic, very high Mg (24%)

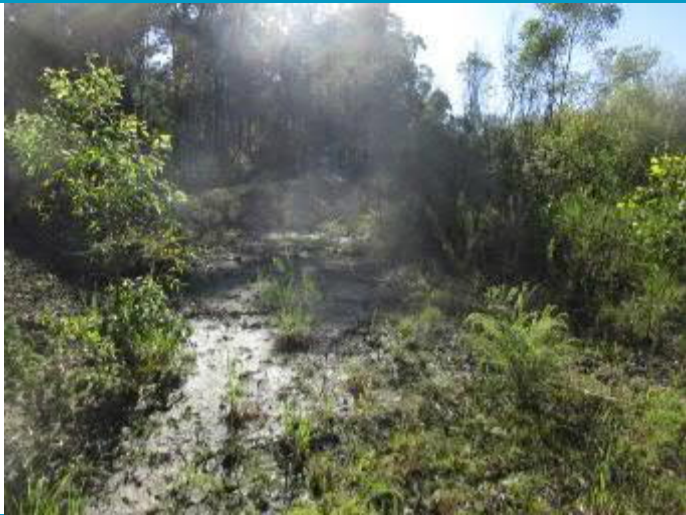
Plate 1 – Sediment Dam A Upslope Channel

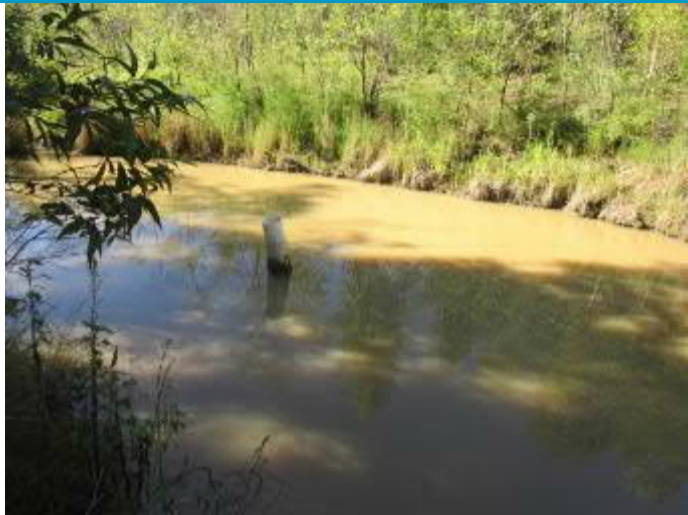
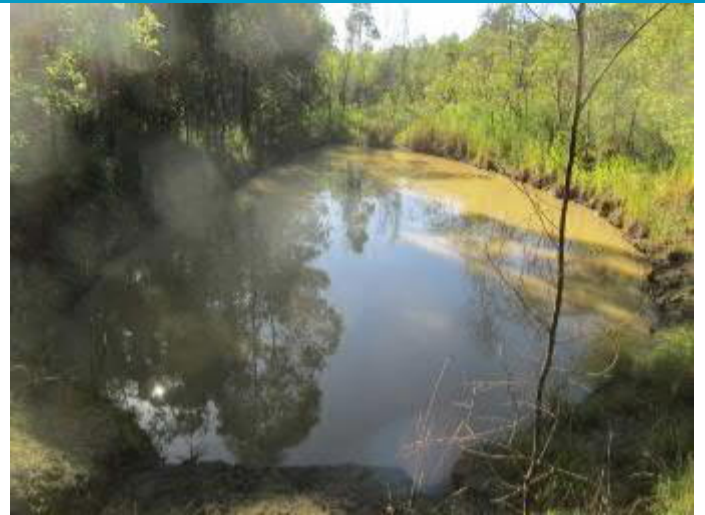
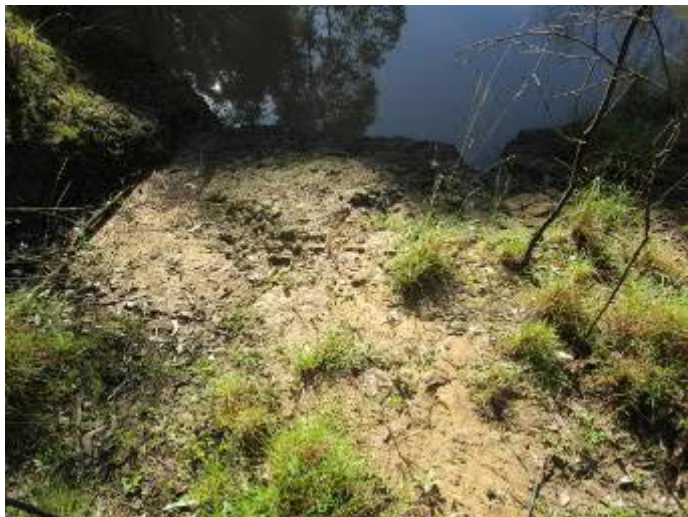
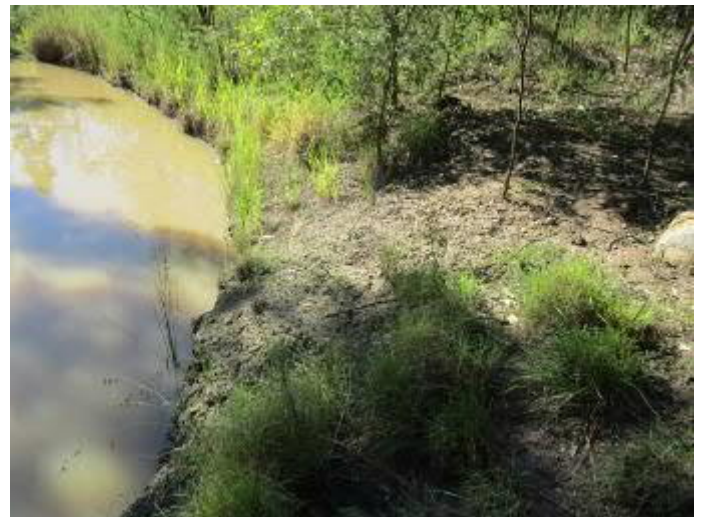
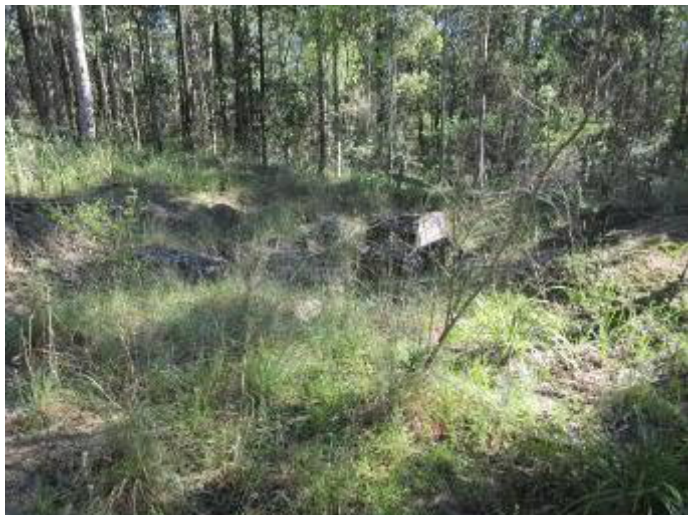
Plate 6 – Sediment Dam A

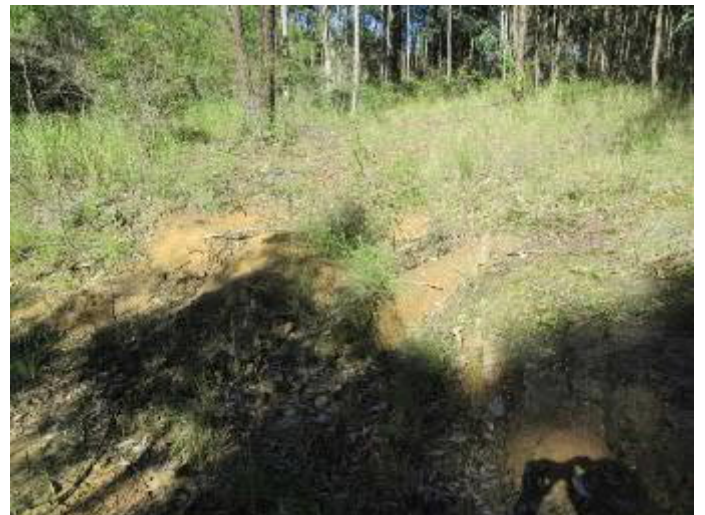
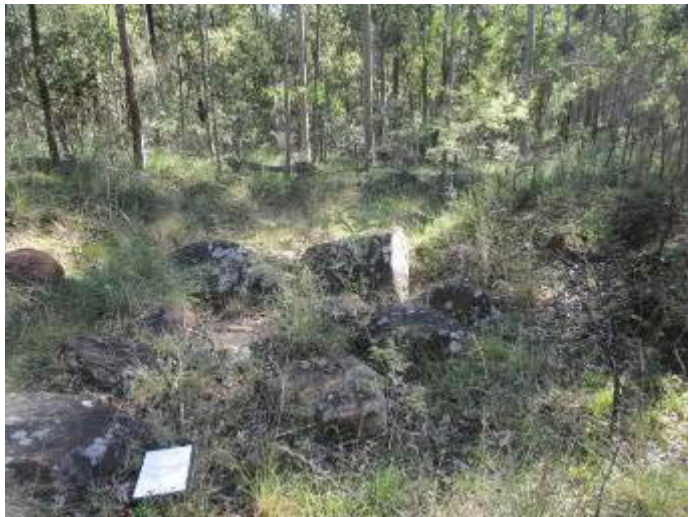
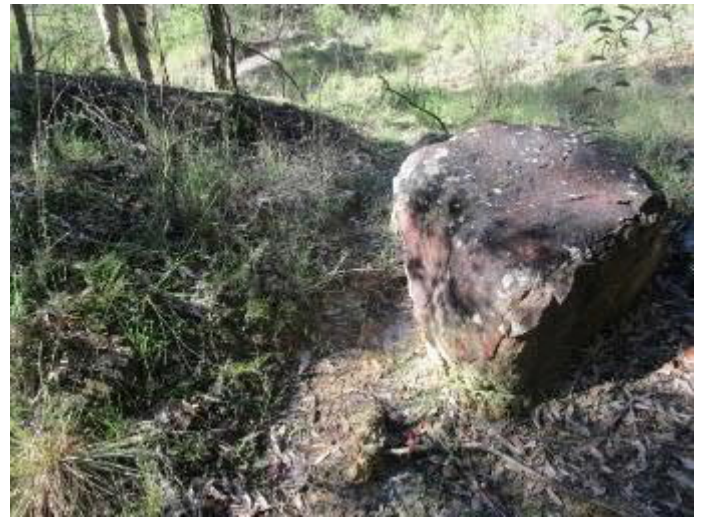
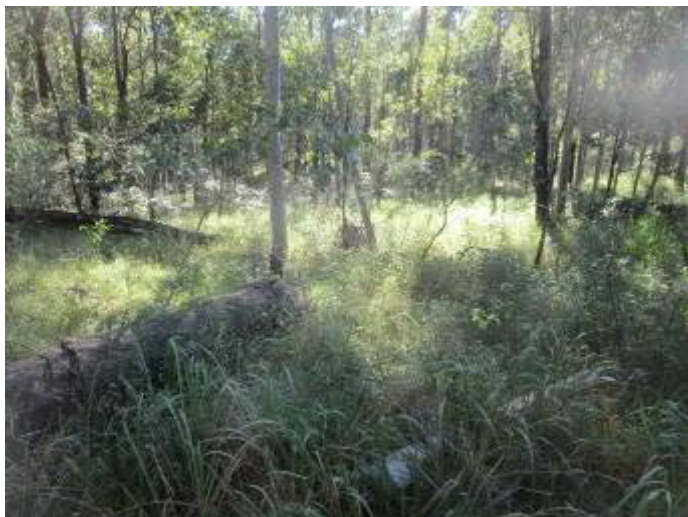
Plate 11 – Sediment Dam A Spillway

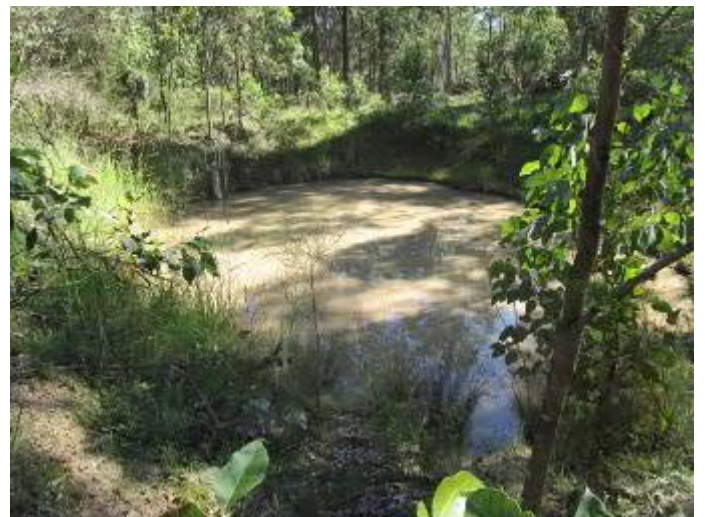
Plate 15 – Sediment Dam A Downslope of Spillway

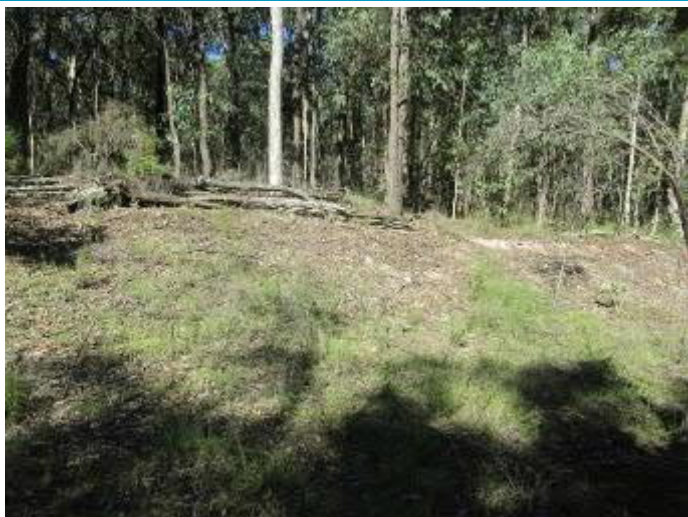
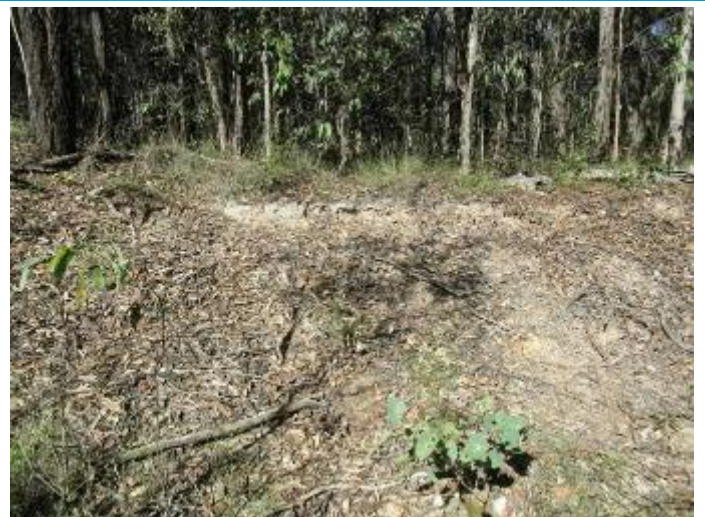
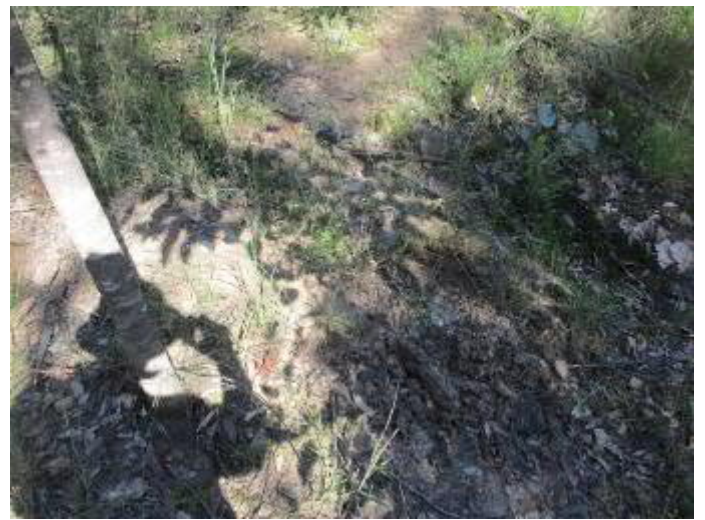
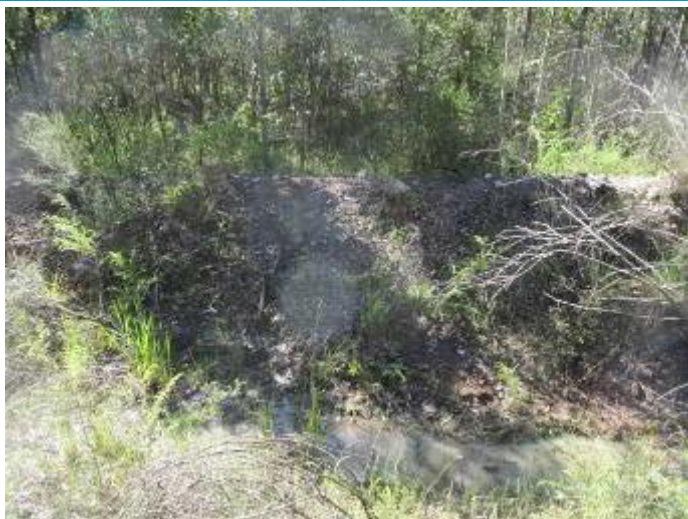
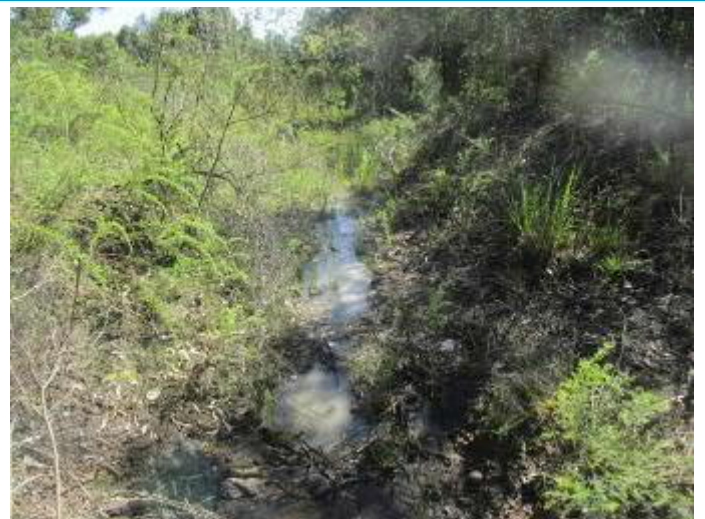
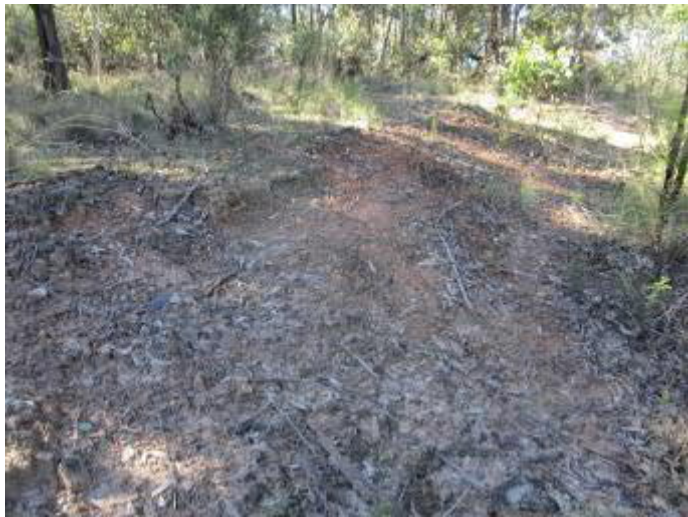
Plate 16 – Sediment Dam B

Photos of Sediment Dam B and an upslope area are provided in Plates 16 to 25 in Appendix C.

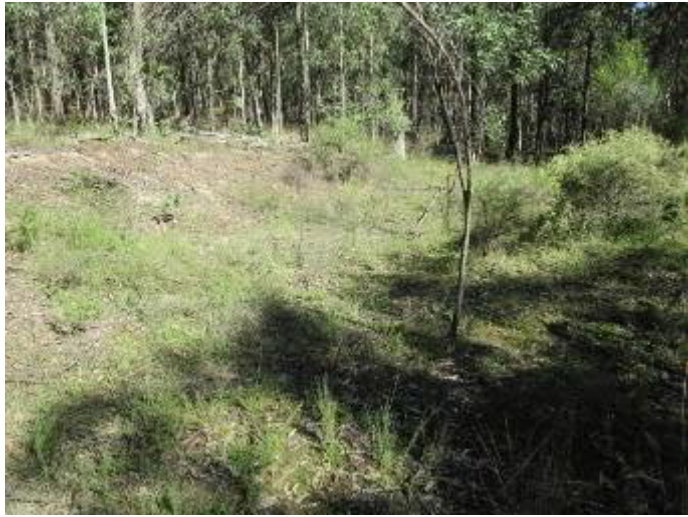
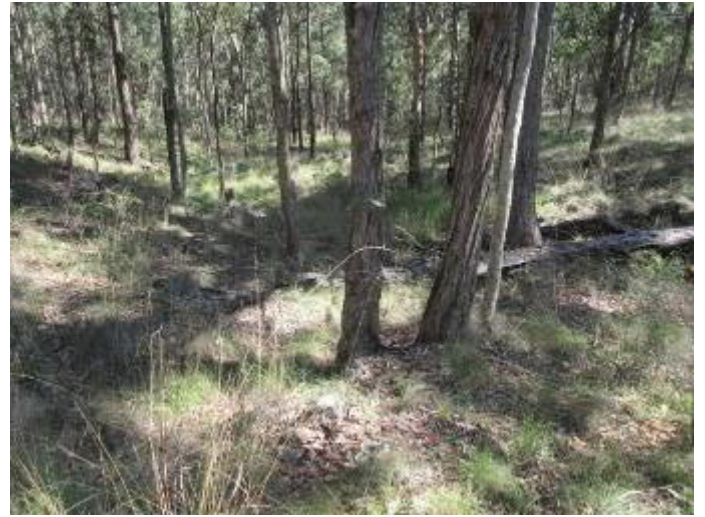
Plate 18 – Sediment Dam B Spillway

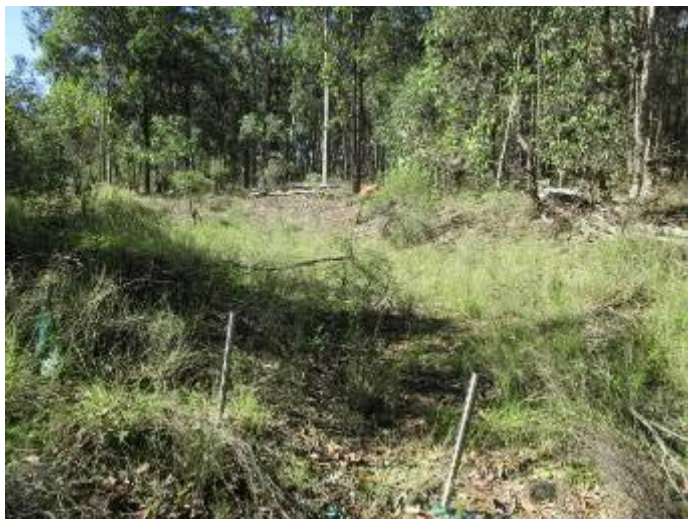
Plate 20 – Sediment Dam B Downslope of Spillway

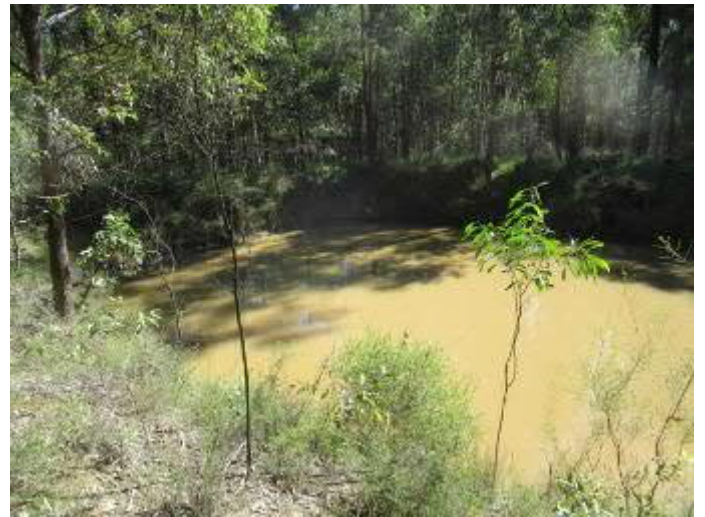
Plate 25 – Small Disturbance Area in Sediment Dam B Catchment

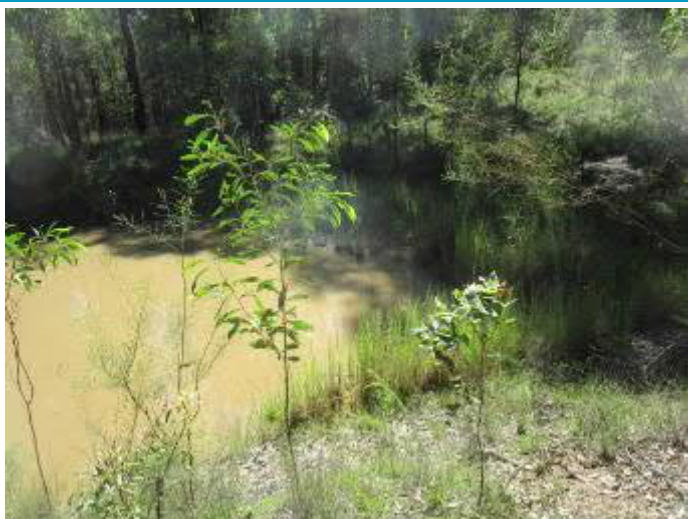
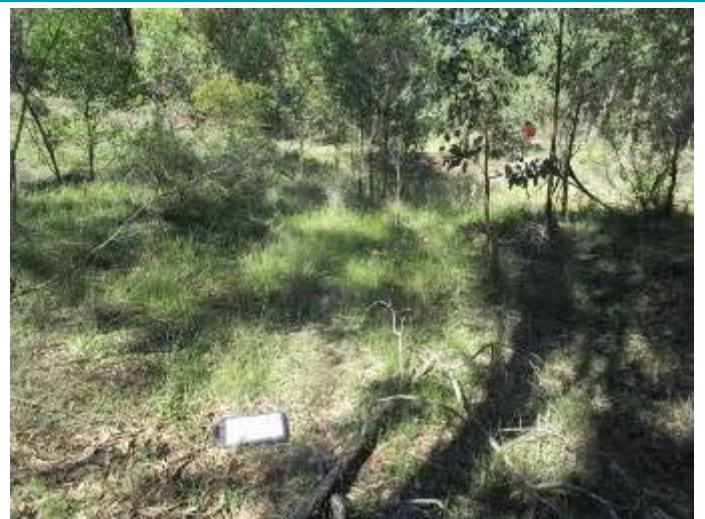
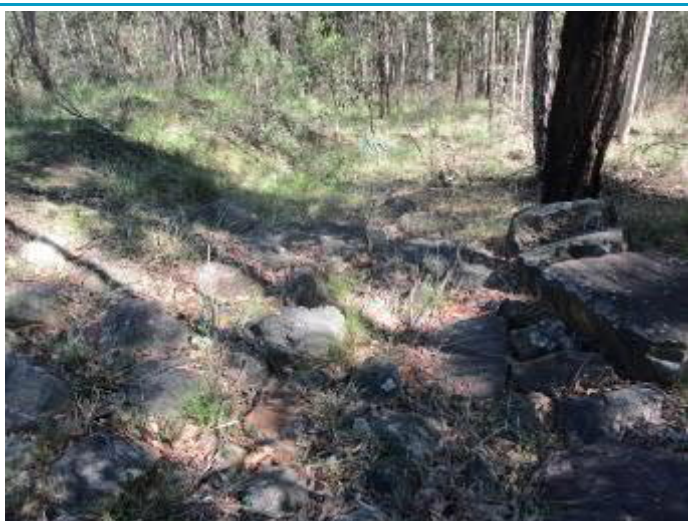
Plate 26 – Sediment Dam C

Photos of Sediment Dam C and an upslope channel are provided in Plates 26 to 32 in Appendix C.

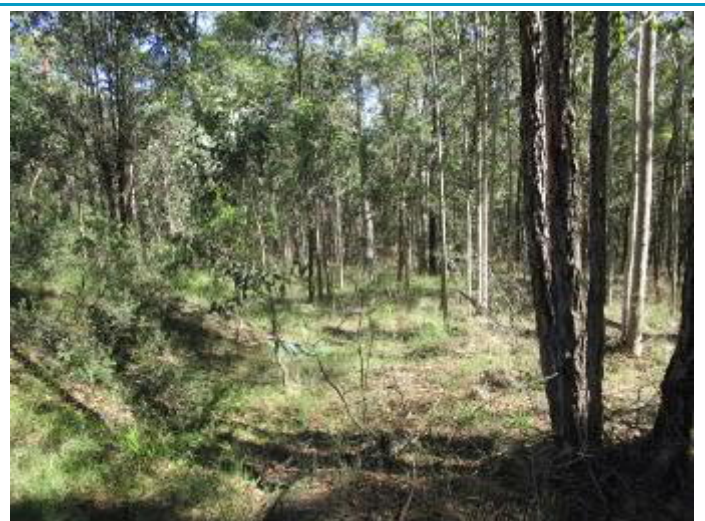
Plate 29 – Sediment Dam C Spillway

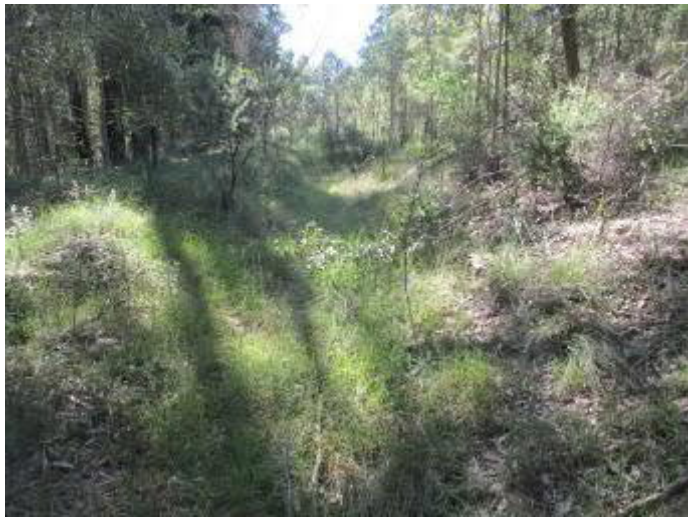
Plate 30 – Sediment Dam C Downslope of Spillway

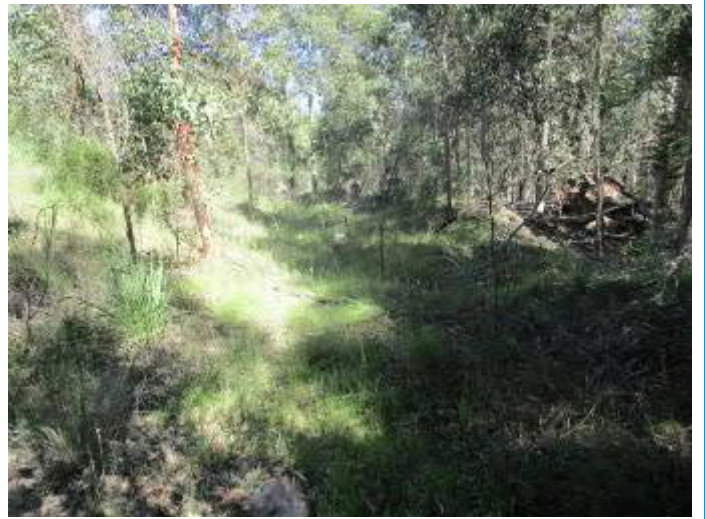
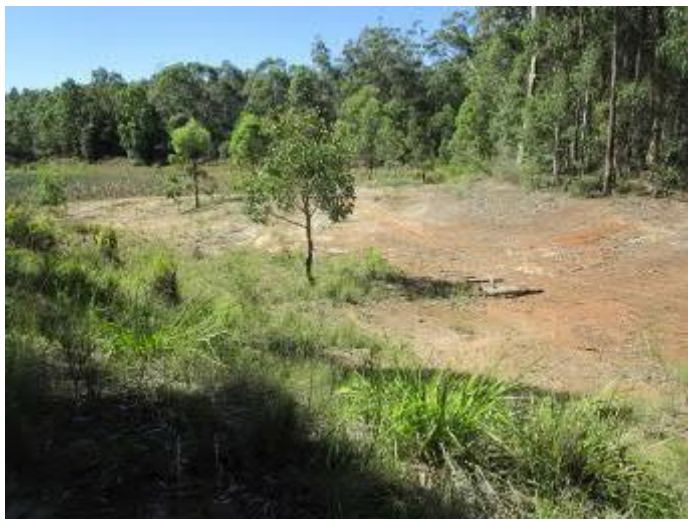
Plate 31 – Channel Upslope of Sediment Dam C

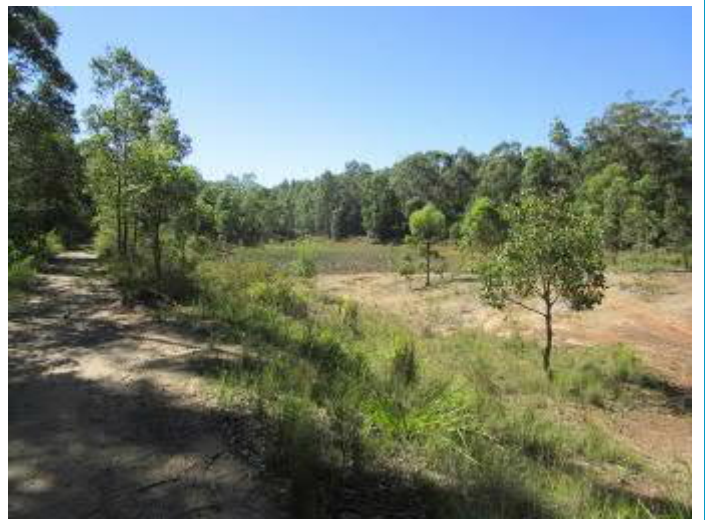
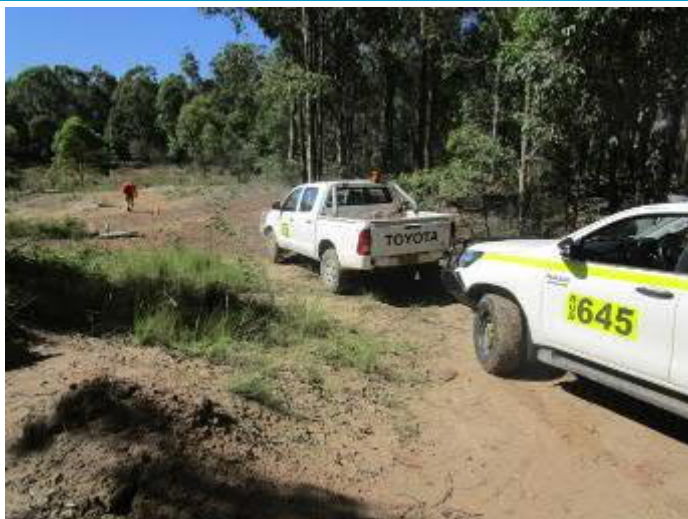
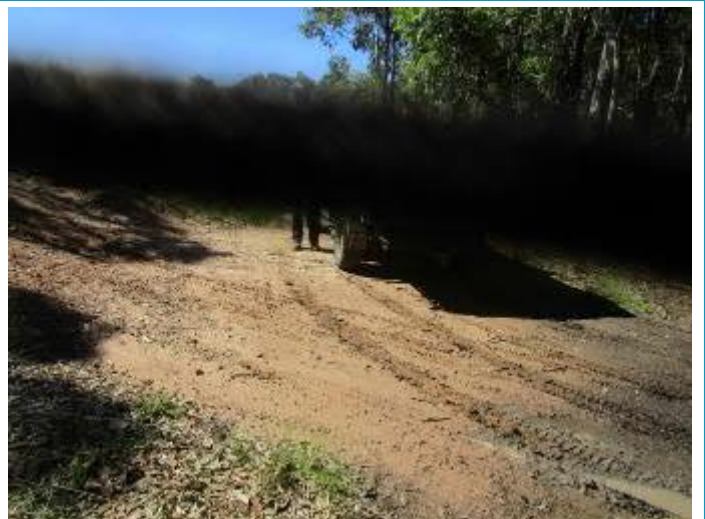
Plate 33 – Teds Hole

Photos of the Teds Hole dam and upslope channels are provided in Plates 33 to 48 in Appendix C.

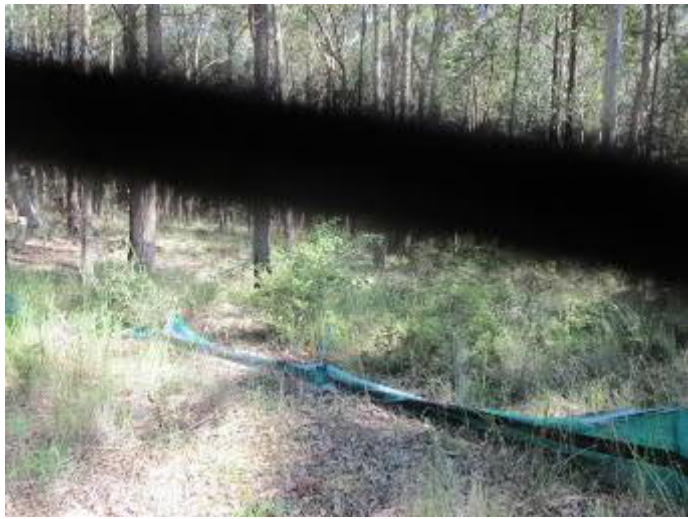
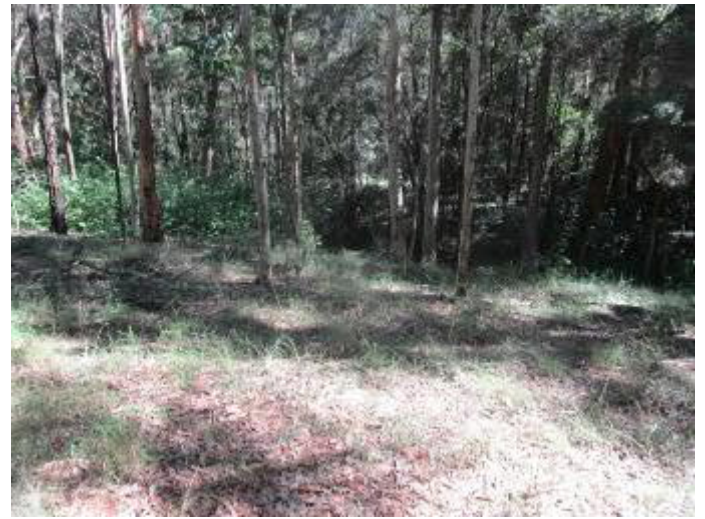
Plate 36 – Teds Hole Spillway

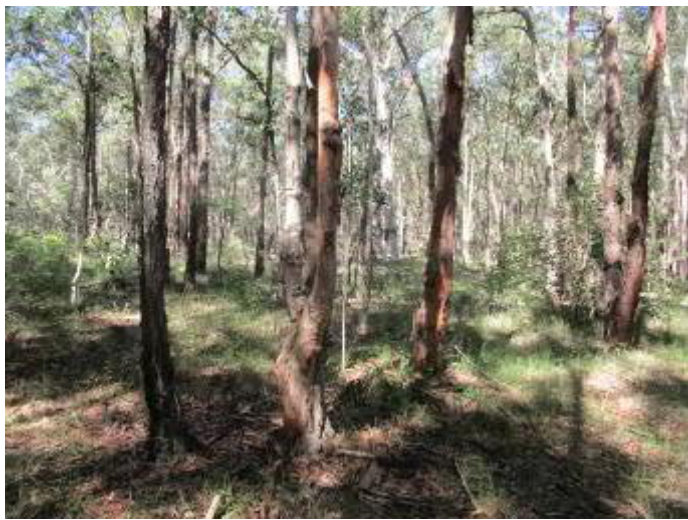
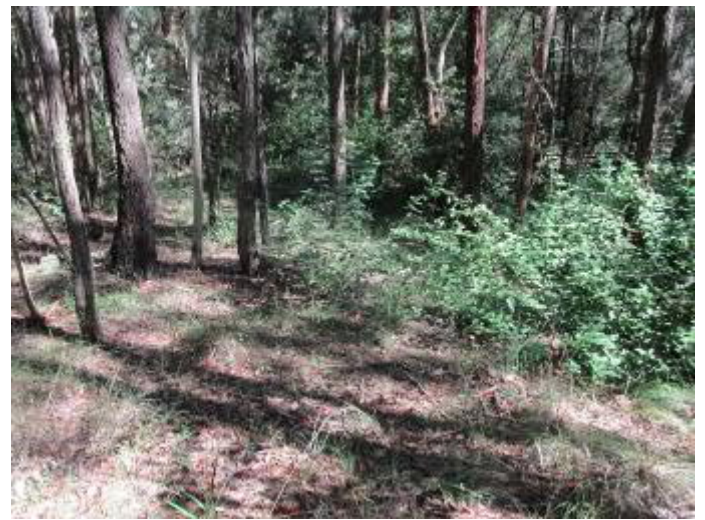
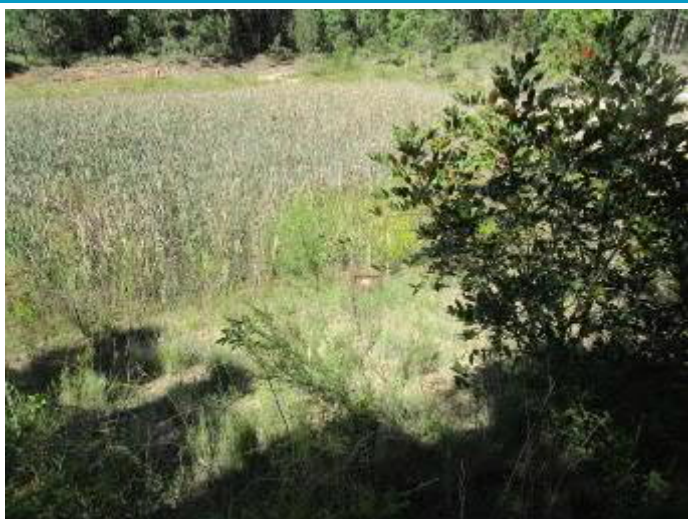
Plate 38 – Teds Hole Downslope of Spillway

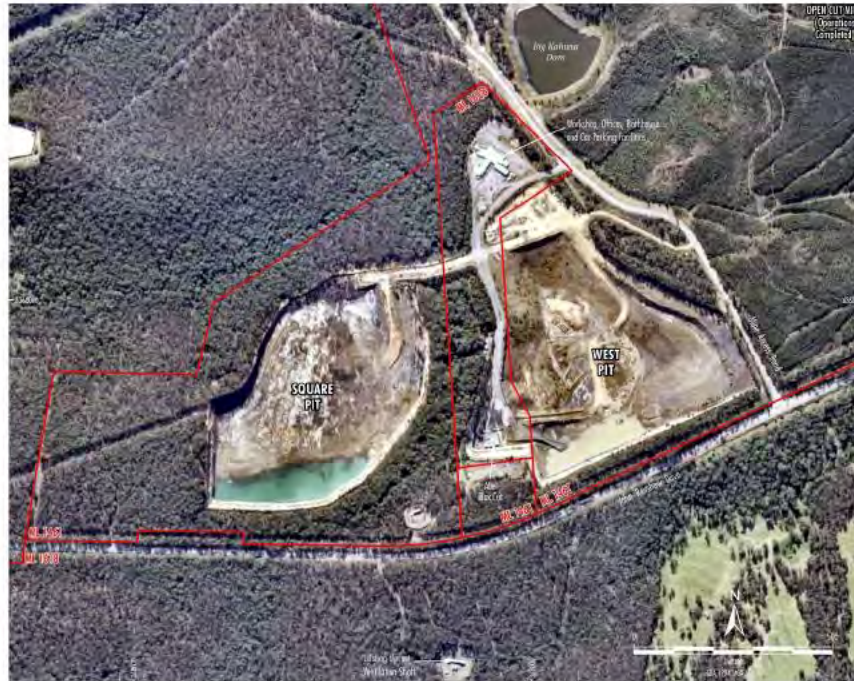
West Pit and Abel Box Cut

- Access to Abel Box Cut secured
- Western, southern and northern highwalls retained
- Eastern low wall partially reprofiled
- Pit catchment water transferred to Big Kahuna Dam

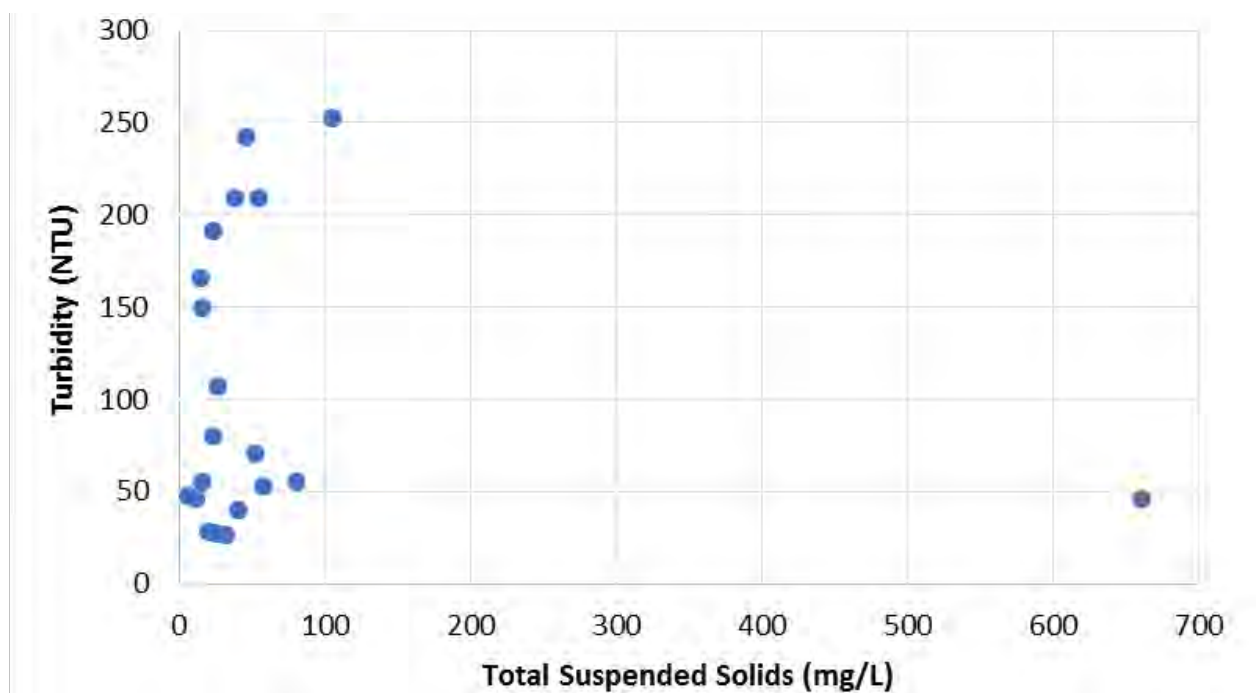
Figure 4 Total Suspended Solids versus Turbidity – Sediment Dam A

Turbidity measurements have been elevated and variable with a range of 25.7 to 252 NTU. The median value of 62.8 NTU is above the upper bound ANZECC (2000) default guideline trigger value. The plot of TSS concentration and turbidity is shown in Figure 4 below.

There is an apparent TSS outlier value (TSS concentration of 661 mg/L and turbidity of 45.8 NTU on 15/1/2020). January 2020 was a low rainfall month with only 3 mm recorded at the Donaldson Coal Mine rainfall station prior to the date of sampling. There is there no obvious reason for this very high TSS concentration. The effect of removing that data pair is shown in the revised plot of TSS concentration and turbidity shown in Figure 5.

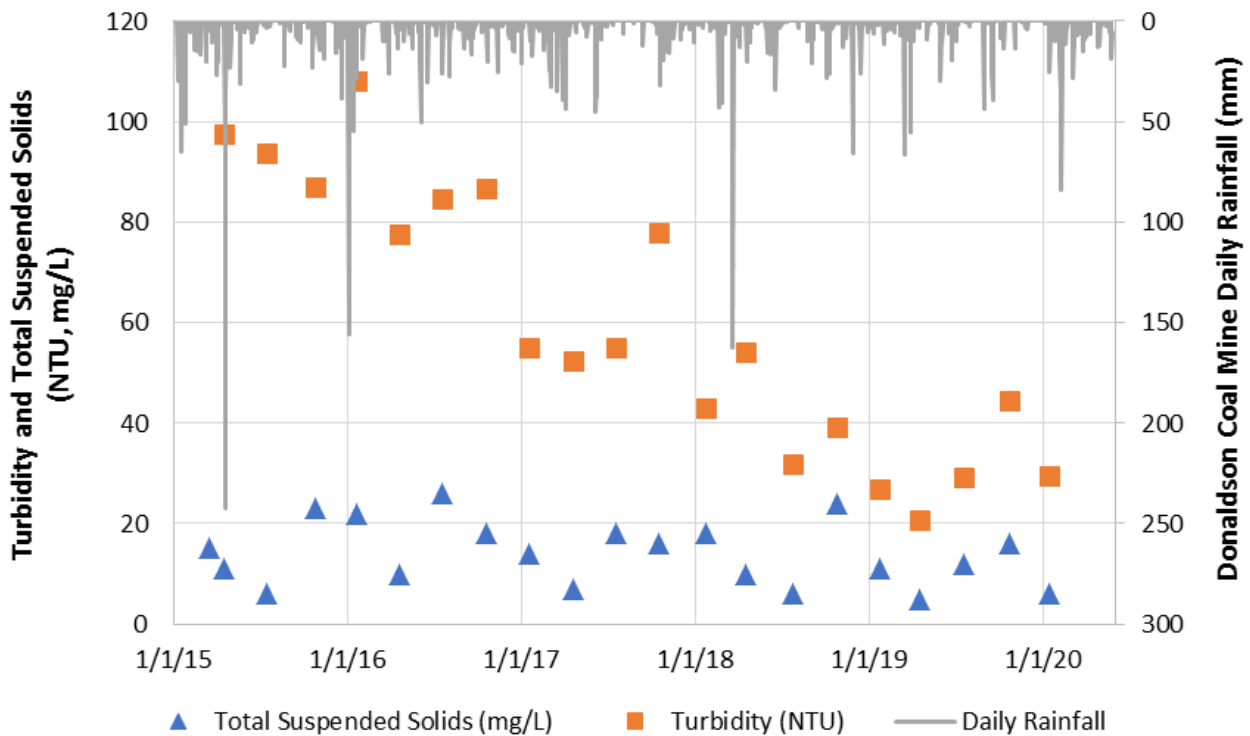
A time series plot of TSS concentration and turbidity together with Donaldson Coal Mine daily rainfall is given in Figure 12 below.

Figure 12 Change in Rumbles Dam Total Suspended Solids and Turbidity over the Monitoring Period

Noteworthy features in Figure 12 are the general and persistent decline in turbidity with time contrasting with generally steady, although also slightly declining, TSS values. There is also some consistency in the pattern of higher and lower values which implies both suspended solids and turbidity have responded to the same processes. There does not appear to be any direct correlation between rainfall and changes in turbidity or TSS in the dam.

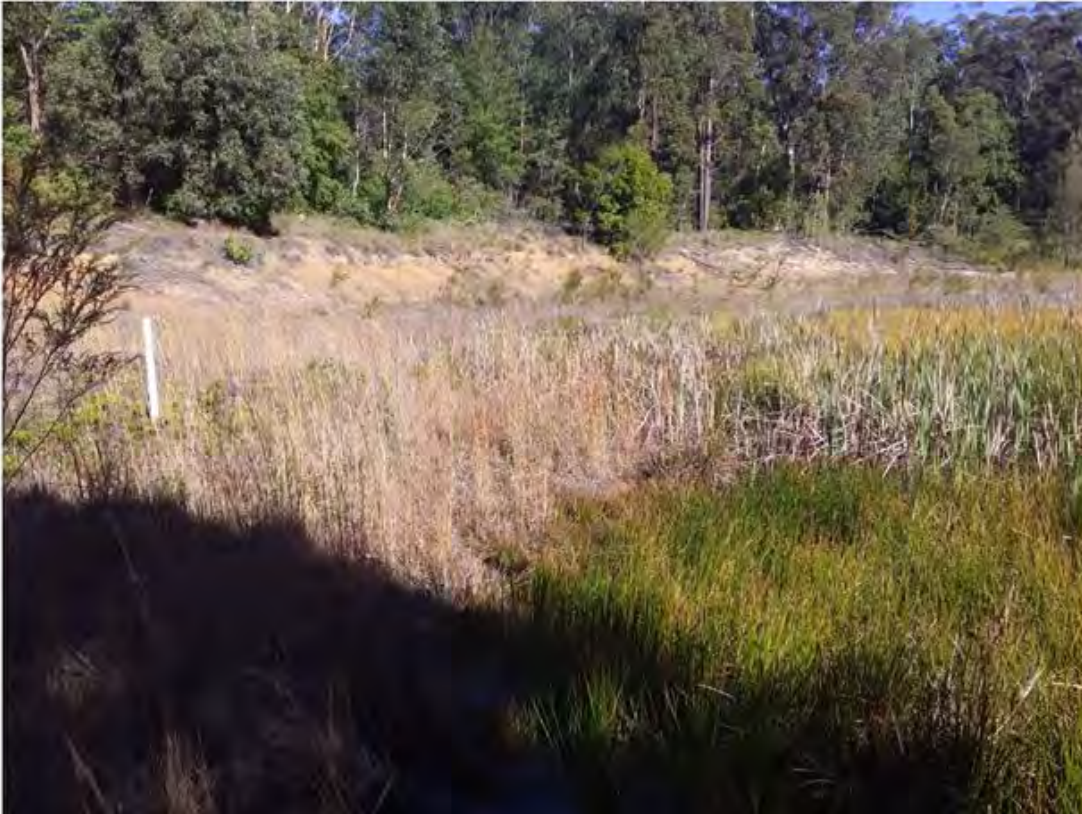
Photograph 1 Potentially Dispersive Soils in Banks of Teds Hole Storage

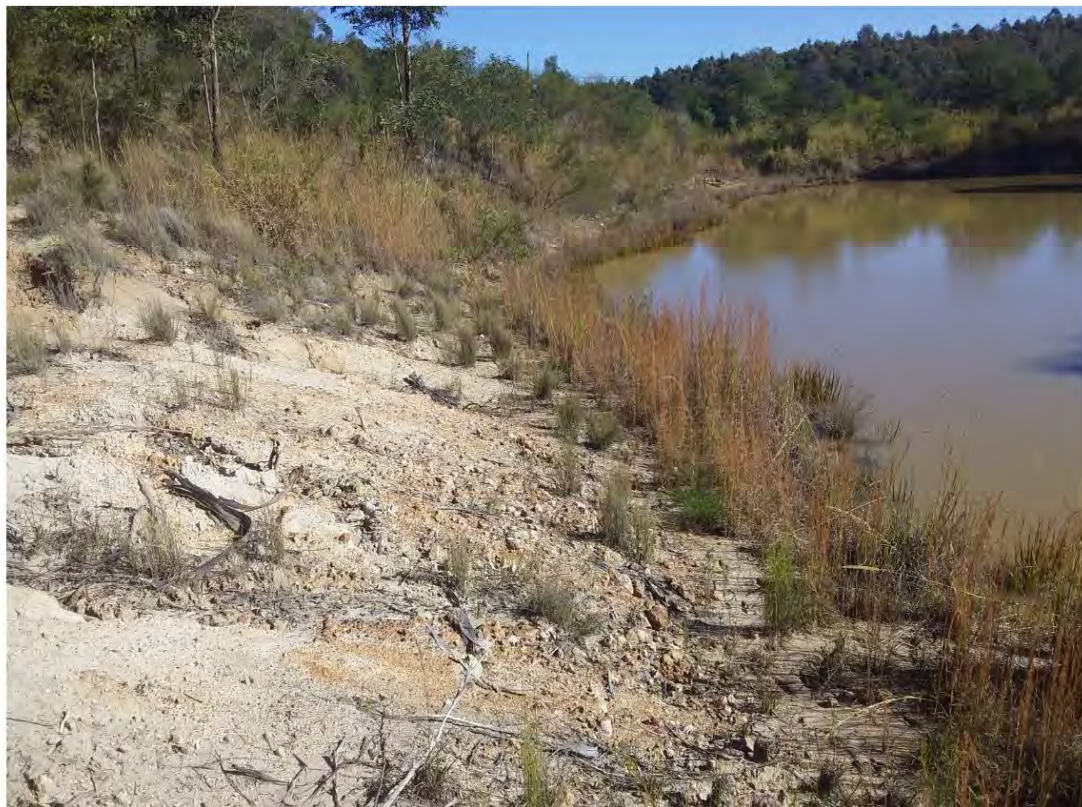
Photograph 2 Potentially Dispersive Soils around Foreshore of Sediment Dam D

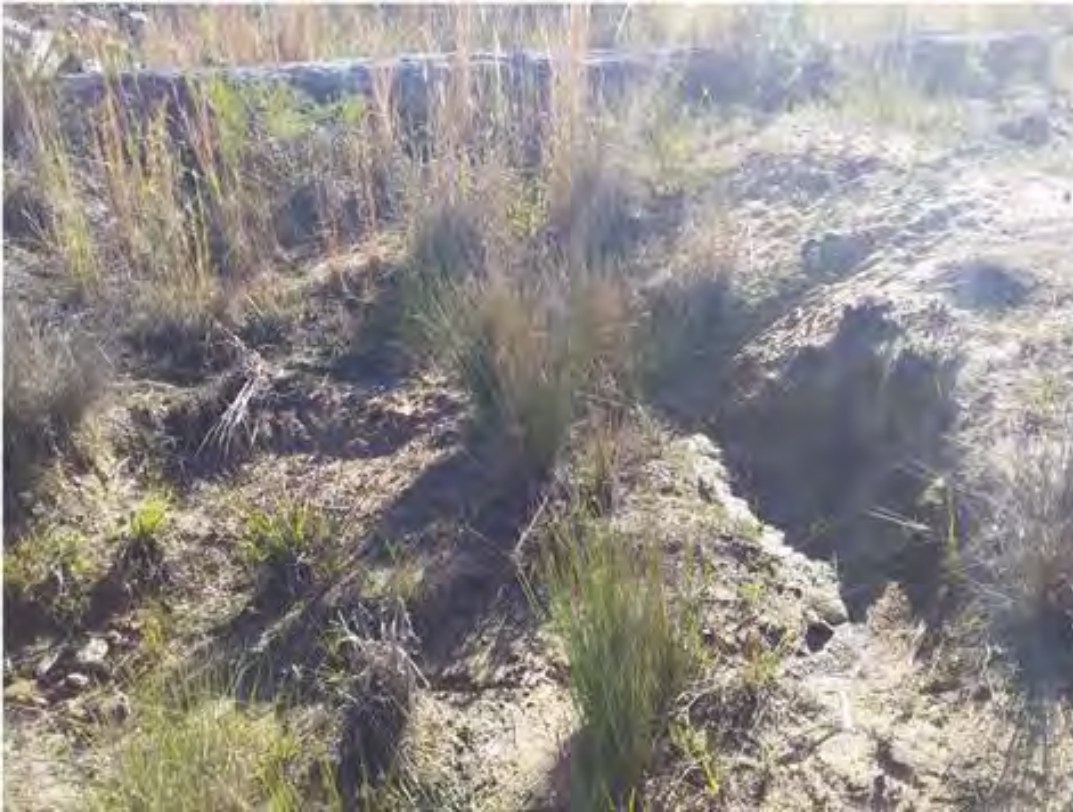
Photograph 3 Potentially Dispersive Soils in Banks of Sediment Dam 3 Storage
