Tasman Extension Project Environmental Impact Statement

SECTION 5

REHABILITATION AND MINE CLOSURE

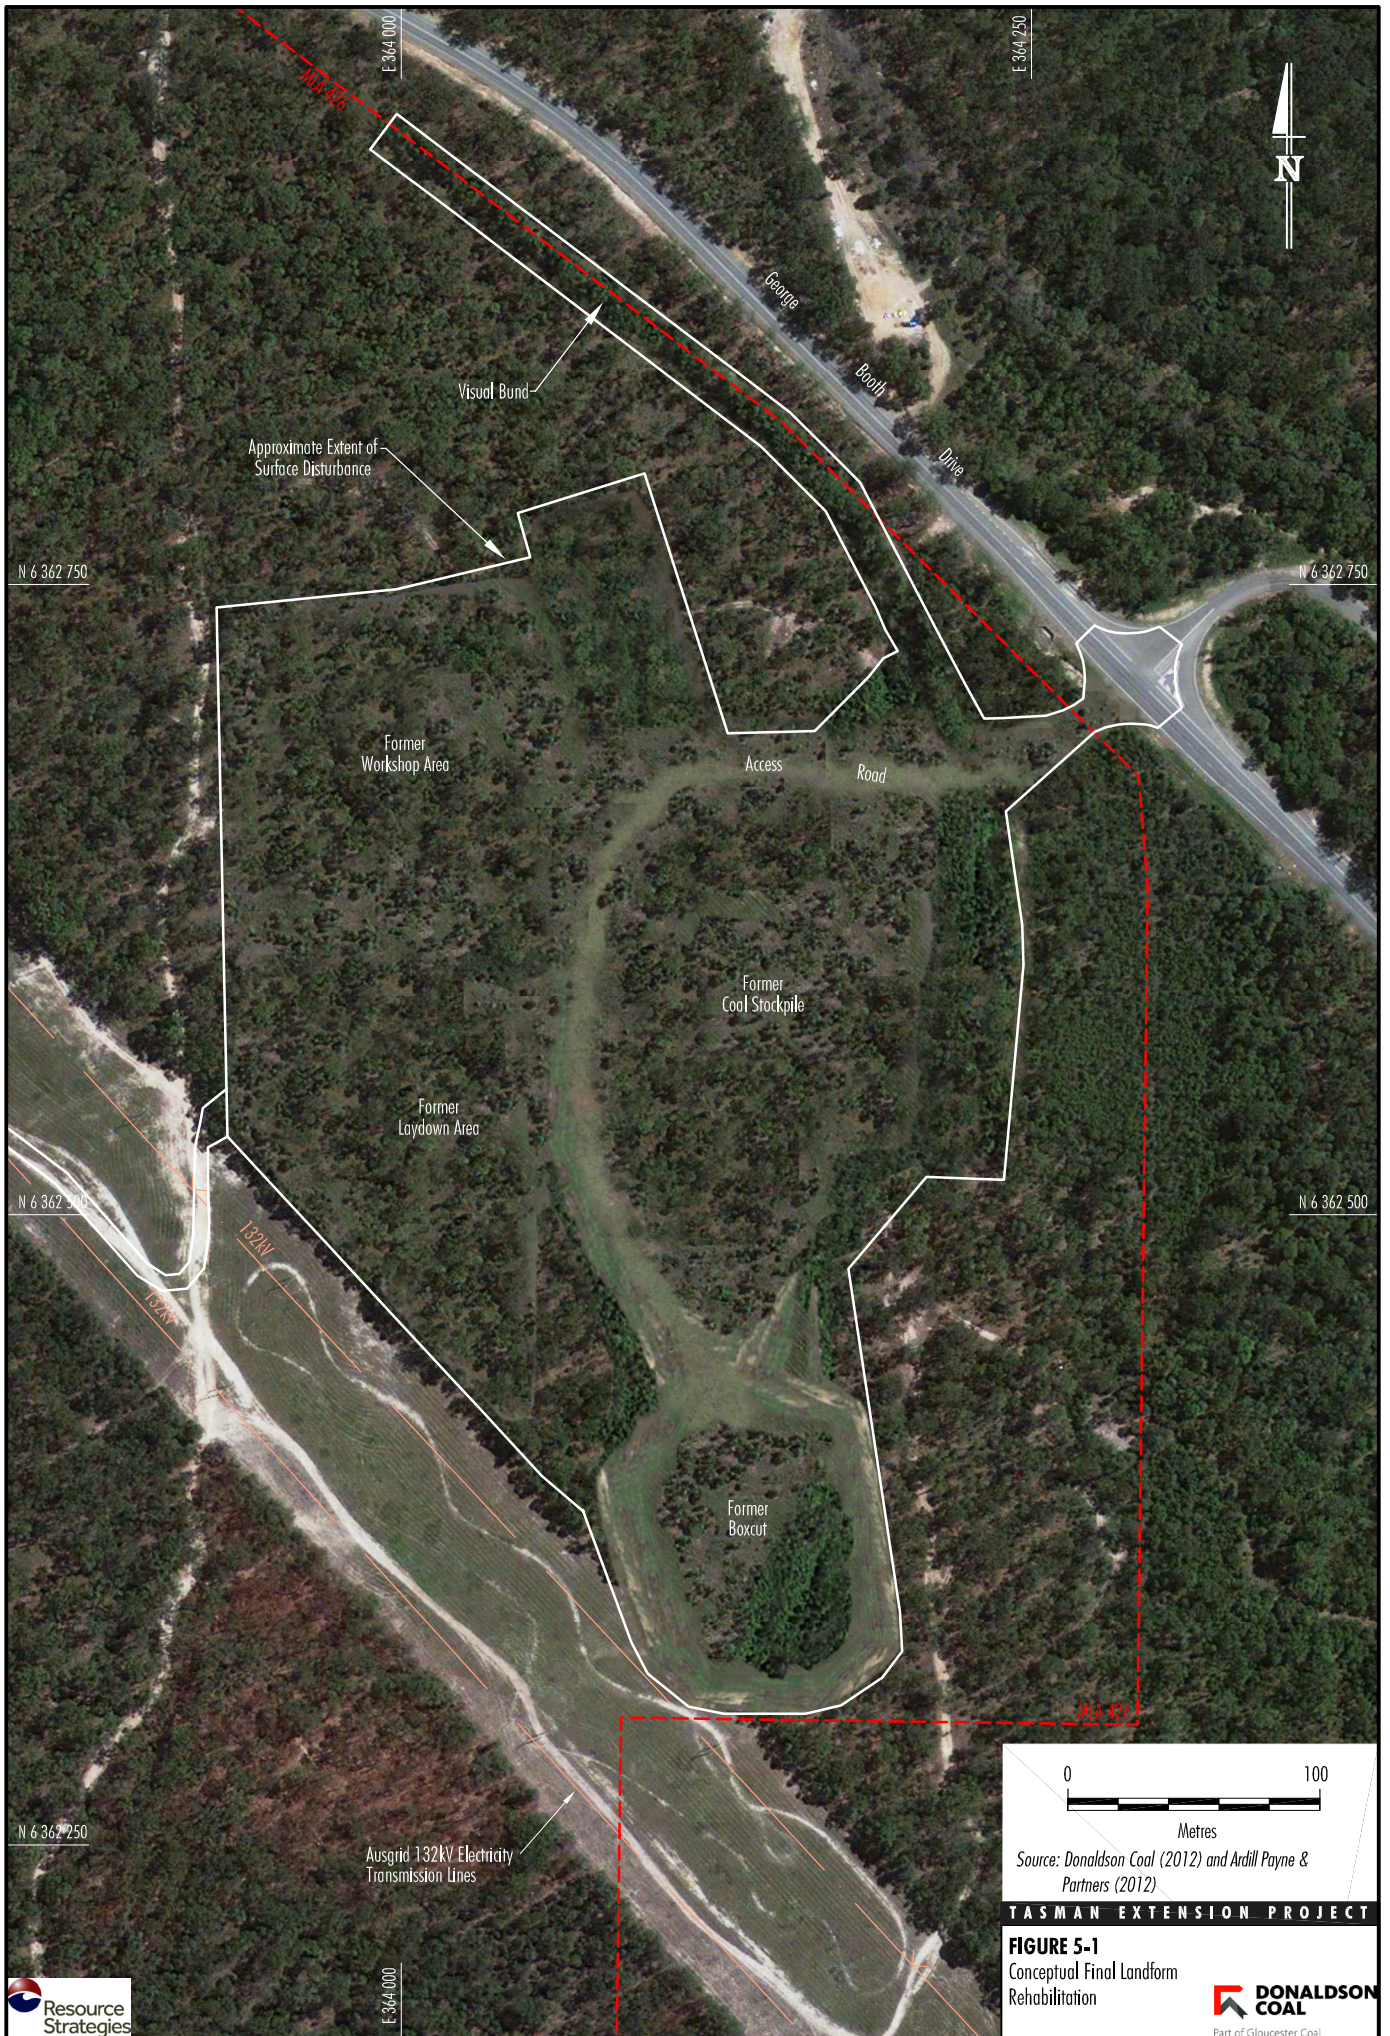
FIGURE 5-1
 Conceptual Final Landform Rehabilitation

Surface disturbance areas requiring rehabilitation at the cessation of the Project would include the new pit top facility, ventilation shaft site and any residual surface disturbance areas. Figure 5-1 shows a conceptual simulation of the rehabilitated final landform.
